MISSISSIPPI POWER & LIGHT COMPANY

SUBJECT: Grand Gulf Nuclear Station
Units 1 and 2
Docket Nos. 50-416 and 50-417
License No. NPF-13
File: 0260/L-860.0/M-018.0
TDI Diesel Generator, Supplemental
Information
AECM-84/0230

RESPONSES TO NRC UNRESOLVED ISSUES

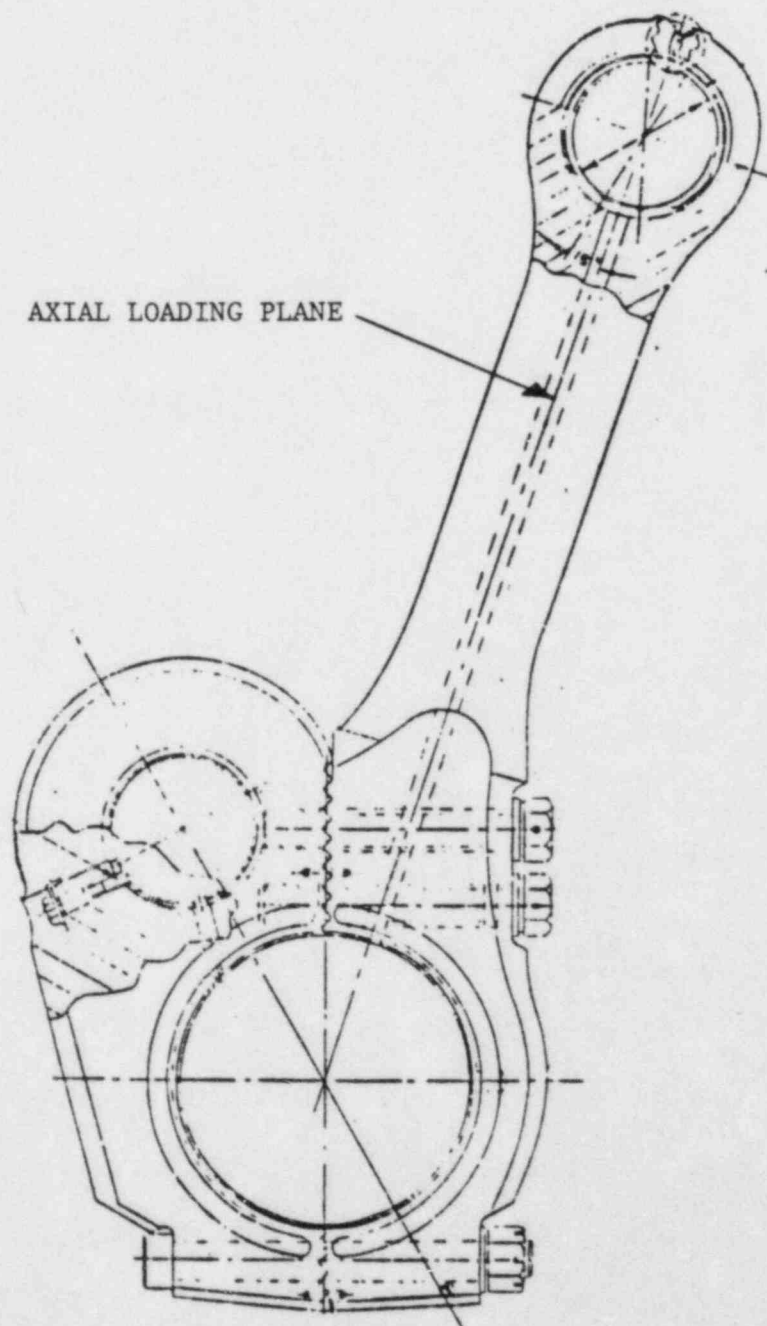
FIGURE 1

FaAA examined representative samples of the bushings found with linear indications on both used and as received bushings. These examinations, utilizing liquid penetrant and scanning electron microscopy, on both used and as received bushings, revealed no differences in either crack surface morphology or liquid penetrant indications. These findings demonstrate that the indications found by liquid penetrant technique do not propagate as cracks. Furthermore, when the bushings were cut for sample removal, the sample piece sprung apart indicating a residual compressive stress on the inside surface of the bushing. This residual compressive stress together with the operational stresses (i.e., firing loads) would put the bushing in a state of triaxial compression. FaAA also observed that the used bushing, which had shown a linear indication in the highly stressed zone, did not show any evidence of permanent deformation. The most highly loaded area of the bushing during operation is an arc of 15° on either side of the bottom of the bushing relative to the firing plane (the axial loading plane on Figure 1).

ARTICULATED CONNECTING ROD

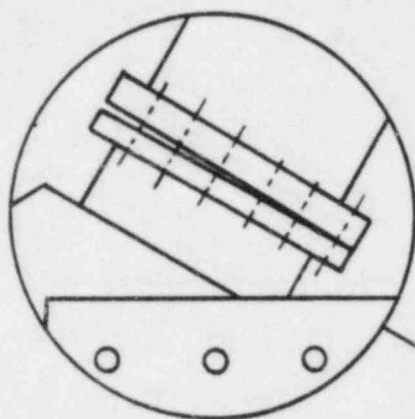
Condition of Turbocharger-
Intercooler Flanges with
Turbocharger Base Bolted
Down

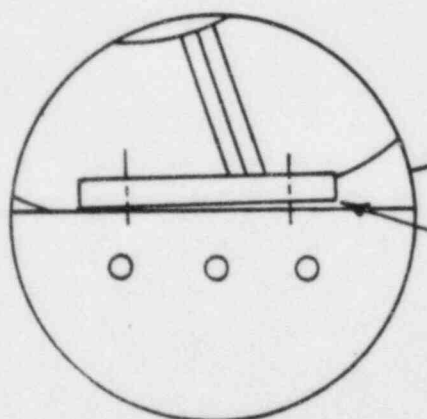
.030
GAP

Condition of Turbocharger
Base When Turbocharger-
Intercooler Flanges Bolted
Together

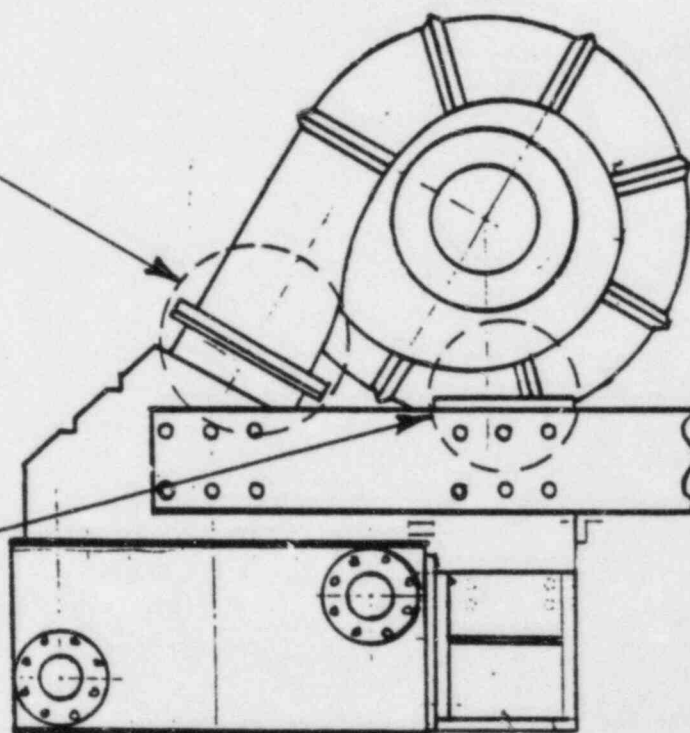
FIGURE 2

The alignment problems with the turbochargers are partially a function of the custom fit arrangement of the turbocharger with the flanged connections on the mating piping and apparatus. Each engine supplied by TDI has slightly different piping due to the fact that it is hand built. The specific problems encountered with the left bank turbocharger on the Division I D/G was the misalignment of the turbocharger and intercooler mating flanges. These flanges were misaligned such that if the flanged connection was tightened down, the turbocharger would cock on the mounting pedestal approximately 30 mils (Figure 2). This problem was attacked several times before a satisfactory conclusion was achieved. Finally, TDI recommended that (1) the intercooler flange be cut, (2) the turbocharger bolted down, (3) the intercooler flange be bolted to the turbocharger, (4) the intercooler flange tack welded to the intercooler, (5) the turbocharger removed, (6) the intercooler flange rewelded, (7) the turbocharger remounted, (8) the turbocharger bolted down, (9) the intercooler flange bolted up, (10) the turbocharger mounting bolts removed, (11) the mounting plate checked for clearances, (12) the turbocharger remounted, (13) a maintenance run performed, (14) the turbocharger mounting bolts removed, (15) the mounting plate rechecked for clearances, (16) the mounting bolts and reinstalled.

LEFT BANK TURBOCHARGER
MOUNTING ARRANGEMENT

At the end of this process the engine was tested for 100 hours and the mounting clearances rechecked. The final conclusion was that the problem has effectively been solved. The final clearances were 0,0,0,3 mils on each of the four corners of the mounting plate. This is considered acceptable and the successful completion of the 100 hour run demonstrated that the problem has been solved.
