NIAGARA MOHAWK POWER CORPORATION

June 2, 1972

Re: Provisional Operating License: DPR-17  
Docket No.: 50-220

# CONSOLIDATED ELECTROMATIC RELIEF VALVE

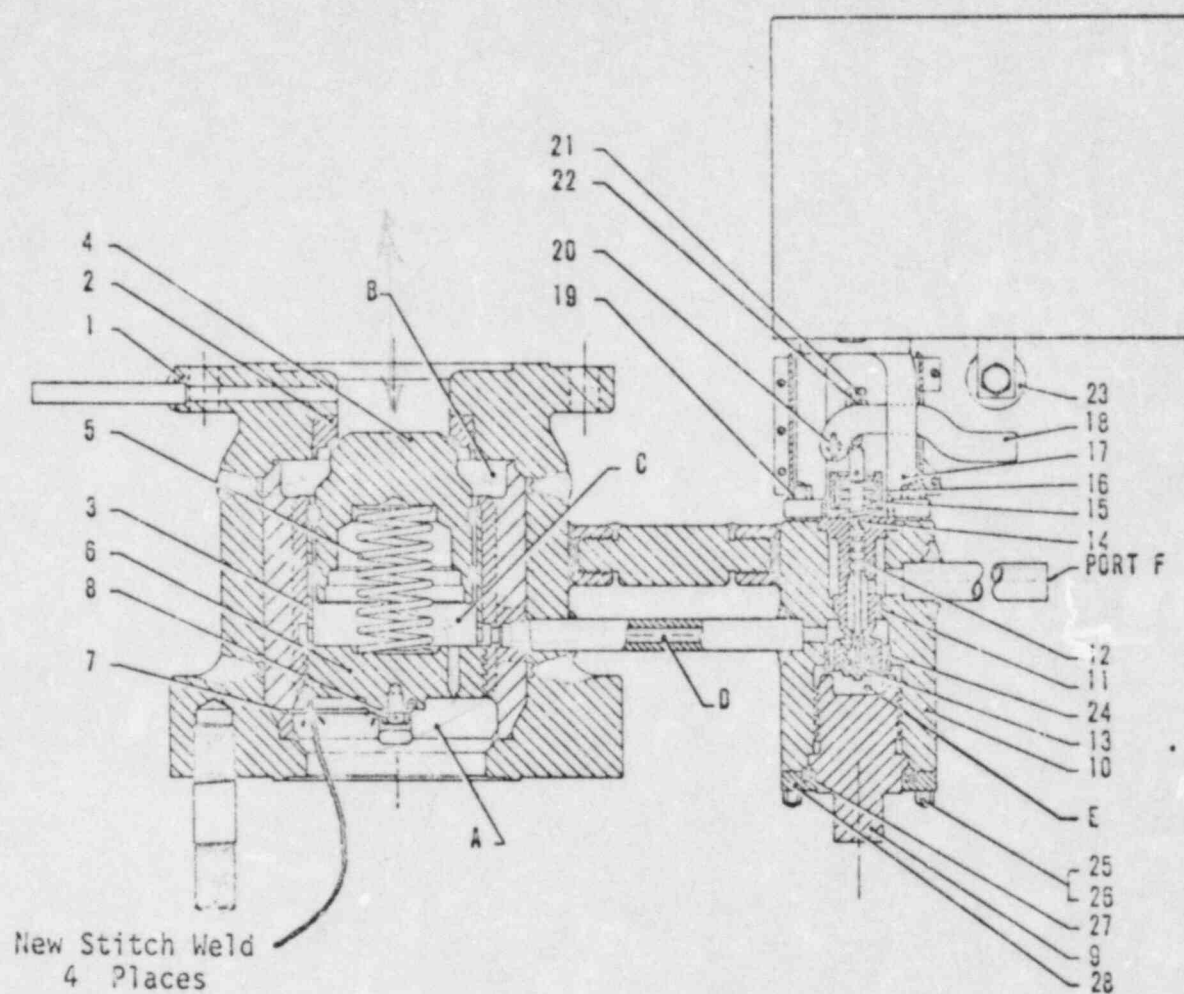
On one valve, the locking screw, Part #8 on enclosed drawing, had become unscrewed allowing lock retainer Plate #7 to fall free (both parts were recovered in the turbine stop valve strainer basket). This permitted the disc retainer, Part #6, to completely back-out falling to the bottom of the valve body. In this condition, it would be impossible to bleed enough steam from Chamber "C" to open the valve as it would be wide open to Chamber "A" and would not have the benefit of the restricting orifice in the retainer plate.

One other valve was found with the locking screw, Part #8, backed out 1/16" but the lock retainer plate and disc retainer had not moved, therefore the valve was operable. Tie-wires holding the locking screws were broken on all six valves.

- #4 Valve Disc.
- #6 Disc Retainer
- #7 Lock Retainer Plate
- #8 Locking Screw

Repair was effected to all six valves by removing the locking screw, Part #8, and lock retainer plate, Part #7. In their place, four 1/4" V grooves, 1" long, were cut in the joint between the disc retainer and the valve body insert. These were stitch welded together. Future maintenance may be accomplished by grinding out the stitch weld. In this manner, there can be no loose parts on the valves to drop into the steam lines and dependability of valve operation is increased.
