Jersey Central Power & Light Company

January 17, 1973

Subject: Oyster Creek Station
Docket No. 50-219
Valve Malfunctions

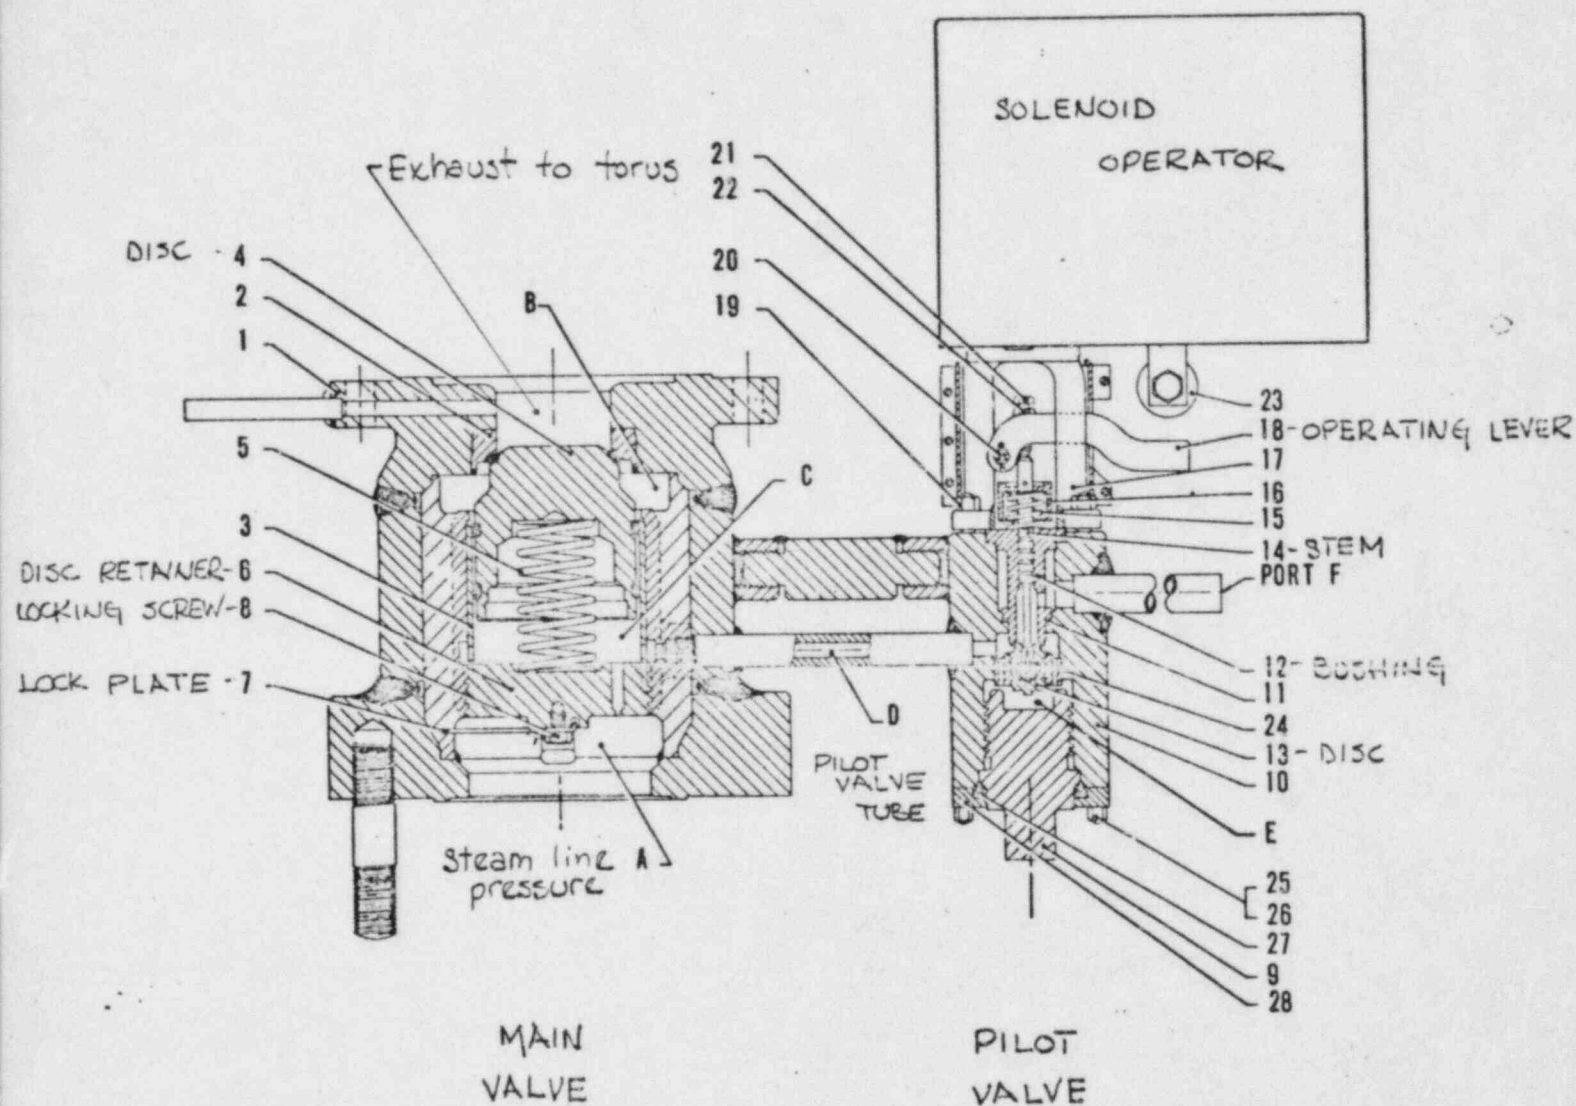
FIGURE 1

Figure 1 attached identifies the valve parts under discussion.

Further investigation revealed that a piece of thread material from the disc retainer of the main valve had blown through the pilot valve tube. During the valve actuation it became lodged between the pilot valve seat and disc, thus the pilot valve was not able to fully close which, in turn, maintained the main valve in an open position.

It was also noted that the tie wire, lock screw and lock arm were missing from the disc retainer. Since the lock arm and screw were missing from the "D" valve, the remaining 4 relief valves were removed for inspection. As a result of this inspection, it was found that a small tab from the lock arm of the "B" relief valve had also broken off. Similar parts for the other 3 valves were found to be in place and secure. In addition, it was observed that the valve operator's spring guide for the "E" relief valve was misaligned, thus causing the solenoid plunger to be restricted in its upward travel.

In order to prevent recurrence of lock arm failures, these components were removed from all relief valve assemblies. A new method of preventing disc retainer rotation was installed. This method consists of pinning the disc retainer to the cage. Dresser Company, manufacturer of the valves, was contacted concerning this repair and approved same, taking into consideration that the installation of a set screw can in no way cause the clearance between the threads to increase. All other lead threads on each disc retainer were examined and feathered edges removed as necessary. The spring guides for the "E" valve were realigned and the solenoid plunger was checked for freedom of movement.

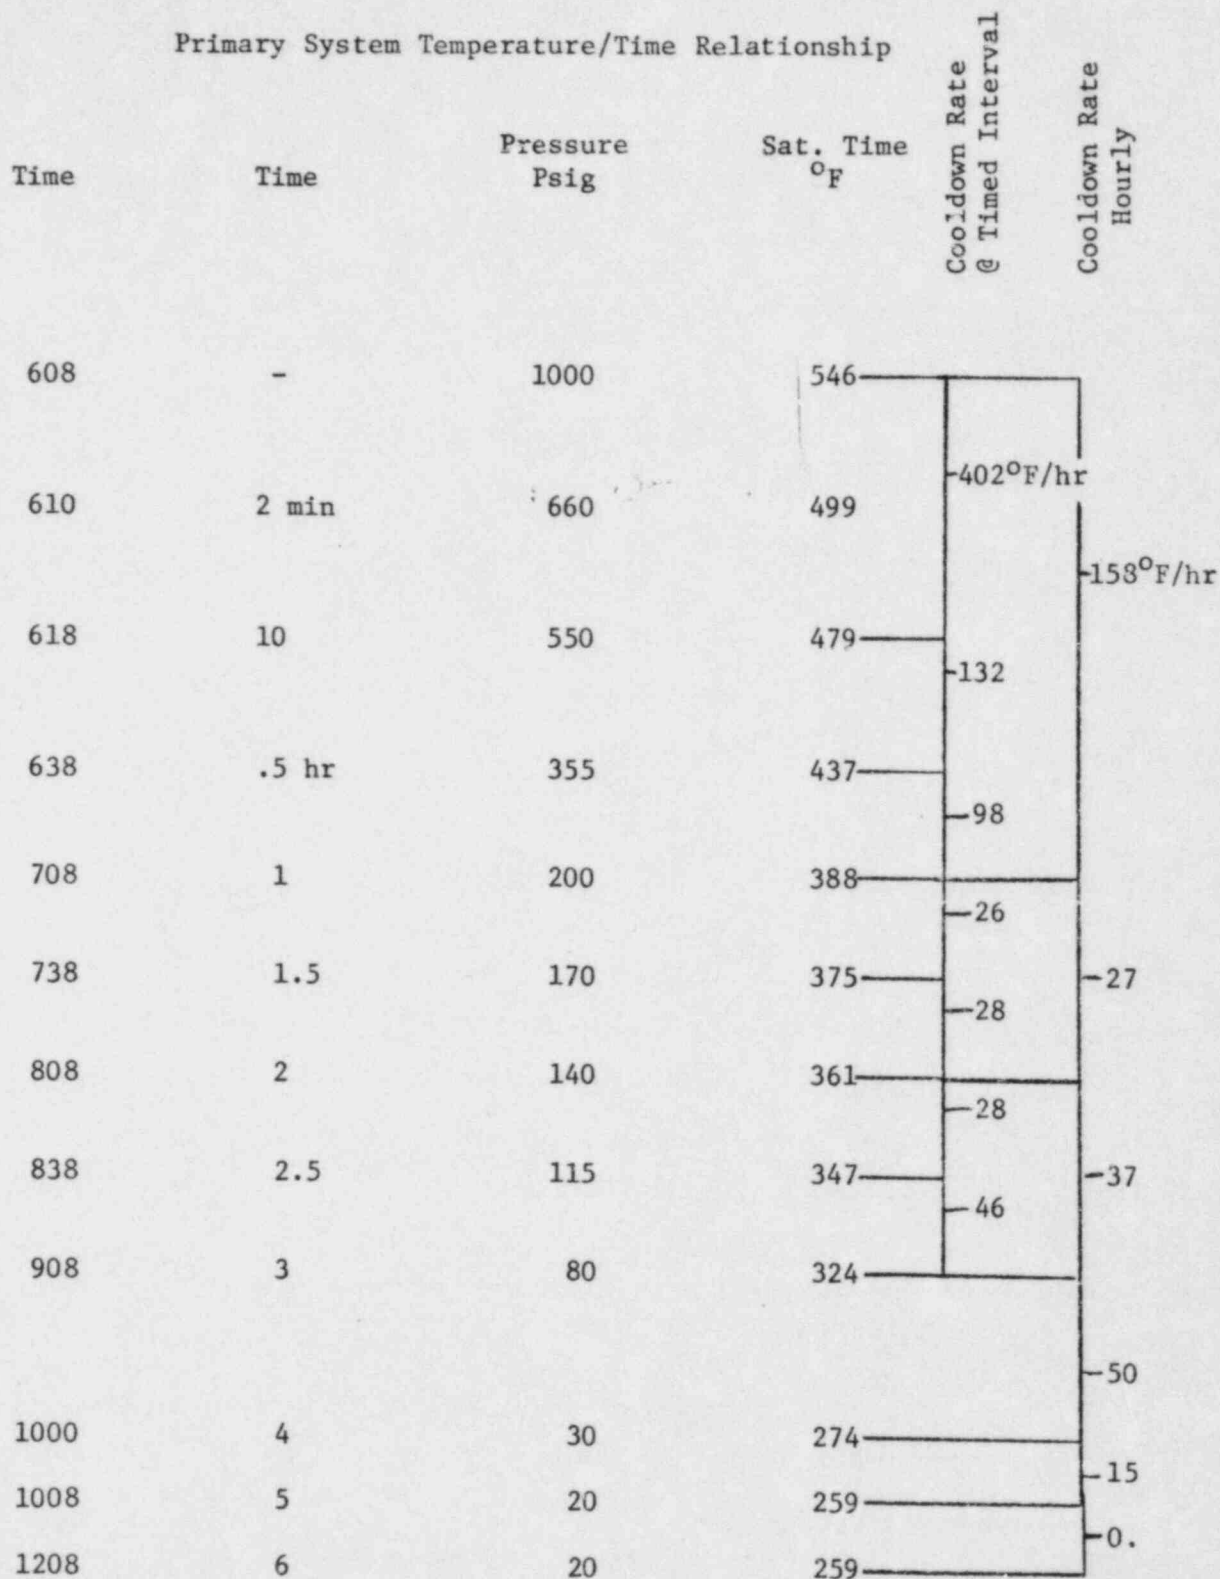
Primary System Temperature/Time Relationship

The safety significance associated with this event centers around the blowdown event. The attached tabulation develops the actual primary system temperature/time relationship.

This event nearly approximates the blowdown case analyzed in Report Number CENC-1143, "Analytical Report for Jersey Central Reactor Vessel". The actual temperature transient analyzed is as follows:

According to this report, which is the basis for Amendment No. 16 of the FDSAR, the reactor head studs are the most limiting components for the blowdown event, being allowed 308 blowdown cycles. The next most limiting component (non-replaceable) is the support skirt which is allowed 780 cycles. The most limiting reactor components considering a 300°F/hr. cooldown from 546°F to 100°F are again the head studs (280 cycles) and the support skirt (780 cycles - based on the more severe stresses caused by the 100°F/hr. cooldown from 546°F to 100°F). Therefore, no unreviewed safety significance is associated with this event other than counting it as a thermal cycle due to a blowdown. Concerning the failure of the "D" Electromatic Relief Valve, the safety significance of this event has been previously analyzed in Amendment No. 15, Section II of the FDSAR (Primary Containment Design Report).
