# Jersey Central Power & Light Company

Subject: Oyster Creek Station  
Docket No. 50-219  
De-energizing of a Backup Scram Solenoid

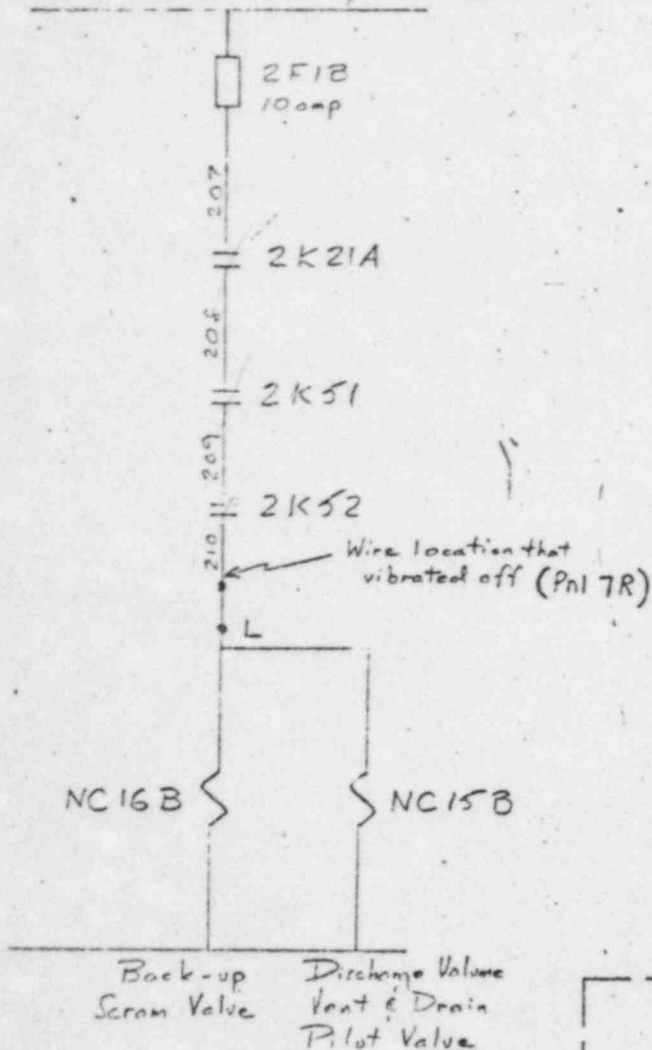
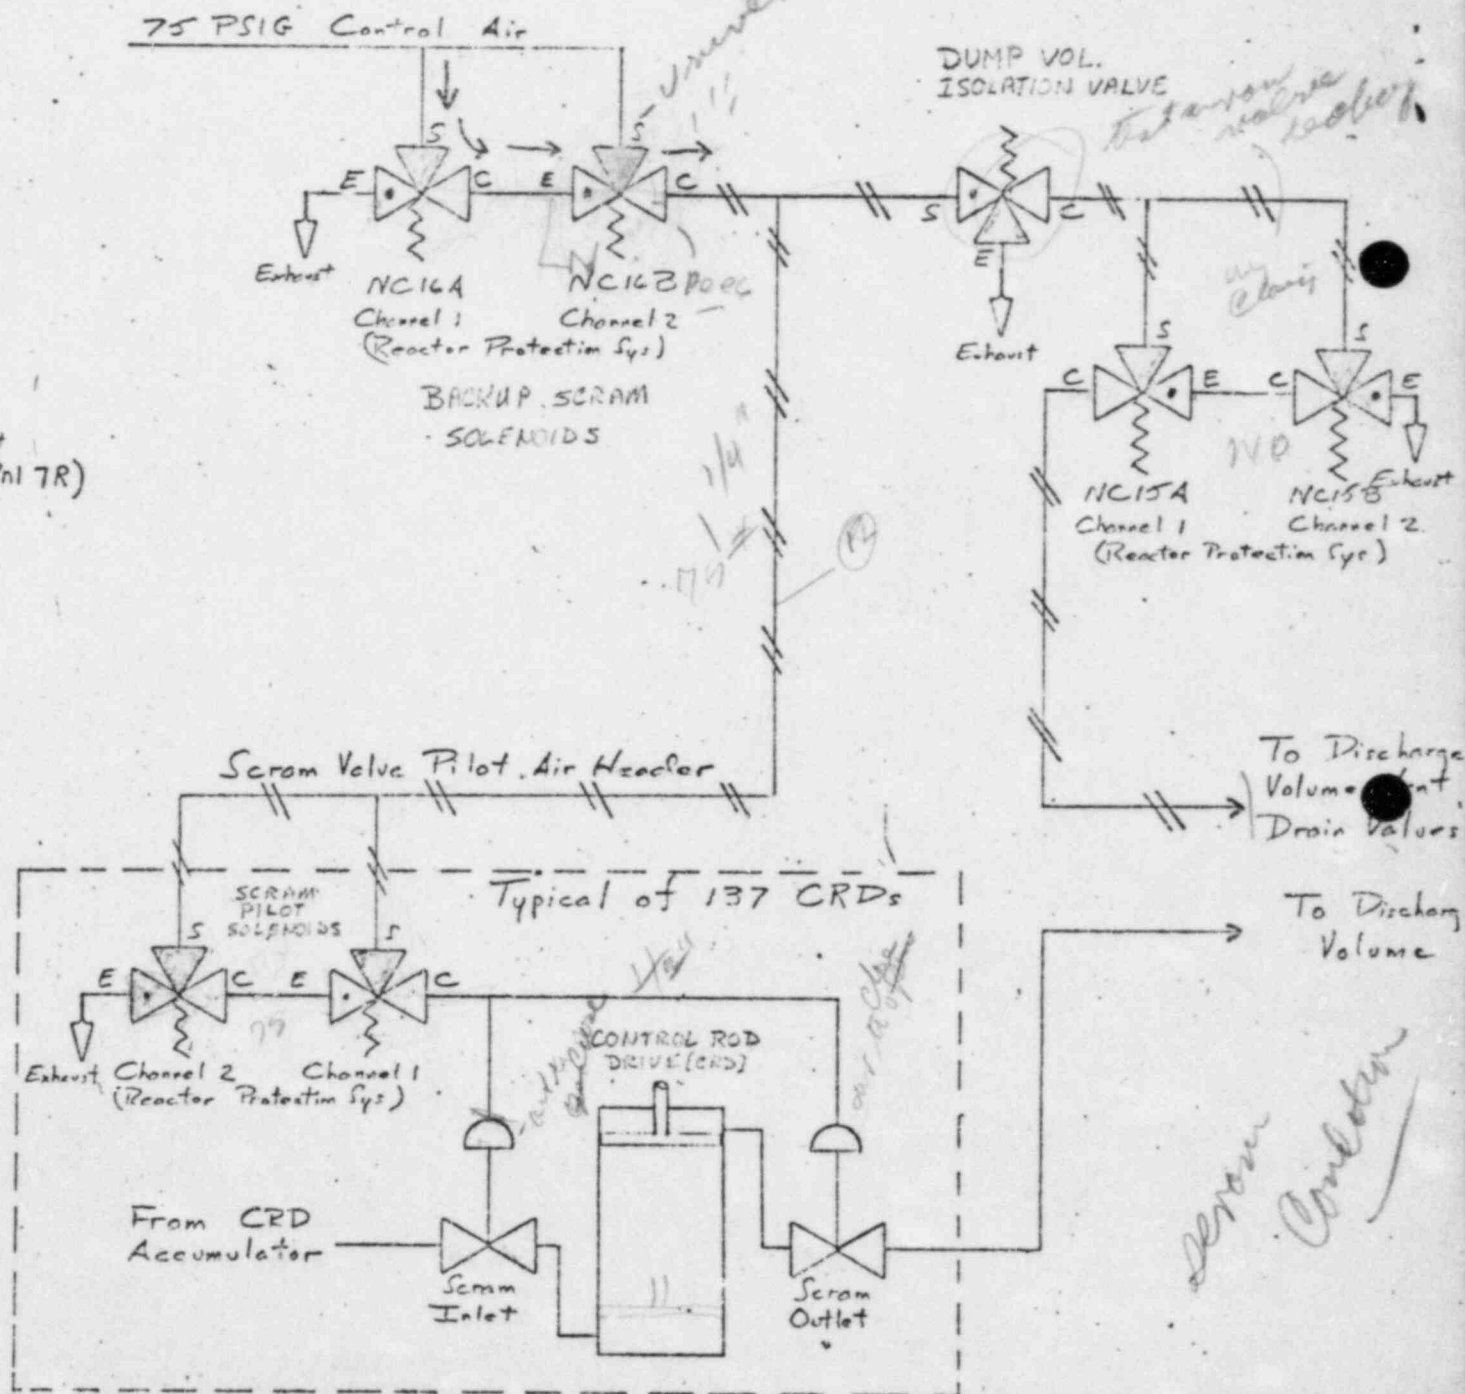
# Reactor Protection System II

The cause of the loss of air pressure was the de-energizing of a backup scram solenoid valve caused by a loose wire connection on an auxiliary contact of relay 2K52 in the reactor protection system (see attached drawing). Until this event occurred, it was assumed that the failure of one solenoid would not cause a loss of scram pilot header air pressure. Two conditions contributed to the loss of air in the scram valve pilot header:

1. When NC16B is de-energized, the air supply to the scram valve pilot header flows through NC16A from the supply port out the cylinder port into the exhaust port of NC16B and out the cylinder port to the scram valve pilot header (indicated by arrows on the attached drawing). When in this configuration, there is a restriction of air flow through the exhaust port due to the pilot-type construction of the valve. This condition has existed unknowingly since the plant was placed in operation.
2. A large number of the scram pilot solenoids (on each control rod drive) have minor air leaks through the "O" ring seal and the cap nuts. This leakage is not a problem during normal operation because the small leakage is made up from the control air supply through NC16B.

Only during an abnormal situation, when the backup scram solenoid NC16B is de-energized and the channel 2 scram pilot solenoids are energized (as happened here), can the combination of leakage in the scram pilot solenoids and restricted flow through the backup scram solenoid result in decreasing pressure in the scram valve pilot air header.

The loose wire was reconnected and a test was performed to duplicate the event. In the case where a half scram was applied to channel 2, NC16B and channel 2 scram valve pilot solenoids are de-energized, the header pressure remained steady. This air pressure was being supplied at the time from NC16A through the restricted exhaust port of NC16B, but there is no leakage path to atmosphere when the 137 scram valves are in their de-energized position. The solenoids were then energized and the wire disconnected on relay 2K52. The header pressure immediately started to decrease. When the header pressure reached 40 psi, the wire was reconnected and the pressure returned to normal. Cap nuts were tightened on many of the scram pilot solenoids to minimize the air leakage. The vendor has been contacted for recommendations to correct the flow restriction through the backup scram solenoid exhaust port. New "O" rings are on hand and will be installed at the next convenient shutdown.
