Subject: Reportable Occurrence 76-08 (14-day report), Abnormal  
degradation of steam generator tubes  
R. E. Ginna Nuclear Power Plant, Unit No. 1  
Docket No. 50-244

LER 76-08/1T  
LICENSEE EVENT REPORT

Ginna Station  
Steam Generator Inspection  
Final Report  
March 9, 1976

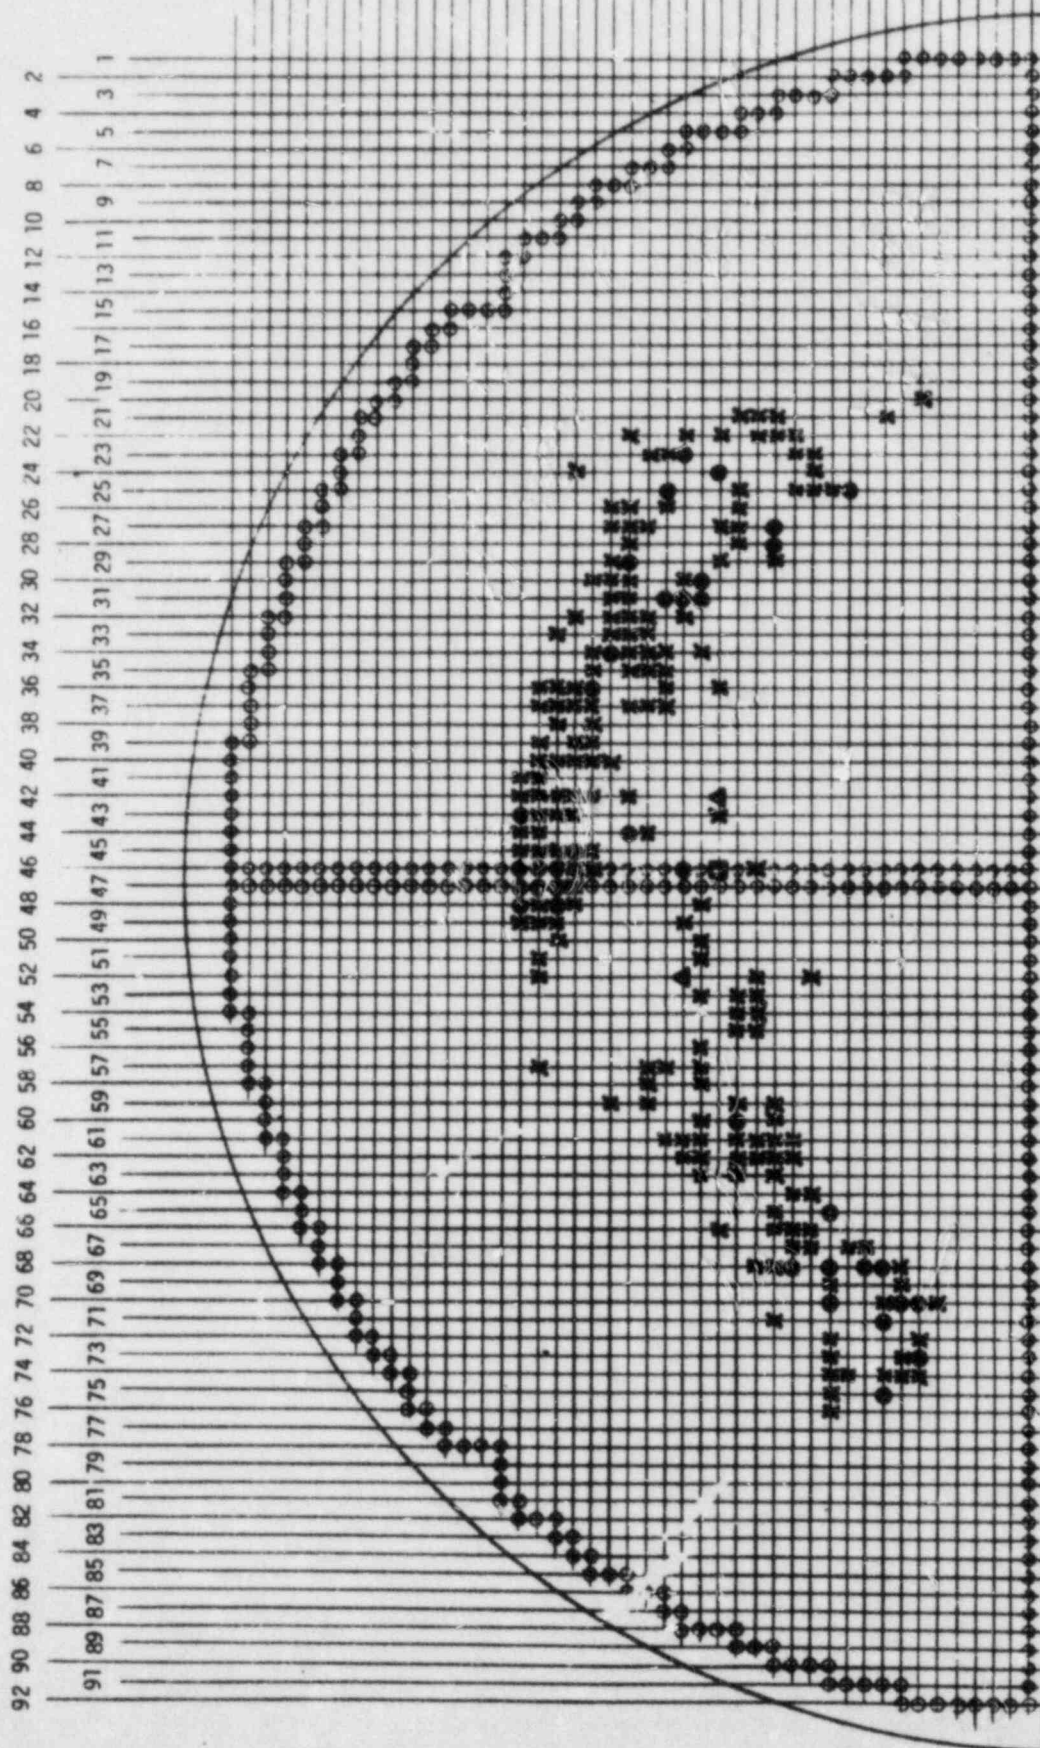
FIGURE (5)

All of the eddy current indications were within the first few inches of tubing directly above the tube sheet. These indications, with the exception of three, are postulated to be due to wastage, based on growth rates. The excepted three tubes, in the "A" inlet, due to their larger growth rates compared to the mean, may have been caused by concentration of caustics. Confirmation of this is not possible since the eddy current examination method cannot differentiate between indications resulting from either wastage or stress corrosion cracking, but can accurately measure the maximum defect penetration to within normal statistical variation. The indications are seen only in those areas where indications have been previously noted. There has been no expansion of the indication region to other areas of the steam generators. This inspection confirmed that the tube leak found in January 1976 was a random failure as reported in Reportable Occurrence 75-13.

Several things are noted from a comparison of results shown in Figures (5) through (7). First the A inlet, with 39 tubes  $\geq 40\%$  indications (present pluggable defect size) has shown only a 5% average growth rate over the past year considering tubes which had indications  $\geq 20\%$  for the last two inspections. Figure (8) is a histogram of the growth rate. Similarly, the "B" inlet has shown only small changes in degradation with the average growth rate over the past year, for tubes  $\geq 20\%$ , of a negative 1.72% and 2 pluggable tubes. A histogram for the "B" inlet indications is shown in Figure (9). This negative mean for changes in indication magnitude is attributed to statistical variations in the eddy current examination

attack of the tube. That the degradation was caused by pockets in the sludge is supported by the fact that 33 of the 39 pluggable tubes in the "A" inlet which deteriorated to  $\geq 40\%$  indications were in adjacent areas within the historical sludge kidney area. Figures (10) through (13) illustrate the sludge profiles for this most recent inspection.

"A" INLET  
EDDY CURRENT INDICATIONS

- a. All tubes with eddy current indications of wall penetration greater than or equal to 40% were plugged.
- b. A thorough lancing of the secondary side of the tube sheets was performed in both steam generators to remove as much as possible any remaining phosphates and/or caustics contained within the sludge. Sludge lancing of both steam generators will be continued in an effort to keep sludge content to a minimum. The lancing, coupled with blowdown during startup and normal operation, should considerably reduce the probability of significant tube degradation during the plants' subsequent operation.

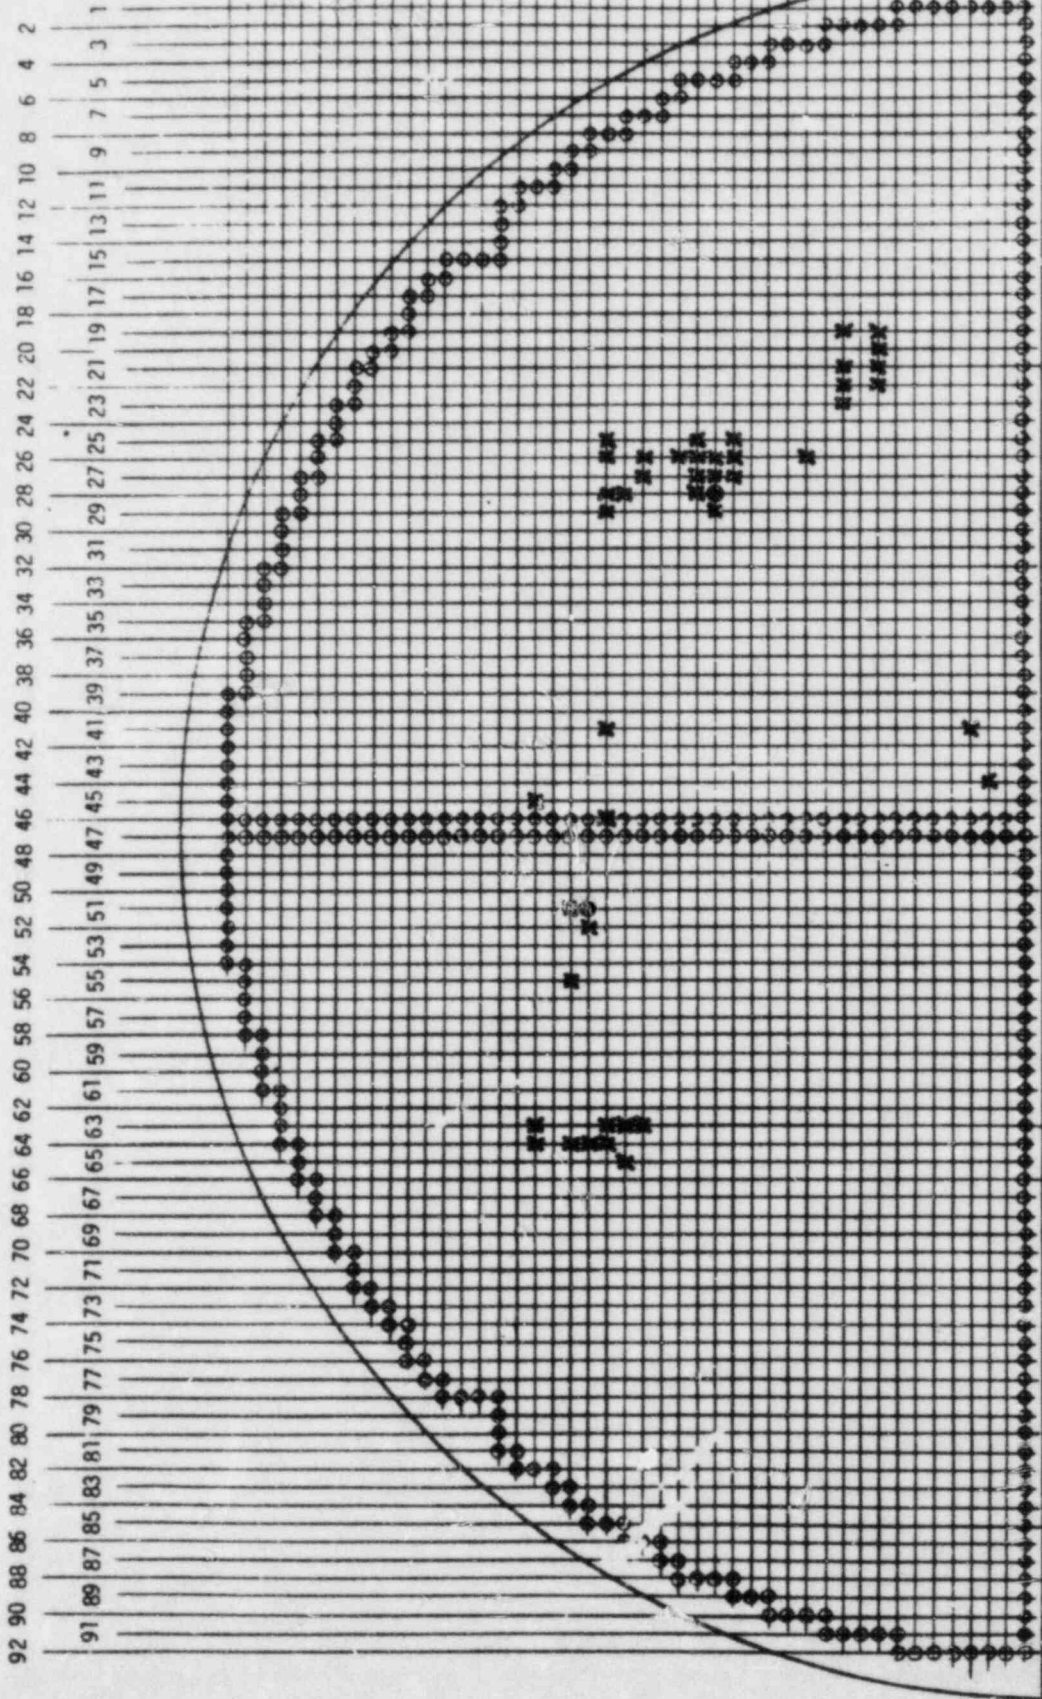
FIGURE (6)

# "B" INLET EDDY CURRENT INDICATIONS

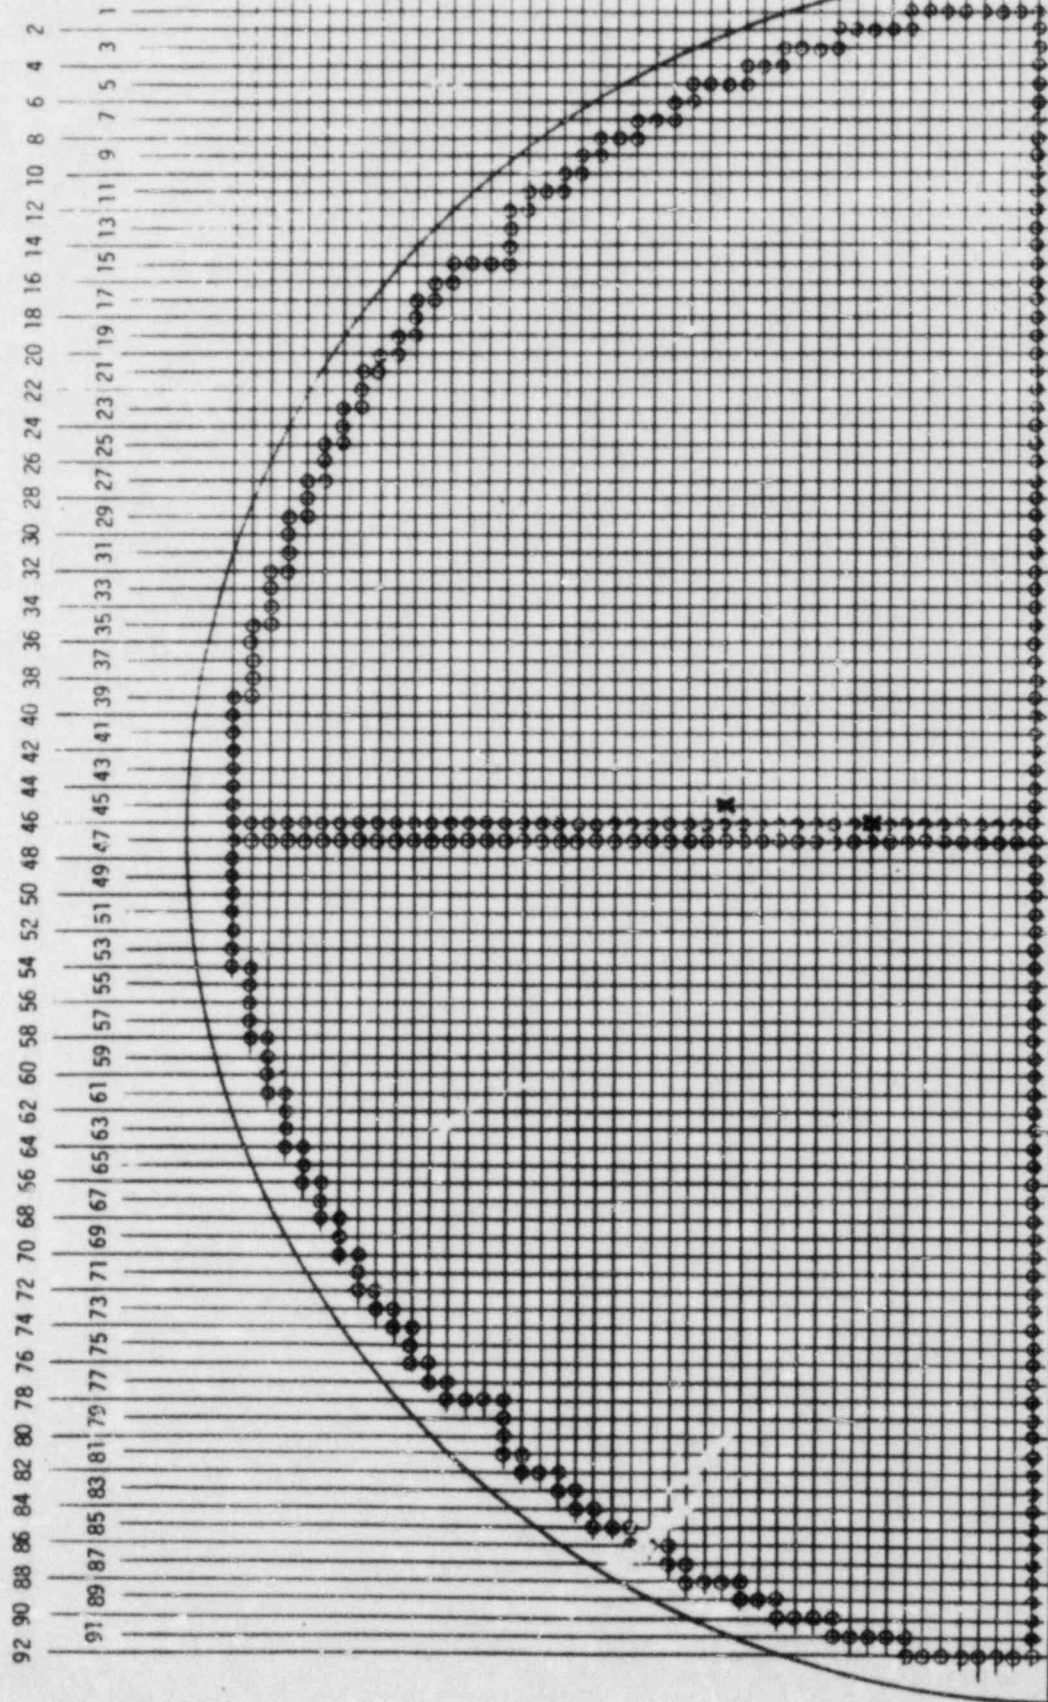
FIGURE (7)

method. The "A" outlet continues to be in excellent condition with only 10 indications of <20% and no reportable ( >20%) indications. The "B" outlet has a large number of indications < 20%. This large number is due to the increased number of inspected tubes and the differences in interpreters of the eddy current examination results. There were two indications >20% with both <25%.

# "B" OUTLET EDDY CURRENT INDICATIONS

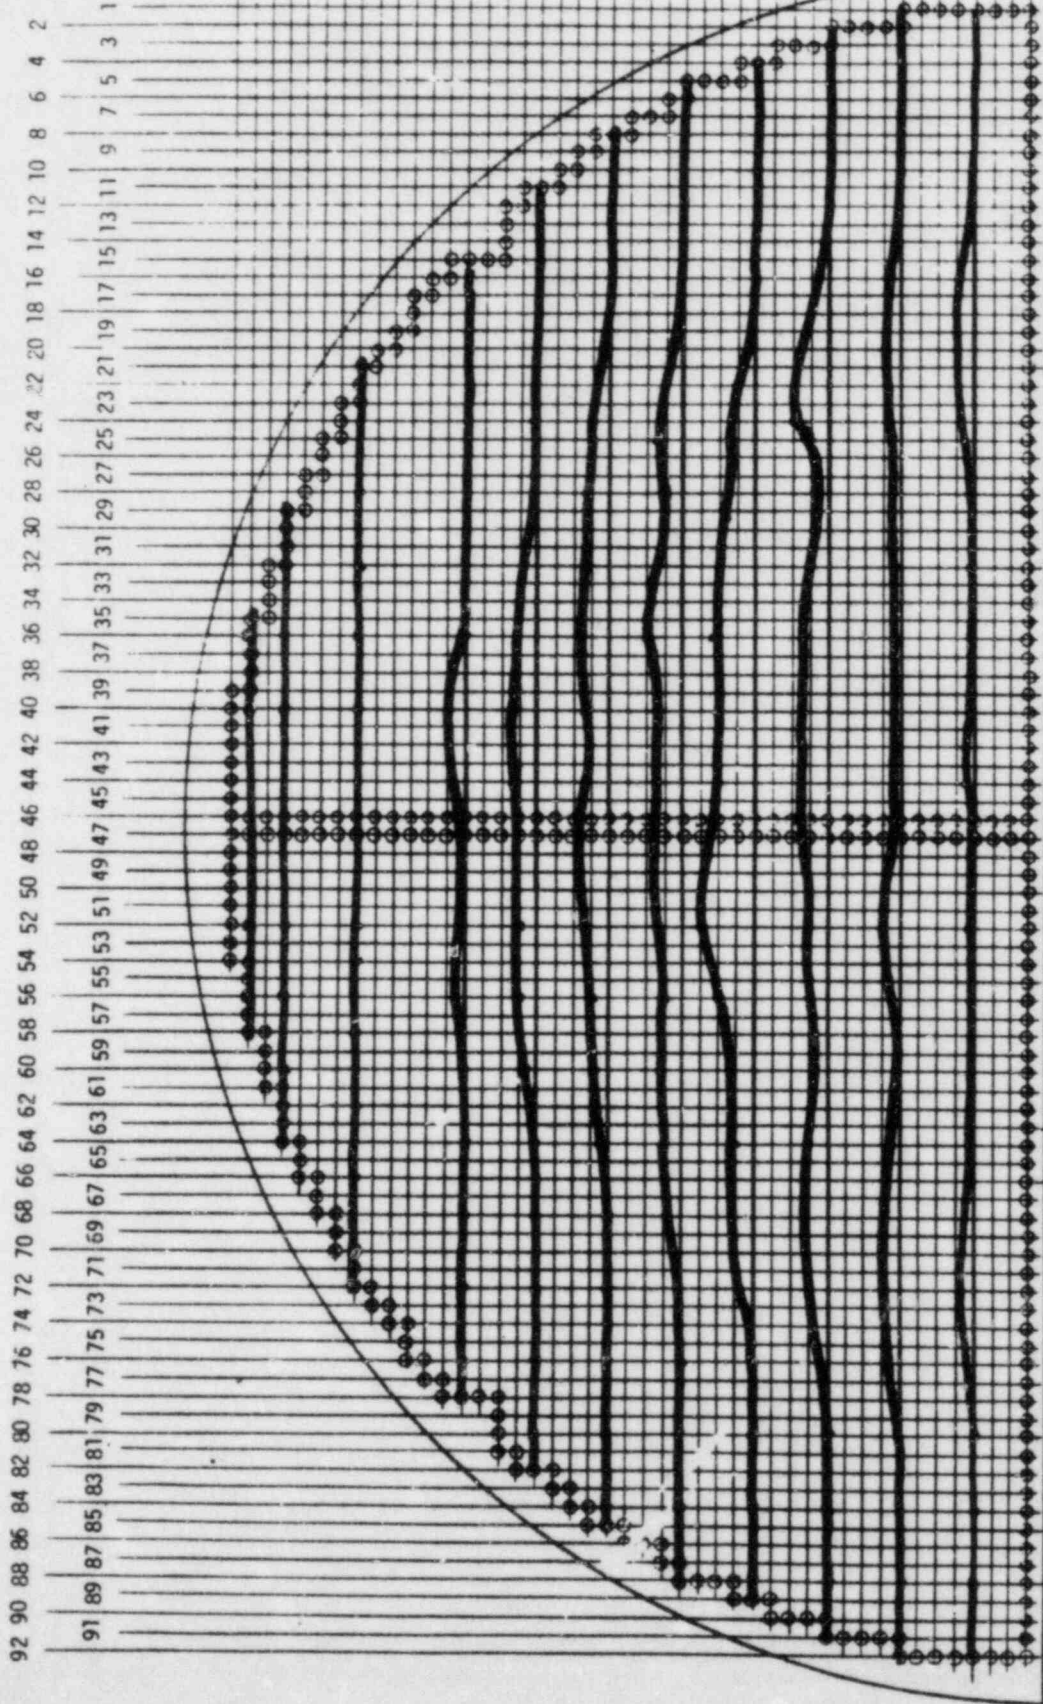
FIGURE (10)

The series of modifications performed on the steam generators in March 1975 to decrease the area of the tube sheet which is susceptible to low flow conditions and sludge buildup have reduced the average sludge depth but has not significantly changed the area of the sludge deposition.

# "A" S/G INLET SLUDGE PROFILE

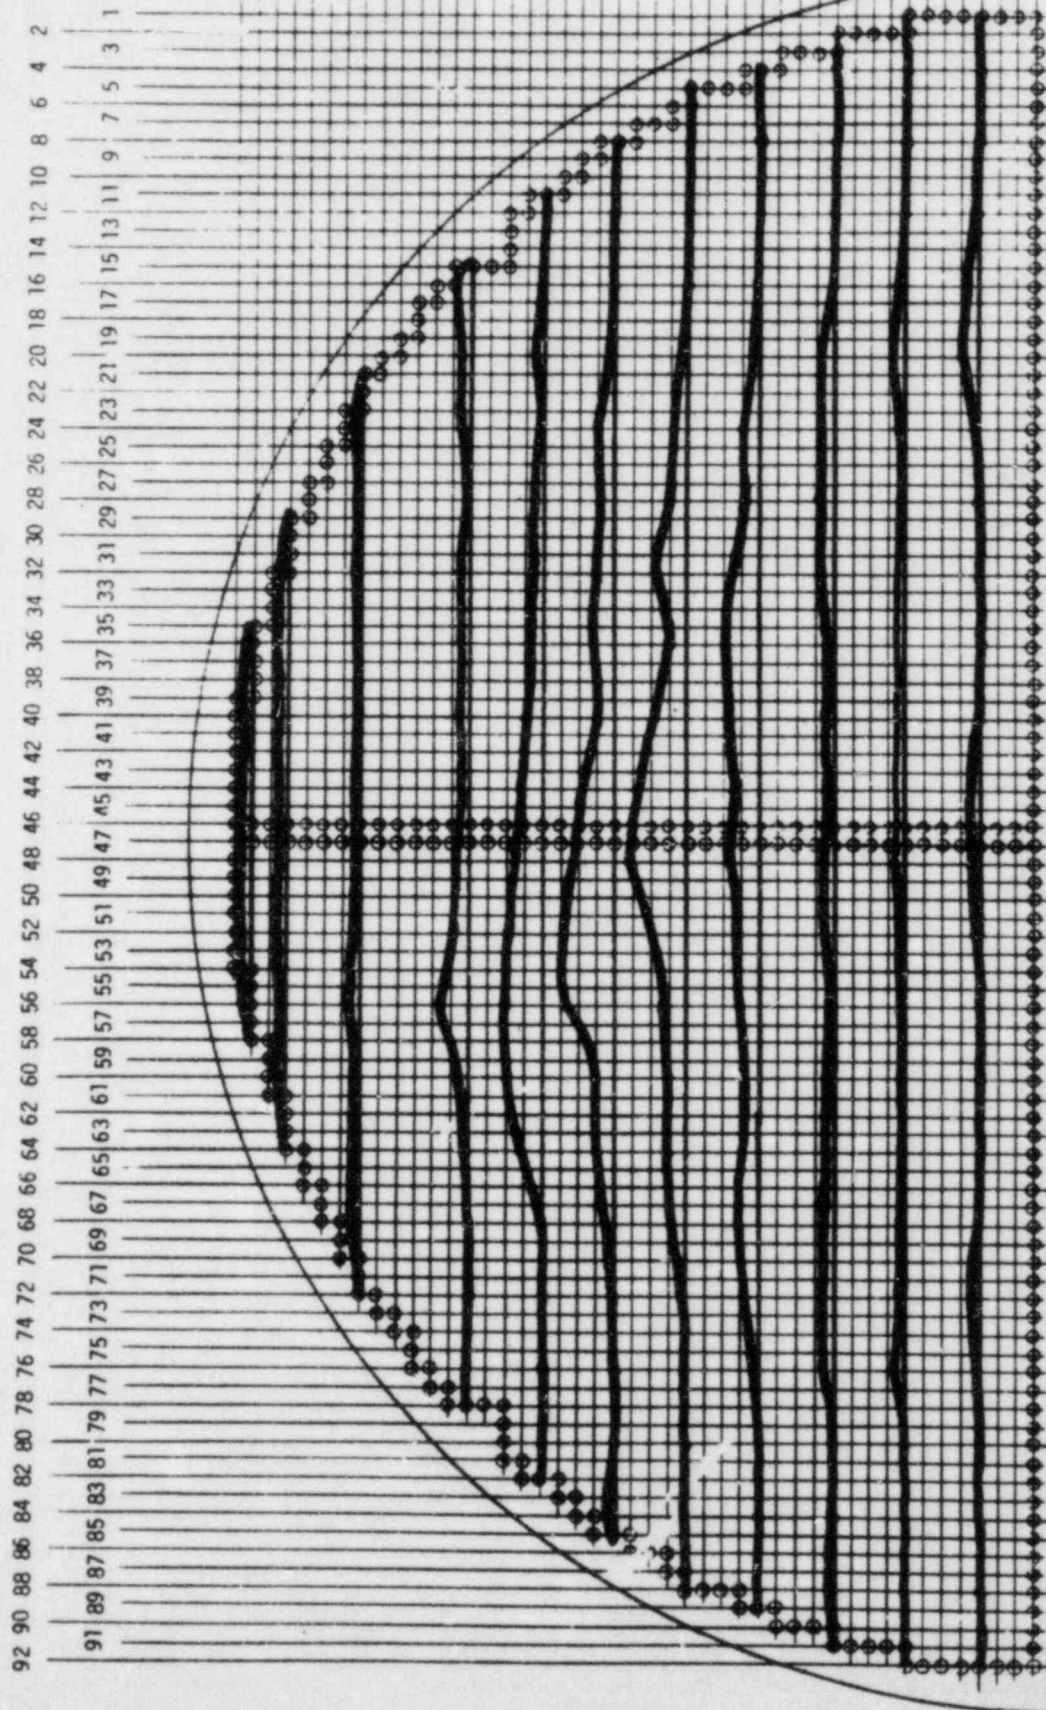
FIGURE (12)

"B" S/G INLET  
SLUDGE PROFILE

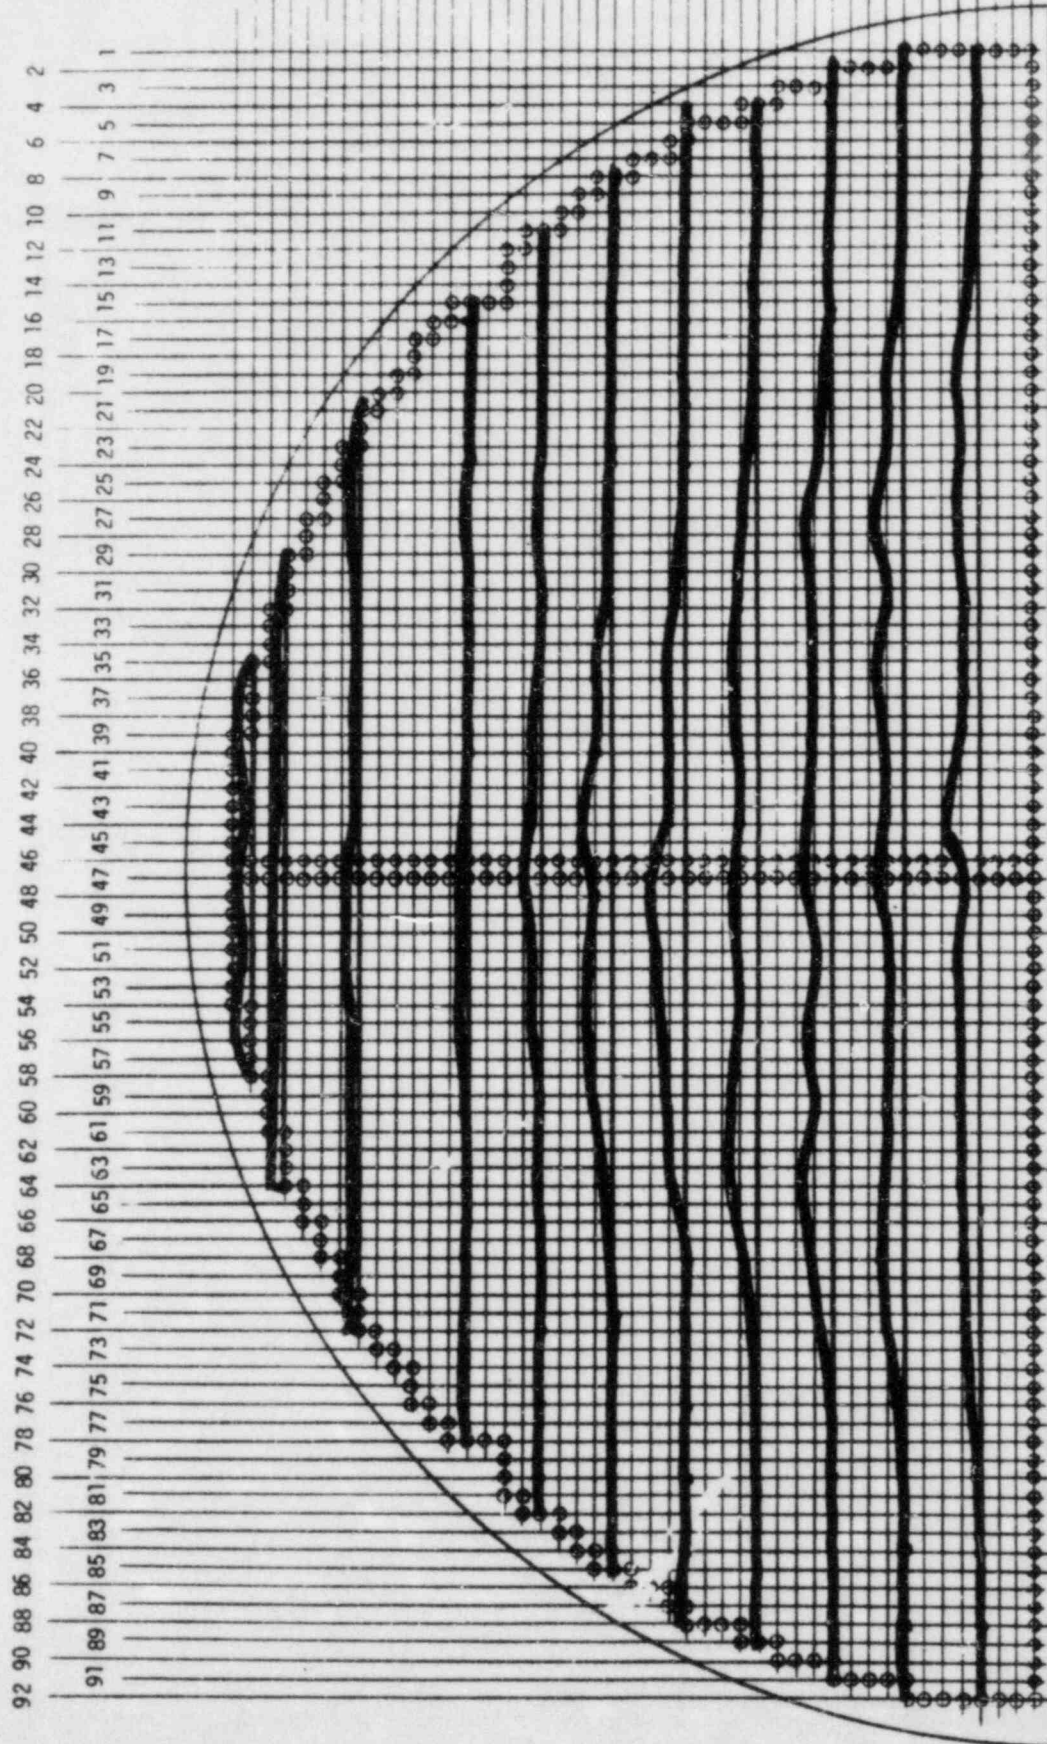
FIGURE (13)

"B" S/G OUTLET  
SIUDGE PROFILE

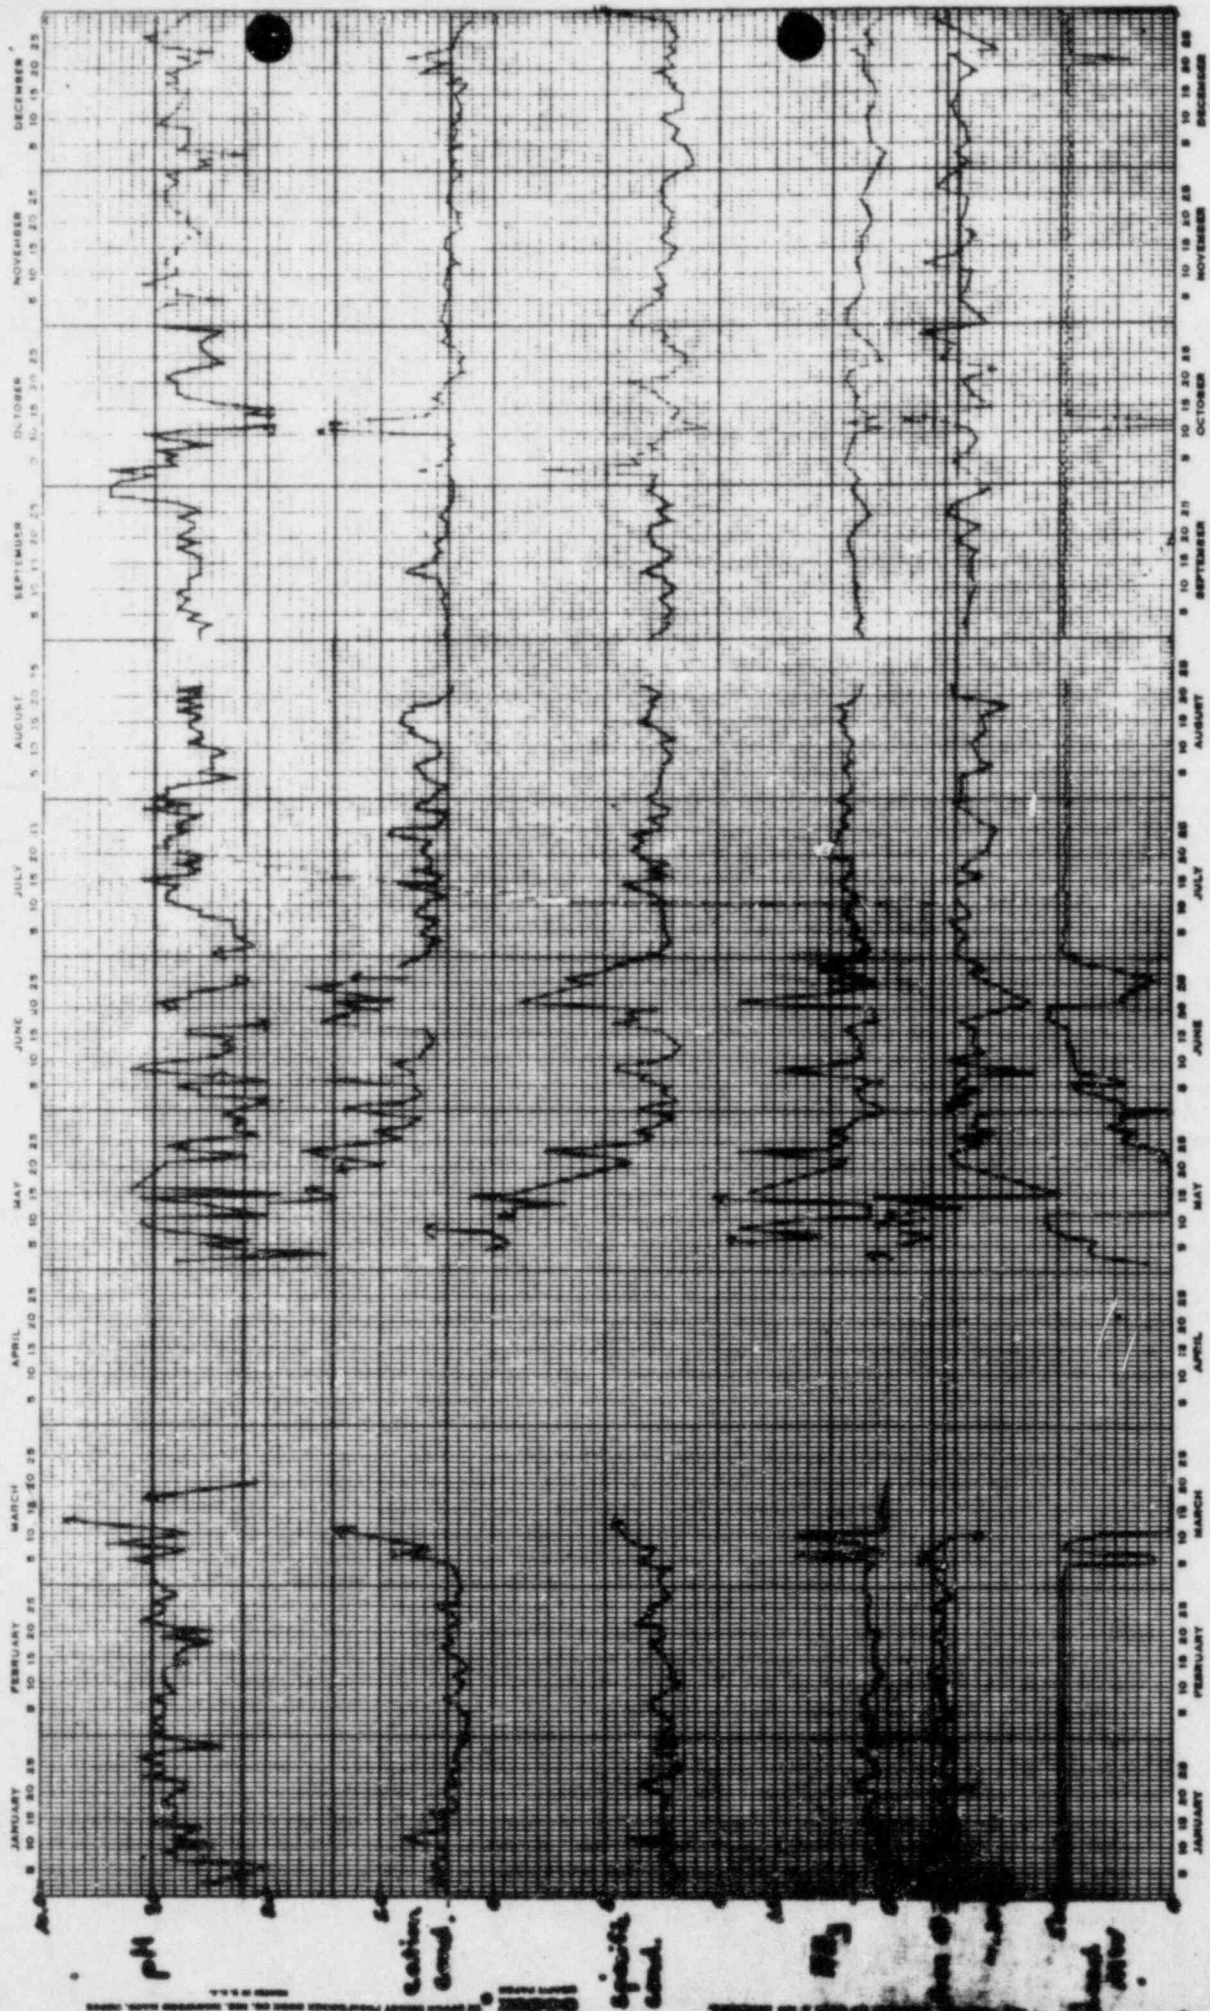
FIGURE (14)

Ginna Station adherence to AVT chemistry control has generally been within specifications during the past year as illustrated on Figures (14) and (15). The AVT chemistry specification for normal power operation and the limiting conditions are given on Table (2).

# R. E. GINNA STATION 1975 "A" STEAM GENERATOR CHEMISTRY

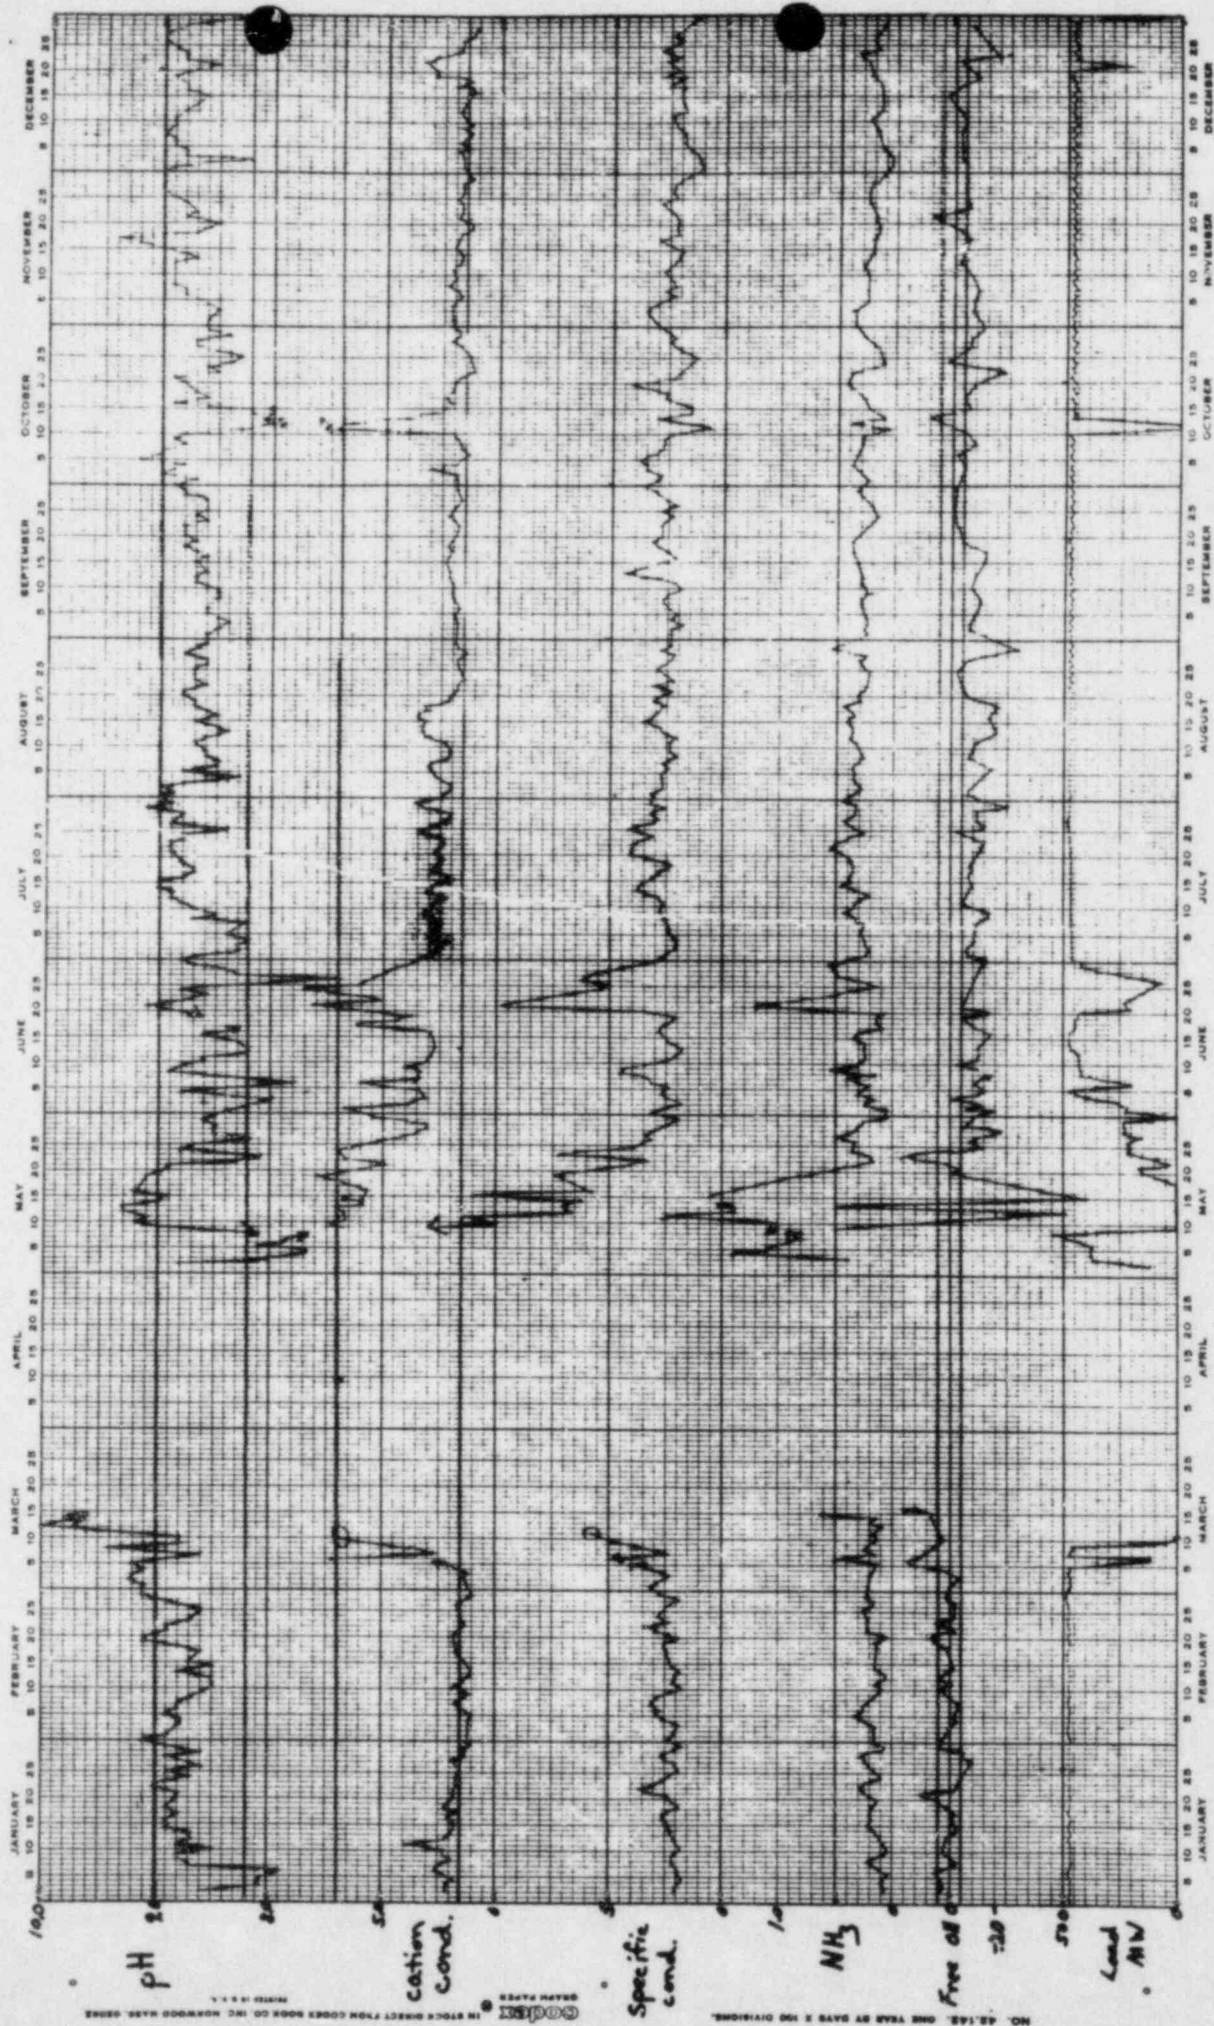
FIGURE (15)

# R. E. GINNA STATION 1975 "B" STEAM GENERATOR CHEMISTRY
