ARKANSAS POWER & LIGHT COMPANY
POST OFFICE BOX 551 LITTLE ROCK, ARKANSAS 72203 (501) 371-4000

2CAN948403

ANO-2 CYCLE 3 REFUELING OUTAGE

FUEL EXAMINATION RESULTS

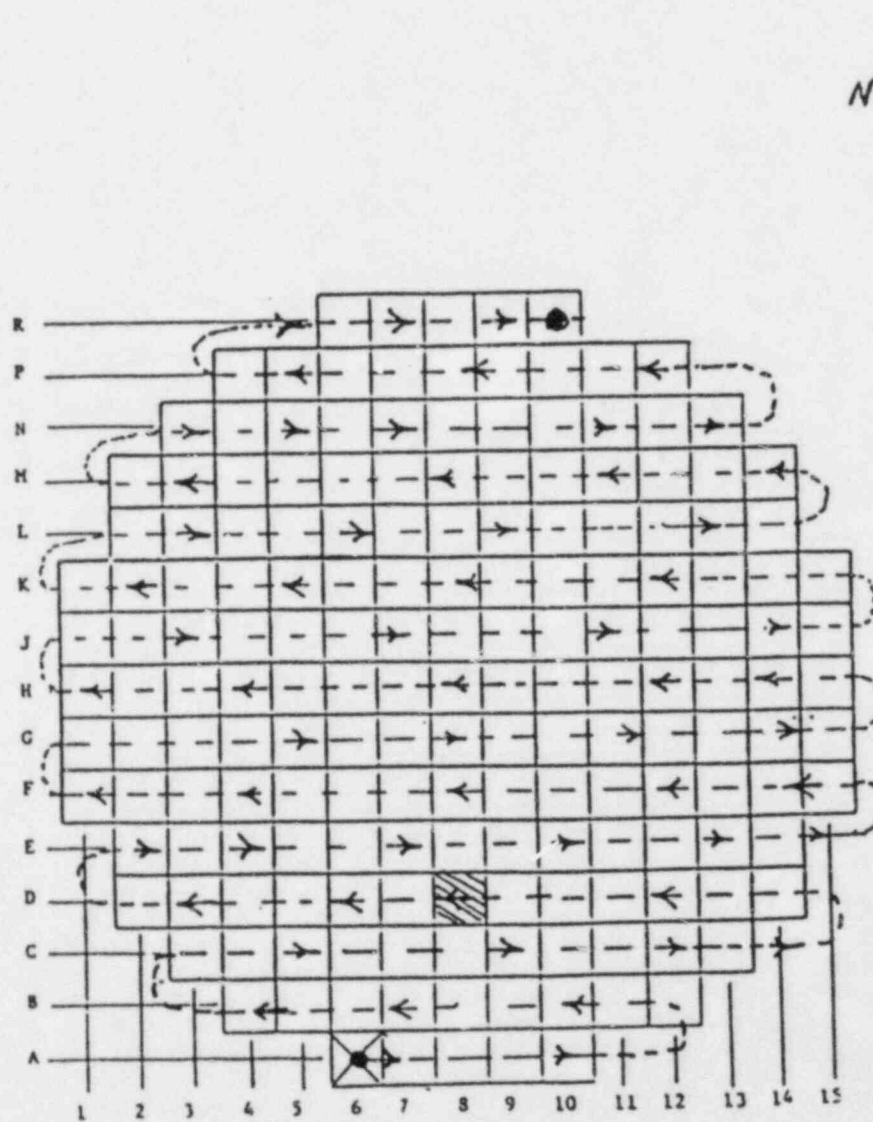
FIGURE 1
OFF-LOAD AT EOC3

- 2.1 The Cycle 3 core was off-loaded in a slab fashion as depicted in Figure 1. A Cycle 3 core map is presented in Figure 2. Since the Cycle 2 off-loading, the refueling machine has been re-worked to decrease its trip response time and a specific log of trips experienced is being kept. Information obtained from the trip log during the cycle 3 off-load is presented in Table I.

AKC105 at D-8 first assembly removed to verify weight readings. Then to A-6.

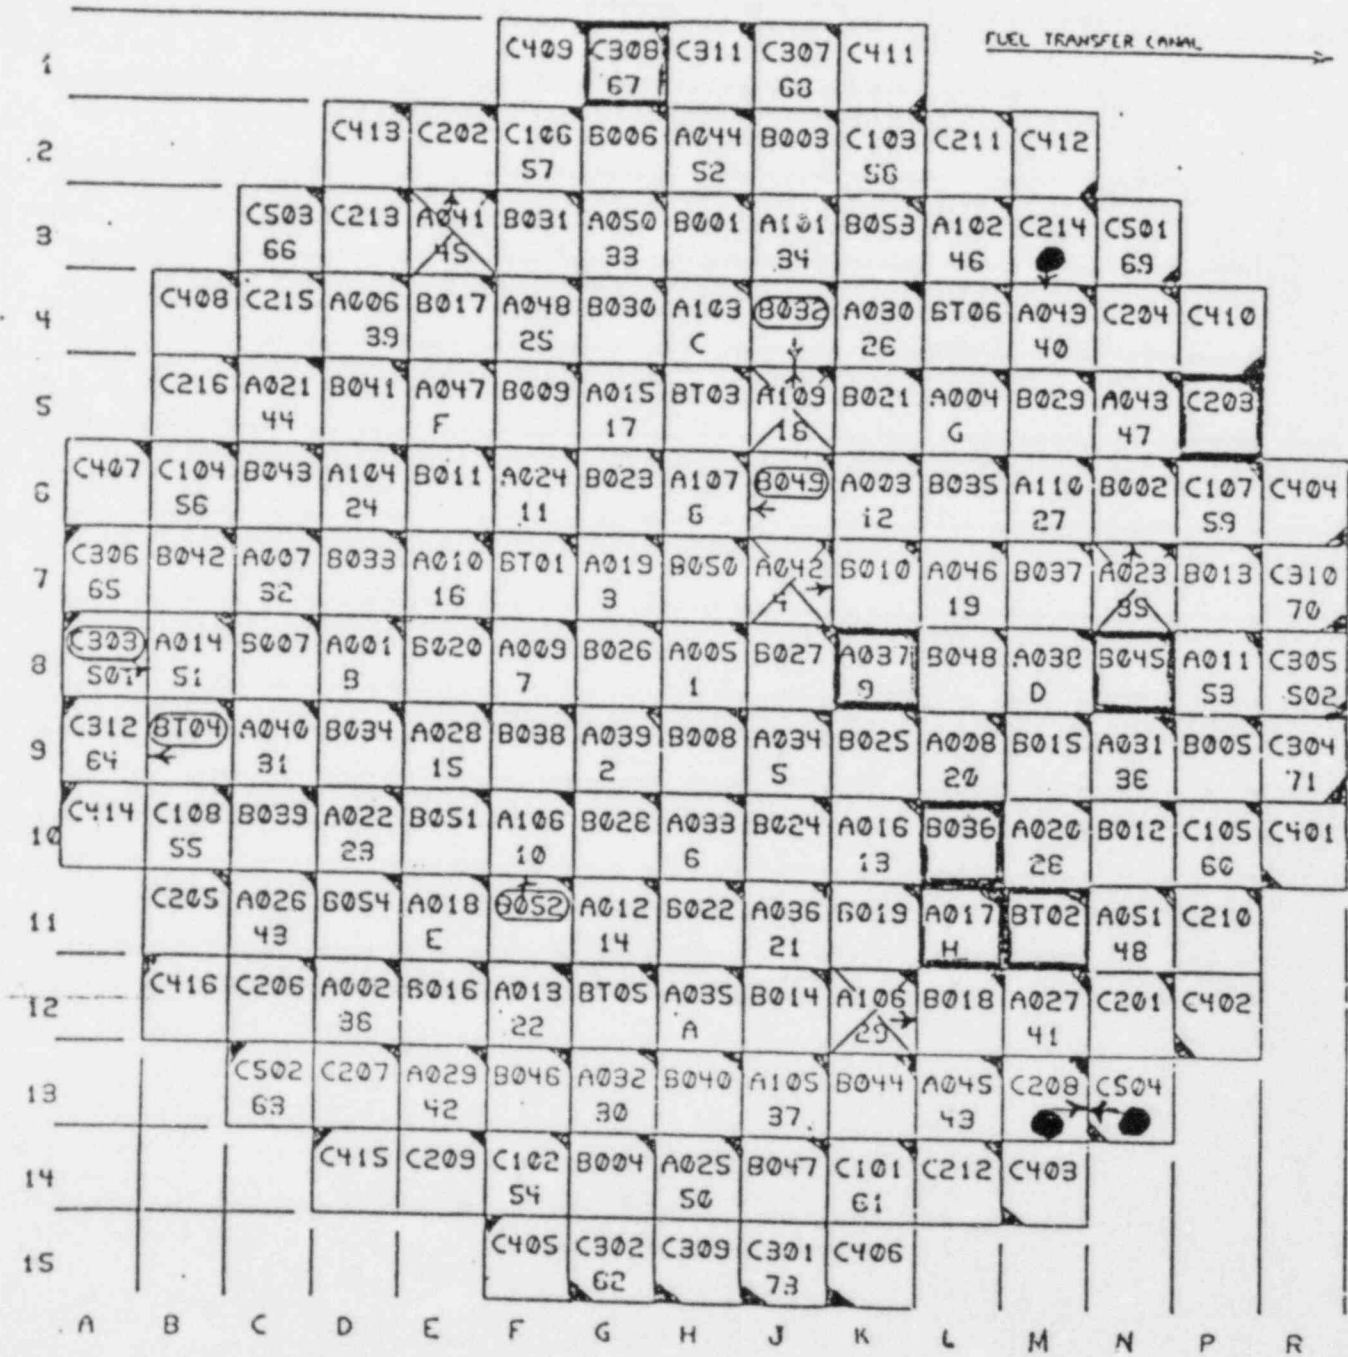
FIGURE 3
ANO-2 CORE LOADING PLAN
CYCLE 1

- 5.4 Of the remaining five cases, it appears likely that three: AKC 208, AKC214, and AKC504, occurred during the Cycle 1 off-load. They have been added to the Cycle 1 core map from Reference 3 to reflect all the assemblies with grid damage attributed to Cycle 1 handling. The result is presented in Figure 3. The operations in which the damage occurred to the weld of AKC413 or to the tab of AKC303 remain unknown.

Grid Damage Shown Is
Attributed To Cycle 1
Handling
