GRAND GULF NUCLEAR STATION

UNIT 1

UPDATE REPORT ON TDI STANDBY

DIESEL GENERATORS

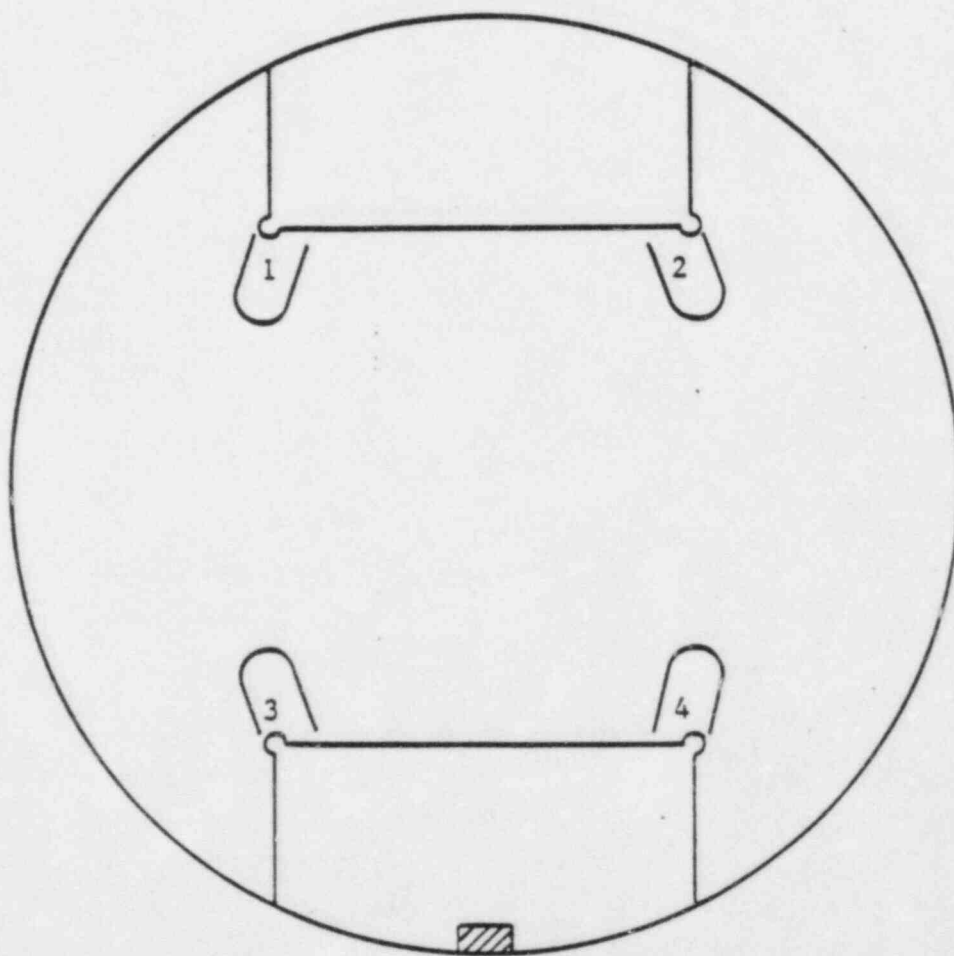
FIGURE 2-1: LOCATION OF STUD BORE AREAS
WITHIN PISTON

Numerous indications were found, ranging from 1/32 to 9/16 inches in length. The following additional inspections were performed to determine if the linear indications were superficial in nature. Each linear indication was ground and/or sanded to a depth of approximately 0.062 inches. These indications were then re-inspected using the liquid fluorescent dye penetrant or wet fluorescent magnetic particle process. Linear indications were found ranging from 1/32 to 1/2 inch in length. The results of these additional inspections are summarized in Table 2-2.

As a result of the Division II modified "AF" piston skirt inspection, the piston skirts in the Division I and II D/Gs have been replaced with the type "AE" piston skirts.

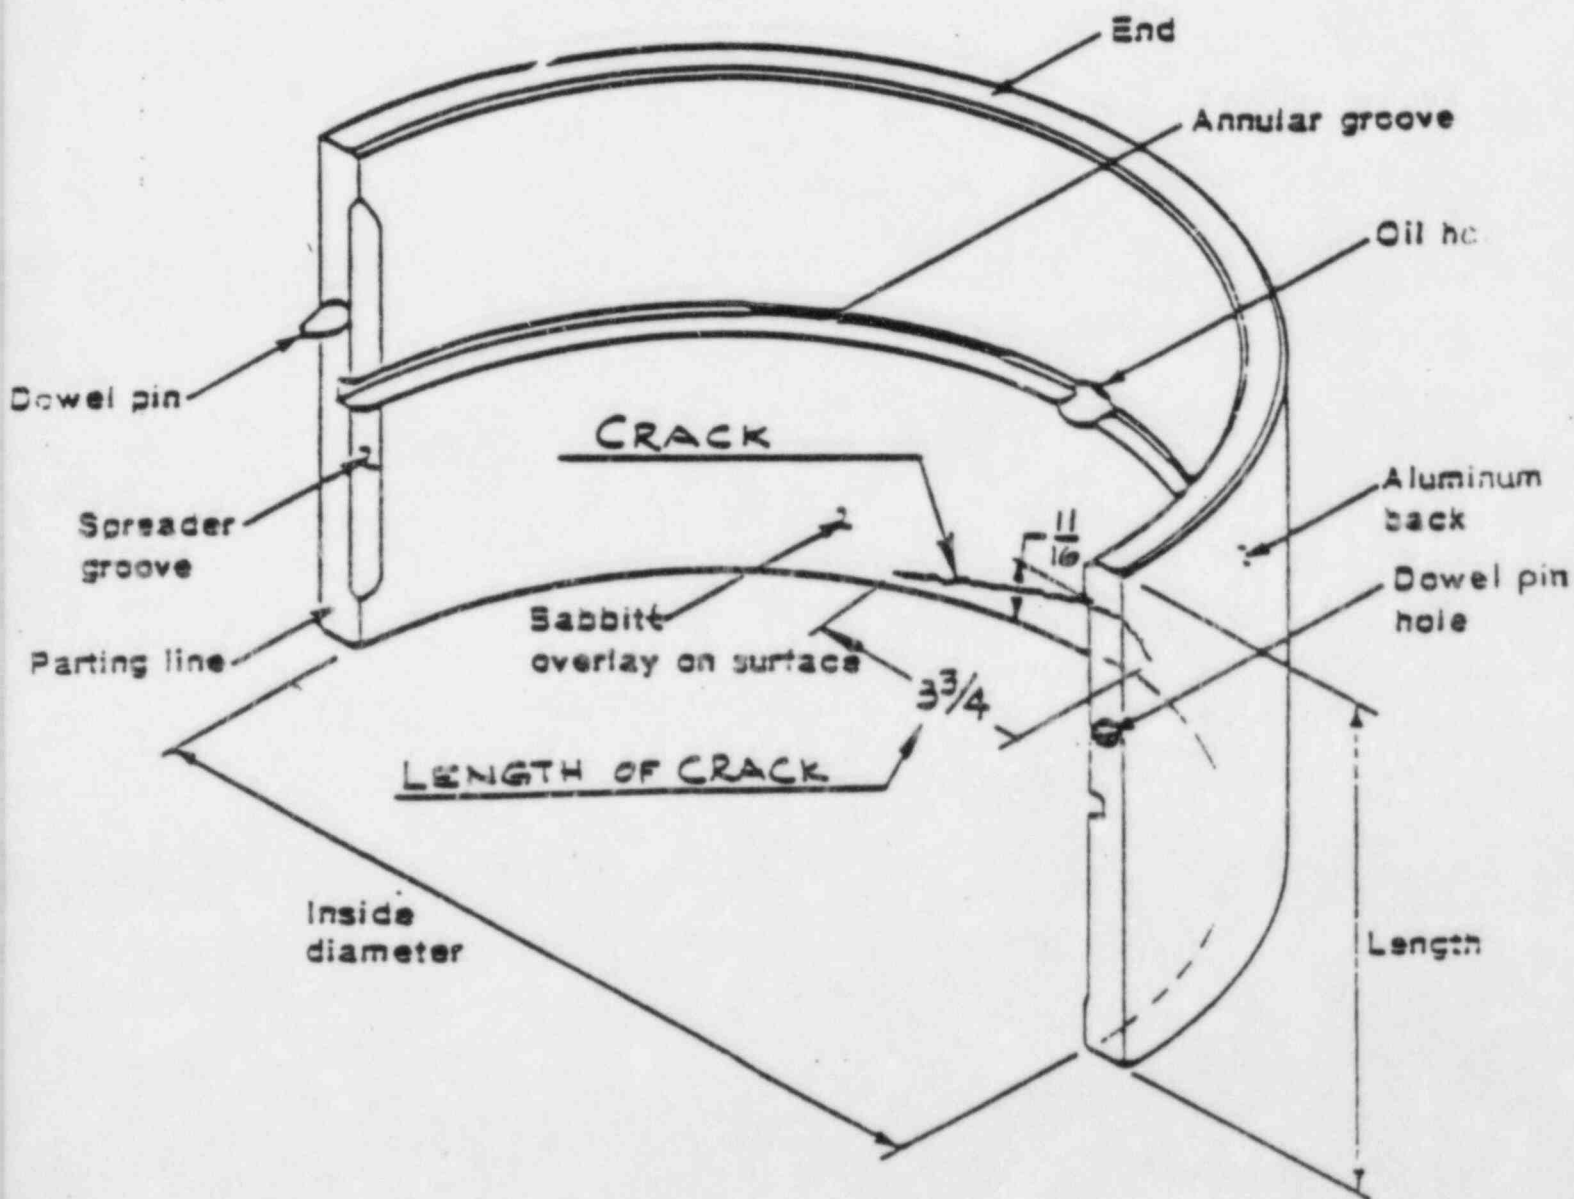
FIGURE 4-1: SHOREHAM CONNECTING ROD BEARING
DESIGN AND NOMENCLATURE
(SCHEMATIC)

A schematic of a cracked Shoreham bearing is shown in Figure 4-1. FaAA performed an analysis (Reference 18) on one of the cracked Shoreham bearings. The cracked bearing was checked for its chemical and physical properties. A scanning electron microscopy (SEM) analysis of the fracture was also performed and dimensional checks were made for wear. The chemical and physical properties met the current design specifications except for elongation. The elongation was found to be below specification, however, the test specimen was not standard, and led to results that were inconclusive. Reference chemical properties for B850.0-T5 are shown in Table 4-1. A Shoreham SEM examination of the fracture face indicated that voids in the bearing shell may have been crack initiation locations. In compression, voids in the "overhang" area would not pose a problem. However, the bearing/rod arrangement on the Shoreham diesels did not support the end part of the bearings (Figure 4-2). This unsupported end combined with the yawing of the crankshaft would put the internal diameter surface into tension. The surface porosity acting as a stress intensifier may have contributed to crack initiation in the unsupported end ("overhang" area). Also, the subsequent shell thickness measurements showed the bearing to be within the manufacturing tolerances, i.e., no appreciable wear.

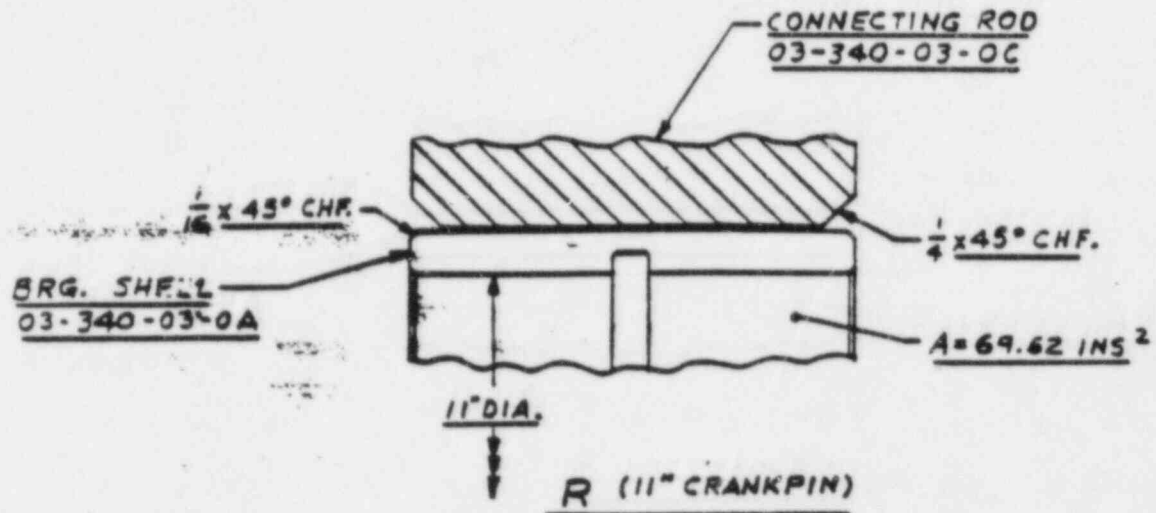
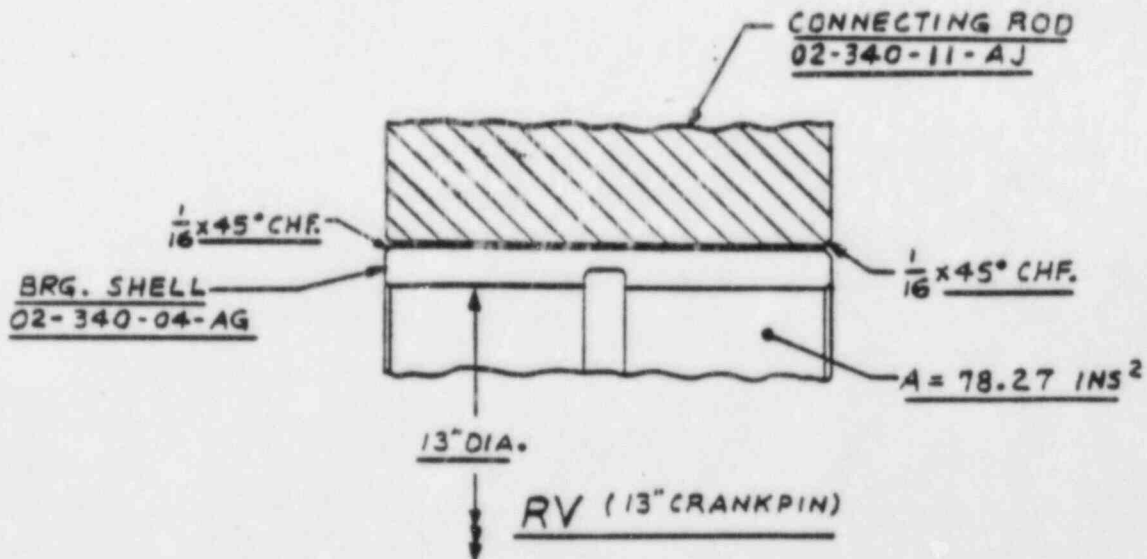
FIGURE 4-2: COMPARISON OF CONNECTING ROD/BEARING CHAMFER ARRANGEMENTS

SCHEMATIC OF SHOREHAM "OVERHANG ARRANGEMENT"
INDICATING UNSUPPORTED BEARING MATERIAL

SCHEMATIC OF GGNS BEARING ARRANGEMENT
WITH BEARING MATERIAL SUPPORTED

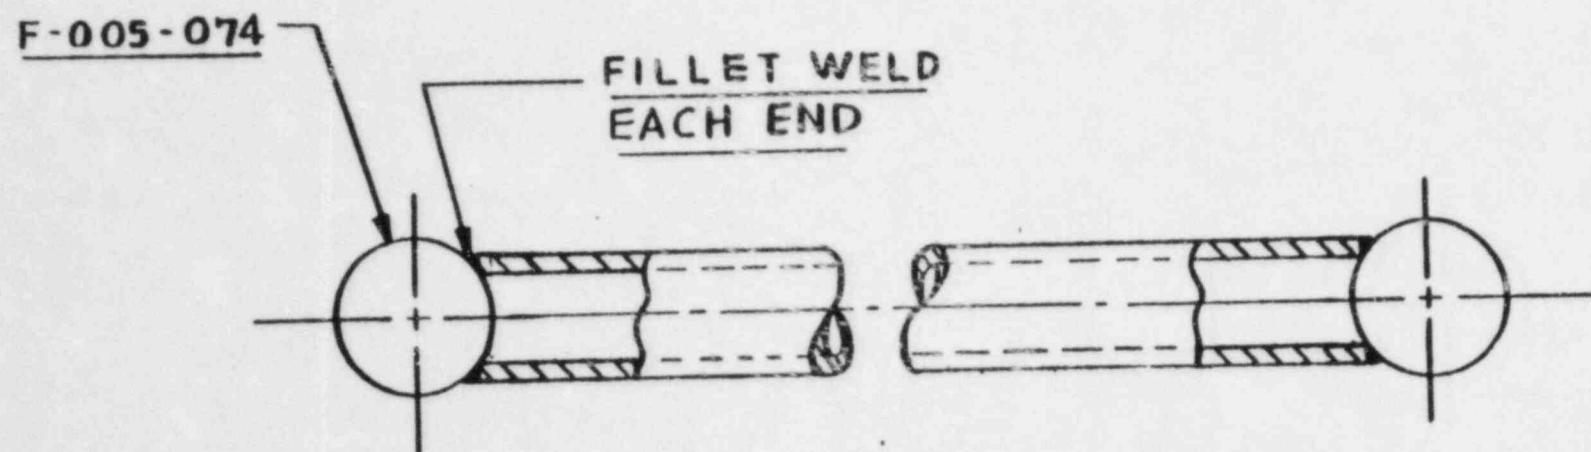
FIGURE 5-1: WELDED BALL CONNECTOR
03-390-04-AB

The connector push rod consisted of a tubular steel body fillet-welded to carbon steel ball bearings. This design is the type which exhibited defects at Grand Gulf and is shown in Figure 5-1. A 1 1/2-inch high carbon steel ball bearing is fitted to 1 1/4-inch OD tubing with a 1/4-inch wall. The inside edge of the tubing has a 45° chamfer which results in a 7/8-inch circular seating ring for the ball at the end of the tube. The ball is attached to the tube with a continuous 360° fillet weld. The materials of construction are as follows:

The first connector push rod found defective was subjected to metallurgical evaluation (Reference 3). The initial weld defect resulted from lack of penetration of the fillet weld with the tubing. Destructive examination of the ball and weld on the opposite end of the defective connector push rod revealed additional cracks in the heat-affected-zone (HAZ) of the ball bearing. The welds exhibited lack of penetration and slag inclusions in the crevice area behind the weld. The metallurgical evaluation concluded that the ball material is difficult to weld. The possibility of finding underbead cracks all around the ball in the HAZ is very high.

MP&L proceeded with an interim inspection program, until replacement connector push rods free of defects could be obtained. The discovery of a cracked connector push rod ball in the Division I diesel, however, demonstrated that the underbead cracks could, in fact, propagate through the ball material.

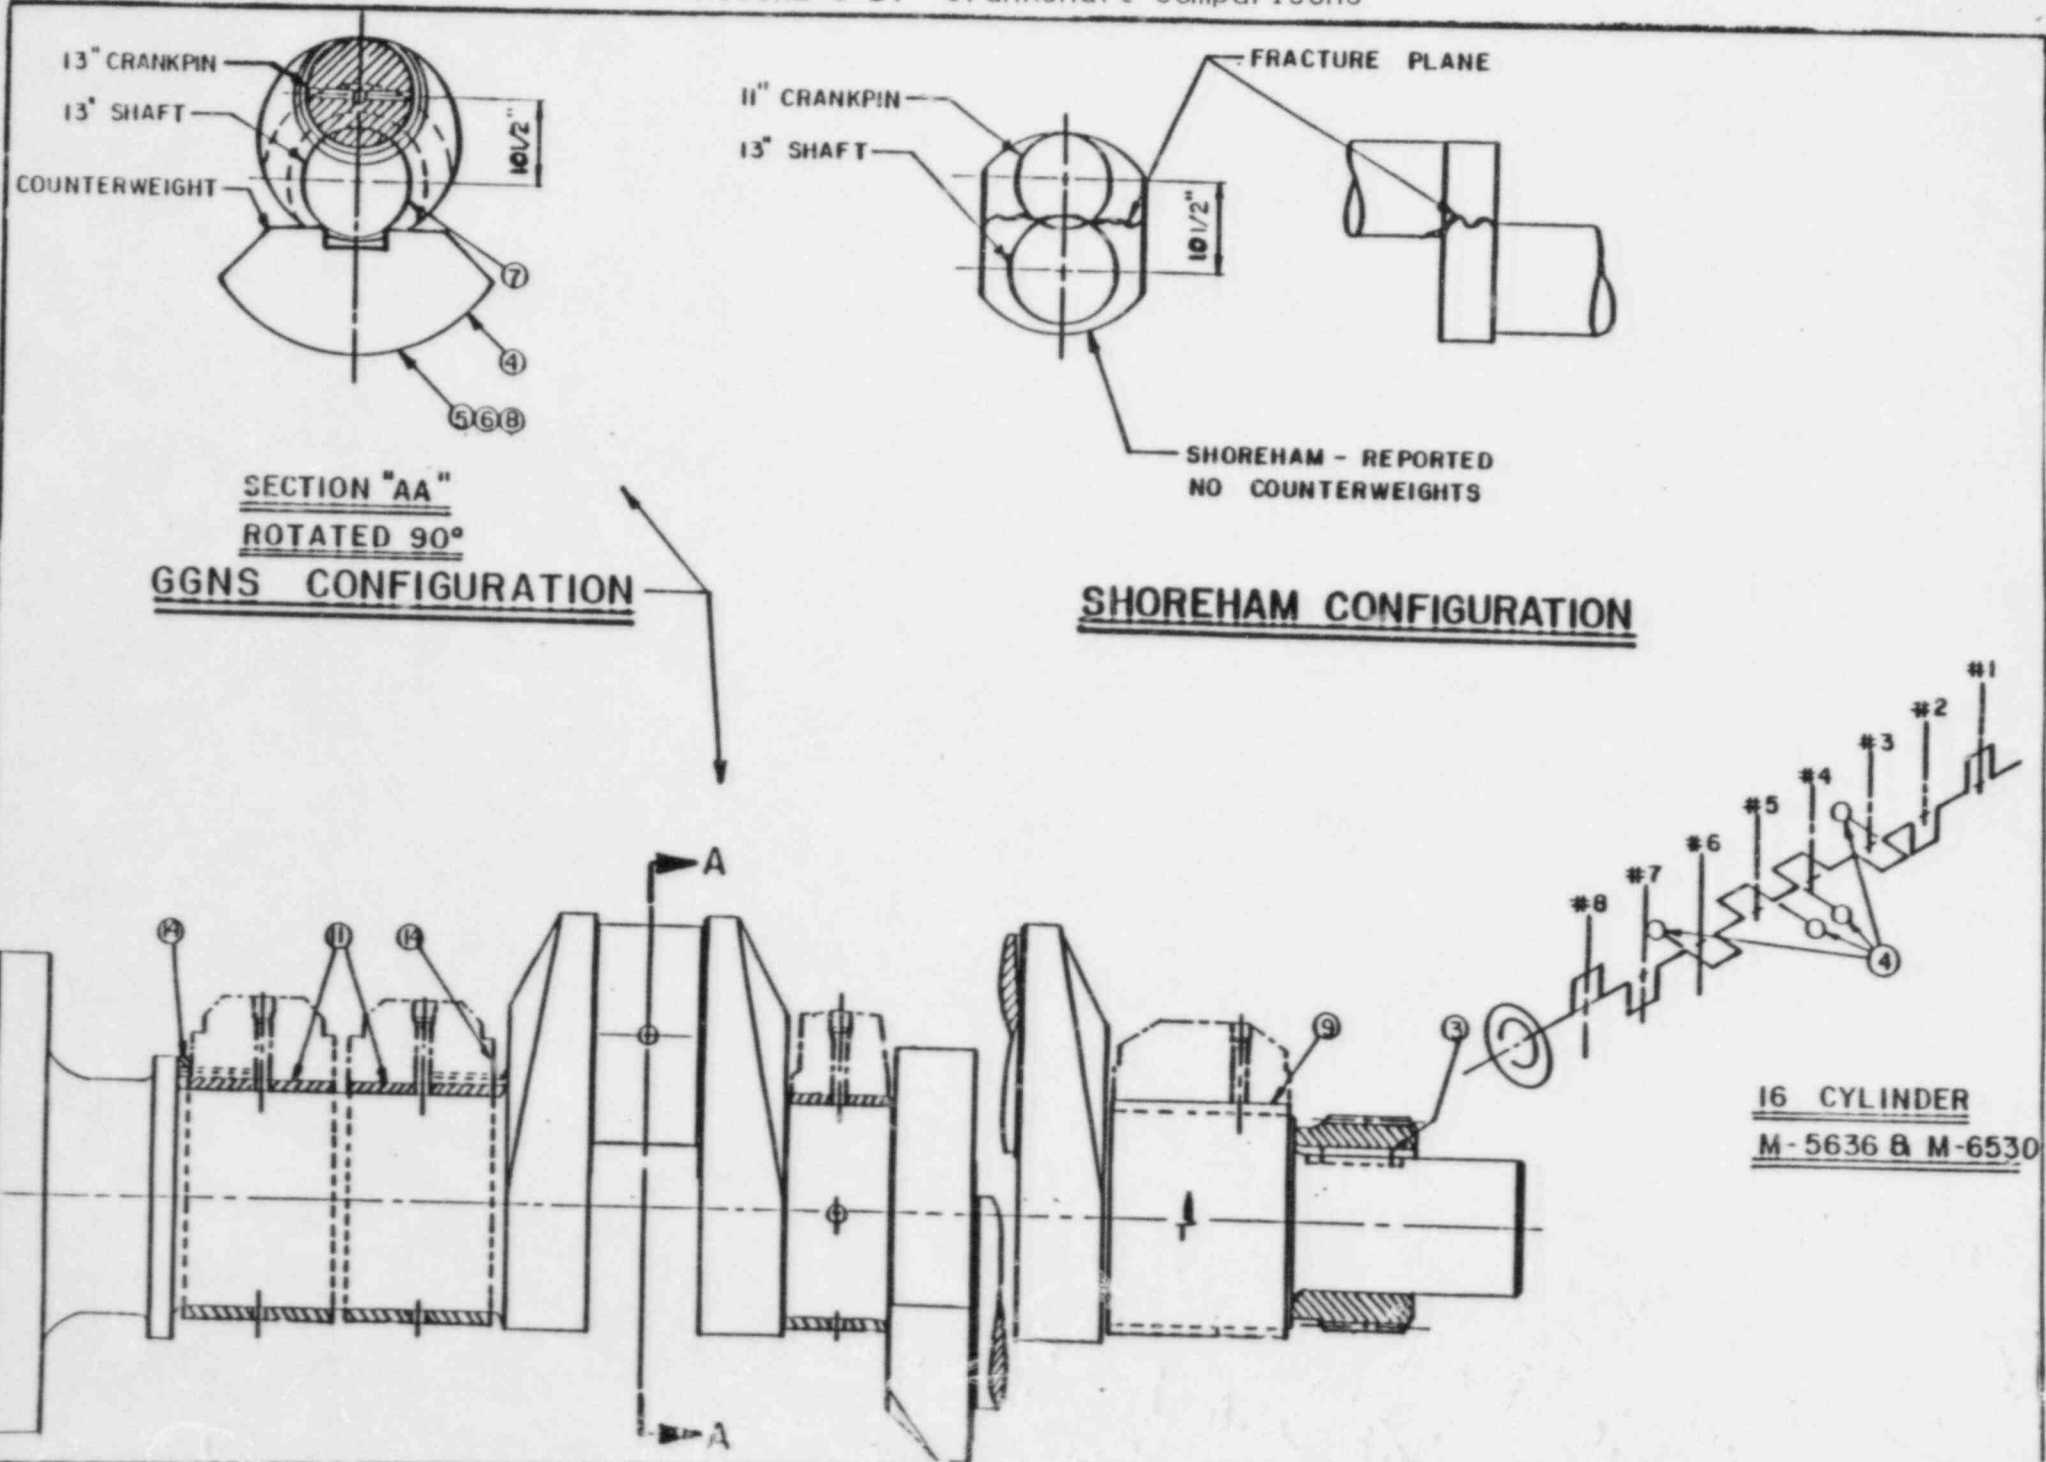
FIGURE 6-1: Crankshaft Comparisons

Investigations were immediately conducted by MP&L on the applicability of the failures at Shoreham to the Grand Gulf TDI diesel generators. A physical comparison (Reference 19) of the DSR-48 (in-line eight cylinder) series engine crankshaft that failed, with that employed in the DSRV-16-4 (Vee-16 cylinder) series at Grand Gulf revealed some important differences. Among the significant design improvements on the Grand Gulf engine are the larger web size and shape, larger crankpin diameter, larger pin fillet radius and the use of counter-weights. In addition, it was learned that TDI may have used potentially non-conservative (1st generation) design harmonic coefficients in 1974 when the Shoreham stress analysis was performed.

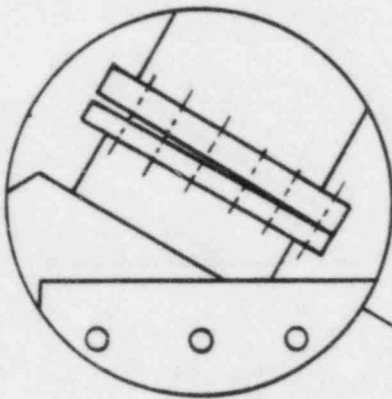
Condition of Turbocharger-
Intercooler Flanges with
Turbocharger Base Bolted
Down

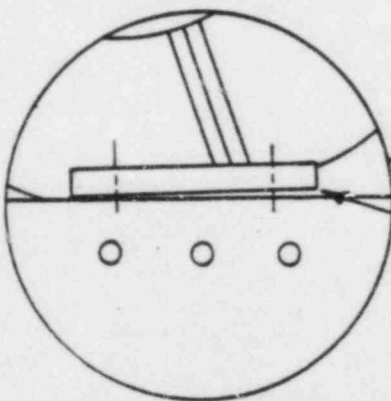
Condition of Turbocharger
Base When Turbocharger-
Intercooler Flanges Bolted
Together
