LICENSEE EVENT REPORT (LER)																			
Facility Name (1)										Docket Number (2)					Page (3)				
SAN ONOFRE NUCLEAR GENERATING STATION, UNIT 2										0150000361					1 of 04				
Title (4)																			
INOPERABLE FIRE SPRINKLER SYSTEM																			
EVENT DATE (5)			LER NUMBER (6)			REPORT DATE (7)			OTHER FACILITIES INVOLVED (8)										
Month	Day	Year	Year	Sequential Number	Revision Number	Month	Day	Year	Facility Names			Docket Number(s)							
1	1	4	9	4	915	0	0	4	0	0	5	2	0	9	5				
OPERATING MODE (9) <input type="checkbox"/> THIS REPORT IS SUBMITTED PURSUANT TO THE REQUIREMENTS OF 10CFR (Check one or more of the following) (11)																			
POWER			<input type="checkbox"/> 20.402(b)			<input type="checkbox"/> 20.405(c)			<input type="checkbox"/> 50.73(a)(2)(iv)			<input type="checkbox"/> 73.71(b)							
LEVEL			<input type="checkbox"/> 20.405(a)(1)(i)			<input type="checkbox"/> 50.36(c)(1)			<input type="checkbox"/> 50.73(a)(2)(v)			<input type="checkbox"/> 73.71(c)

SAN ONOFRE NUCLEAR GENERATION STATION UNIT 2	DOCKET NUMBER 05000361	LER NUMBER 95-004-00	PAGE 2 of 4
---	---------------------------	-------------------------	----------------

DESCRIPTIO

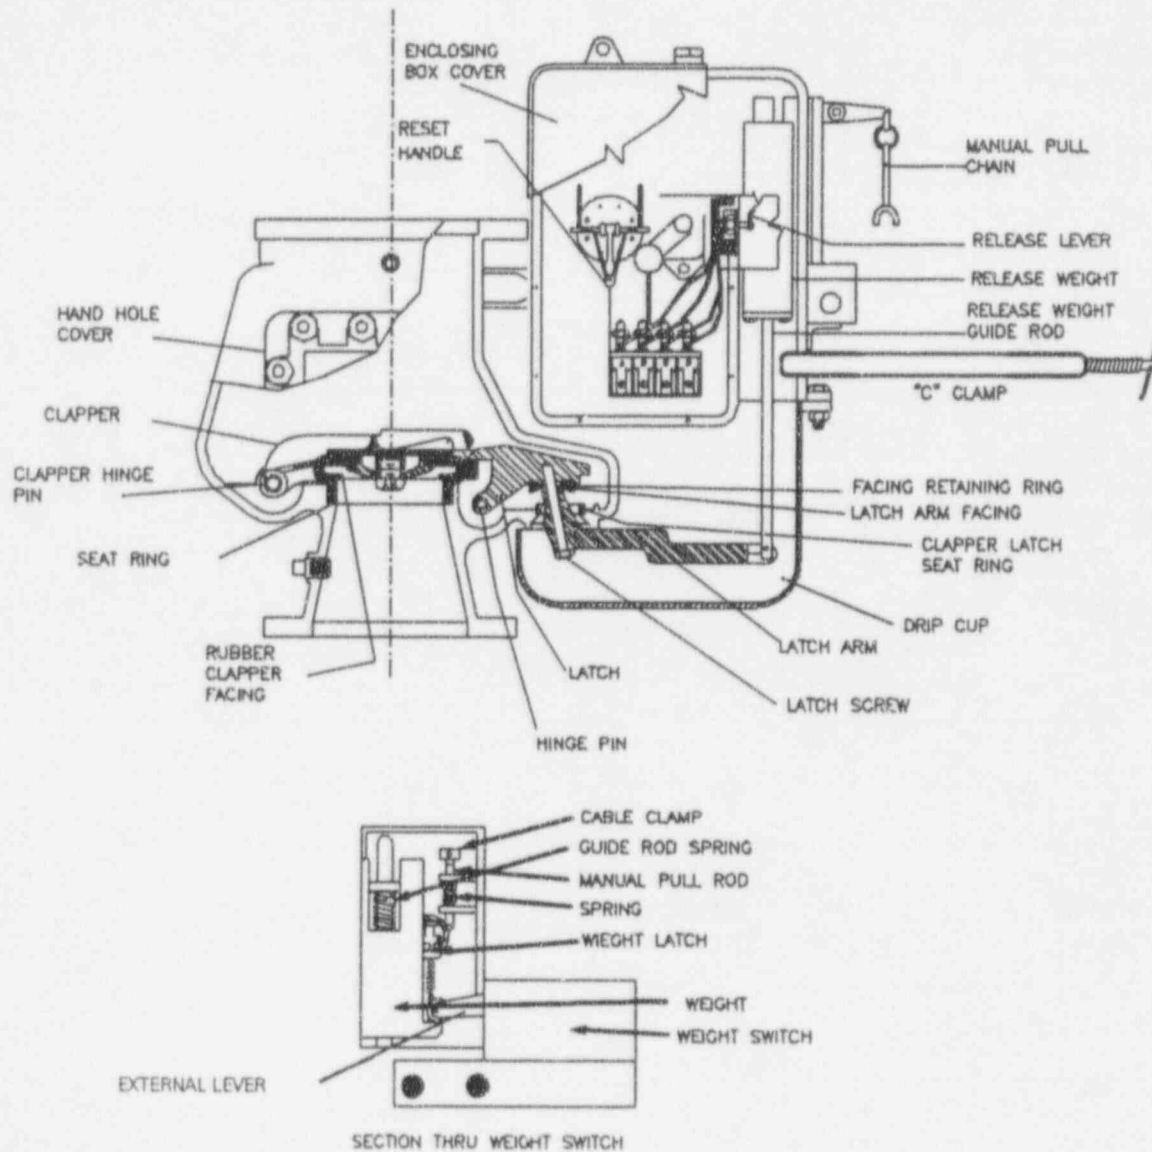
Figure 1

San Onofre fire suppression spray/sprinkler systems are required by Technical Specification (TS) 3.7.8.2 to be operable whenever equipment protected by the system is required to be operable. Fire suppression water flow for some systems is controlled by an Automatic Sprinkler Corporation of America (ASCOA) Model-C pre-action or deluge valve, installed in non-safety related fire protection systems (see attached figure).

Edison initially believed the valve failed at the time of the surveillance. However, Edison subsequently determined that the weight switch, initially installed on the valve on 9/17/94, had been incorrectly assembled by the manufacturer, Micro Switch (a Division of Honeywell). The internal flat spring in the switch was reversed, limiting external lever rotation.

On 4/20/95, Edison discovered that the weight switch had also been slightly mispositioned in the valve (the weight switch external lever had been placed against the vertical surface of the release weight rather than on the tab at the base of the weight). Improper placement of the weight switch alone is not sufficient to affect valve operability, as evidenced by two other valves with mispositioned weight switches which continue to successfully pass their surveillance testing.

The intermittent failure was due to release weight binding caused by a combination of the incorrectly manufactured weight switch and the slight mispositioning of the weight switch.

MODEL C PRE-ACTION OR DELUGE VALVE

Edison replaced the incorrectly manufactured weight switch on 1/26/95 and ensured it was correctly positioned. The valve was satisfactorily tested, the release weight was reset, and the valve was returned to service on 1/27/95.
