REPORT
ON
SYSTEM DISTURBANCE

MAY 16, 1977

FLORIDA POWER & LIGHT COMPANY
JUNE 29, 1977

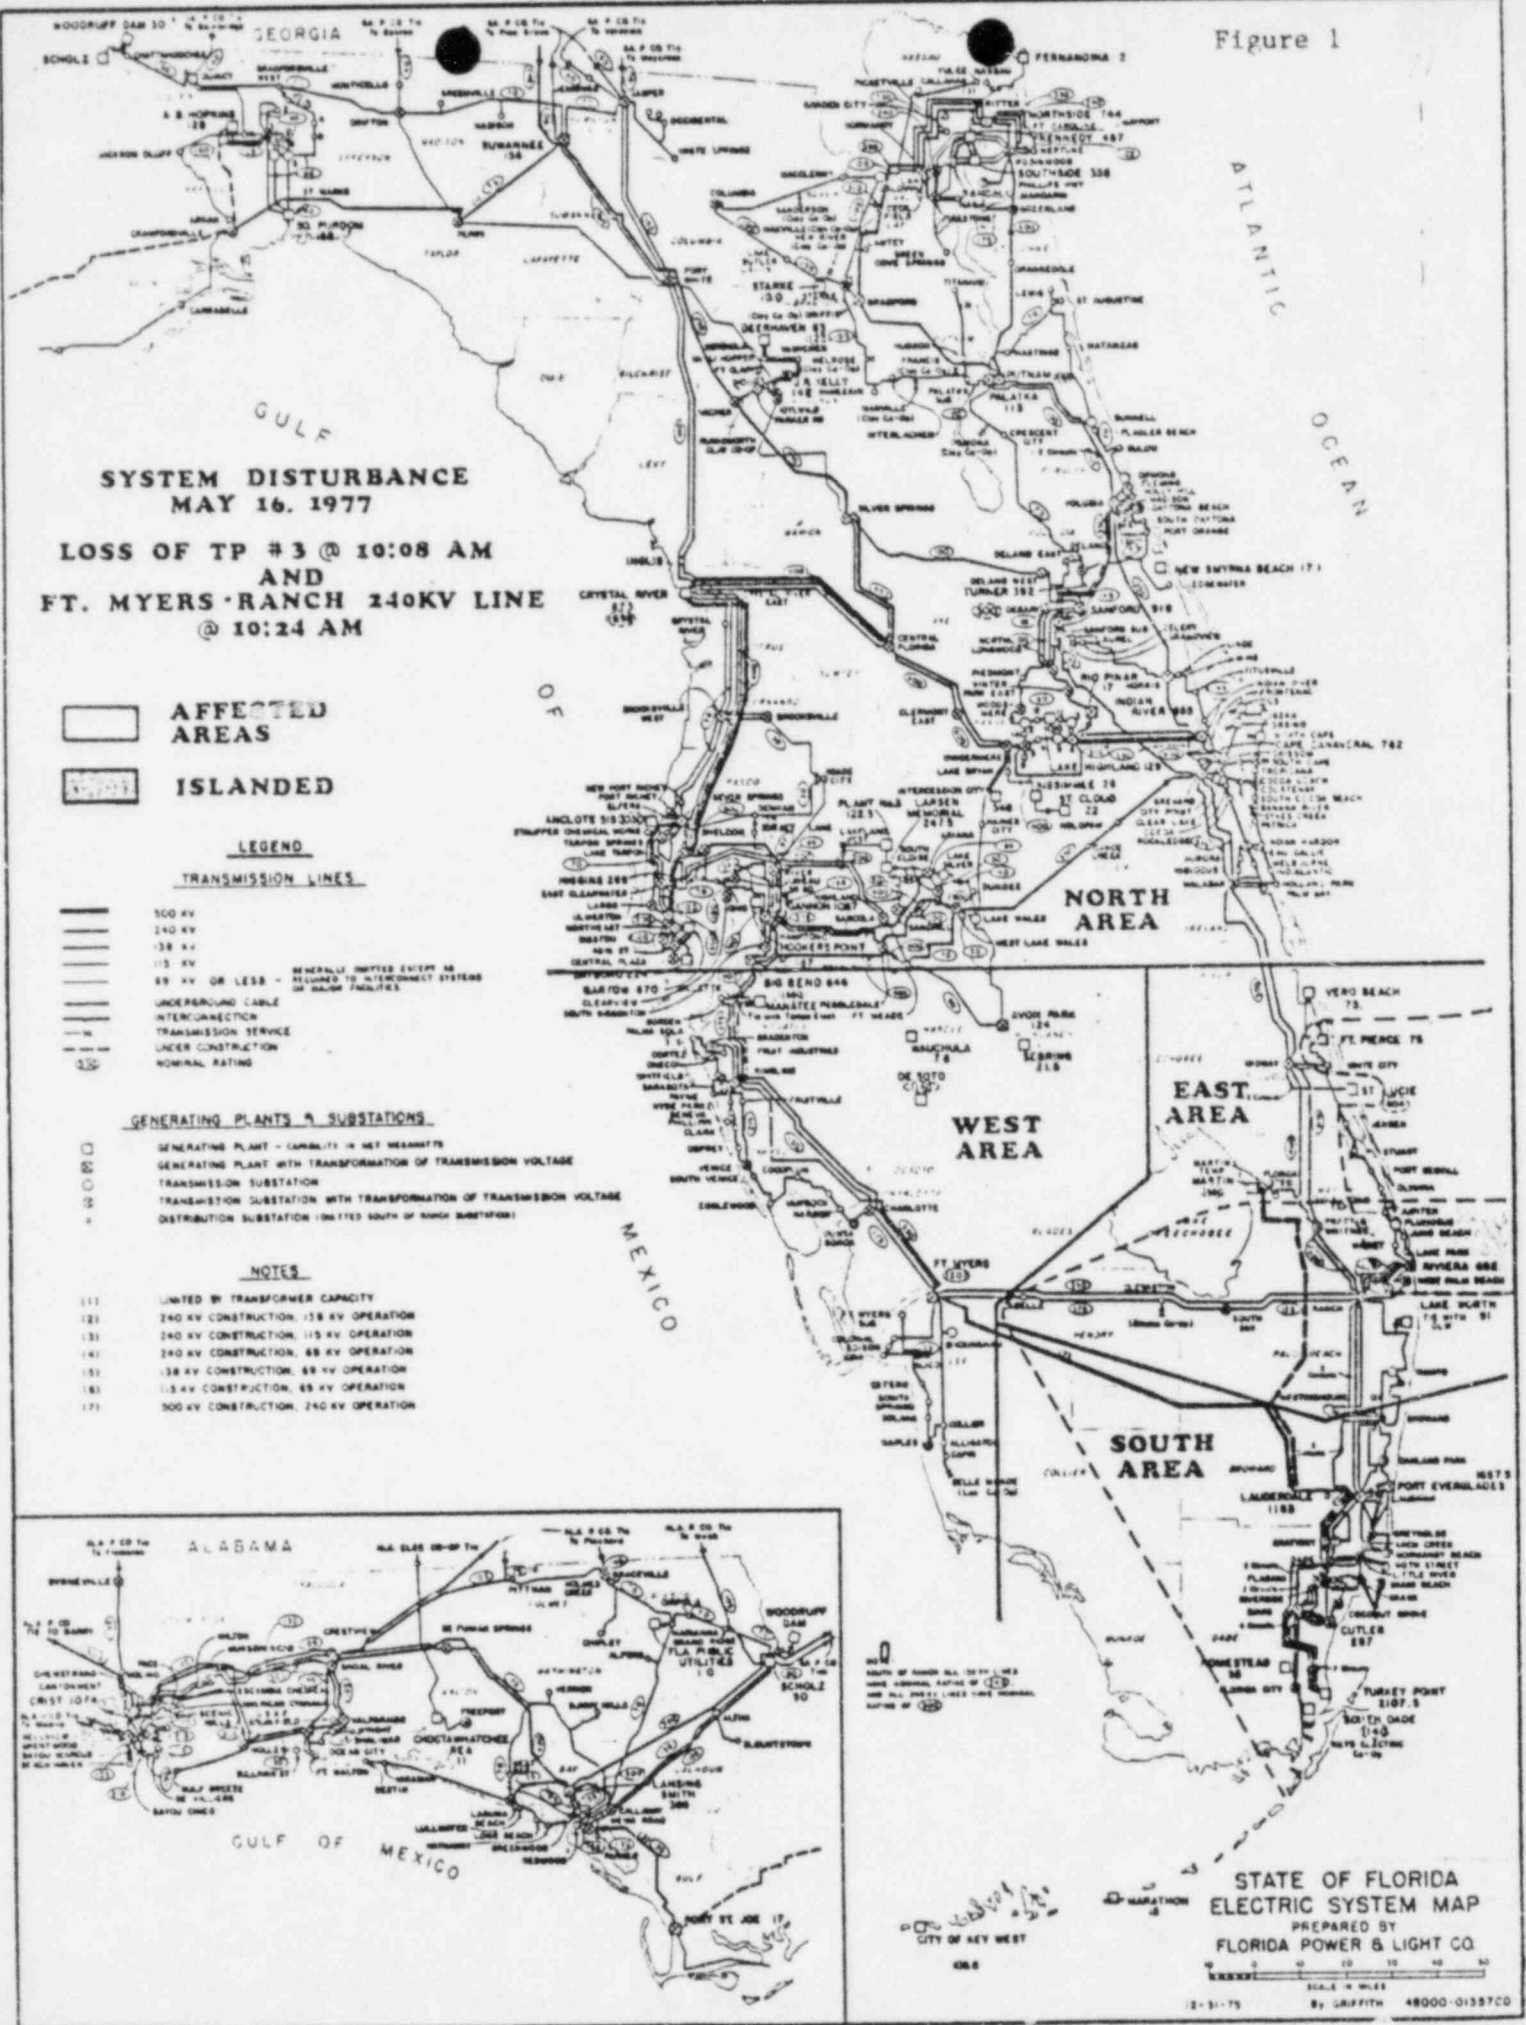
Figure 1

At 10:24 a.m. the Ft. Myers-Ranch 240 kV Line, carrying approximately 420 MW, tripped due to a phase-to-ground fault. The east and south areas of the FPL system (See Figure 1) became separated from the north and west areas when three 240 kV and seven 138 kV lines relayed sequentially due to instability. This split of the transmission system resulted in the St. Lucie Plant of the east area being tied only to the north and the Riviera Plant being islanded along with a portion of the east area load.

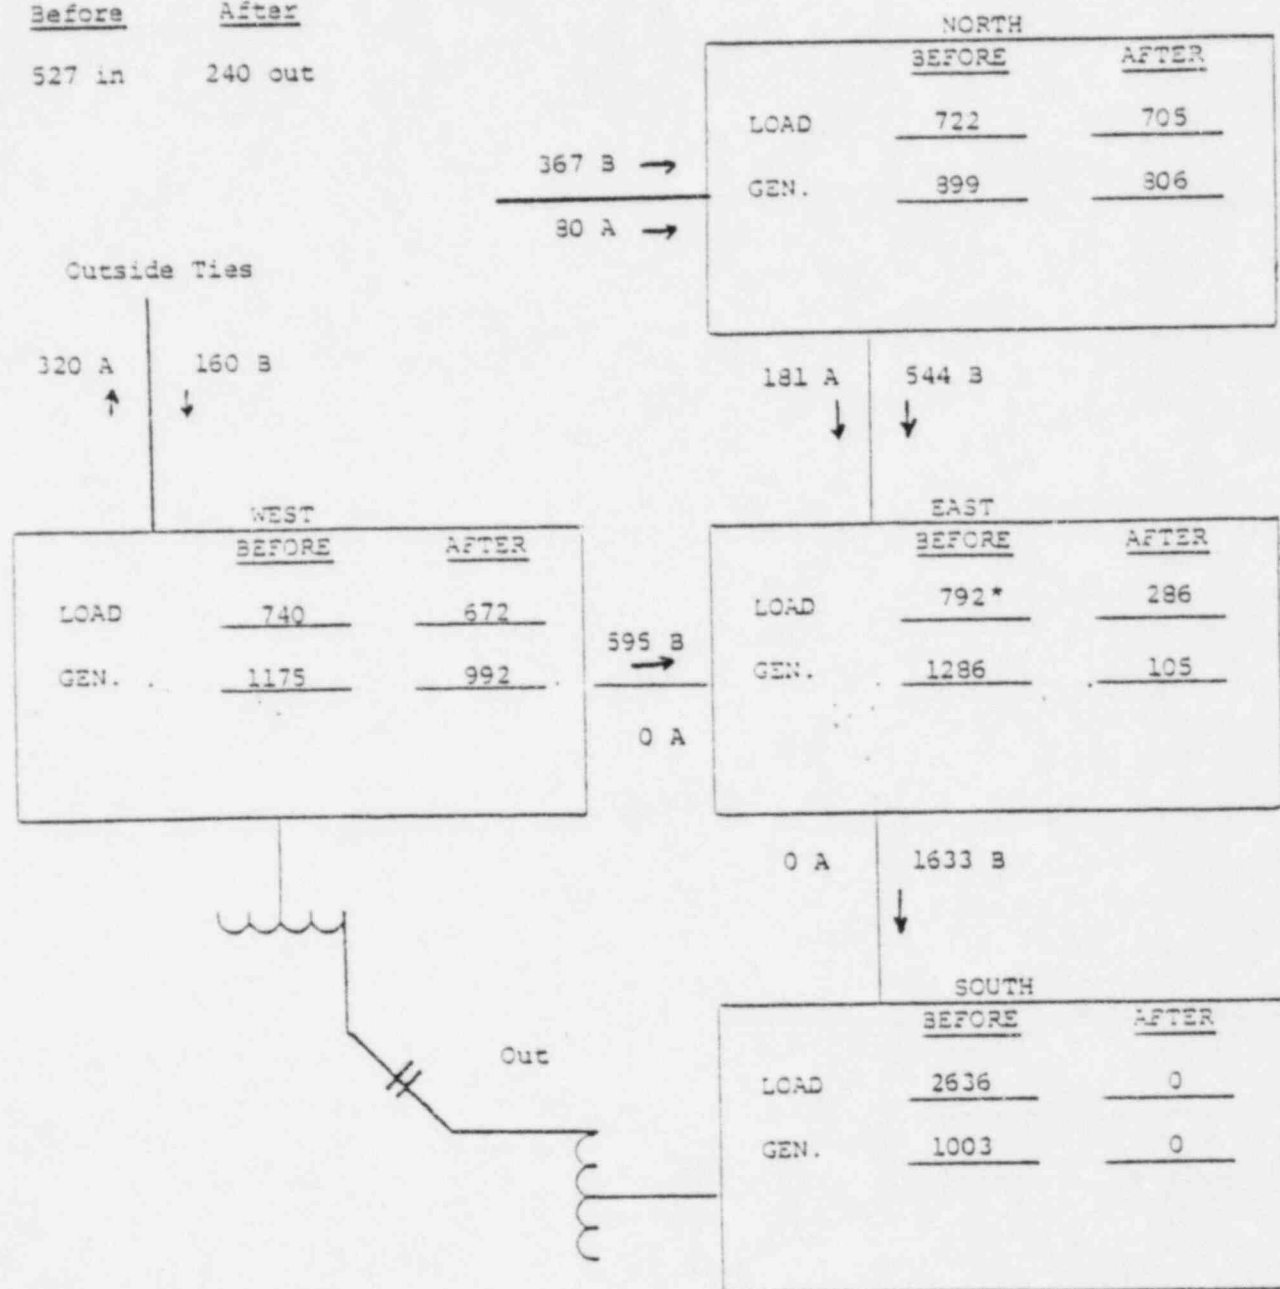
Figure 2

EVENT Loss of Ft. Myers - Ranch 240kV Line TIME 10:24 a.m.

Net Interchange
Before After
 527 in 240 out

<u>SYSTEM</u>	<u>BEFORE</u>	<u>AFTER</u>
LOAD	4890	1663
GEN.	4363	1903

*321 MW isolated with South area after system split.

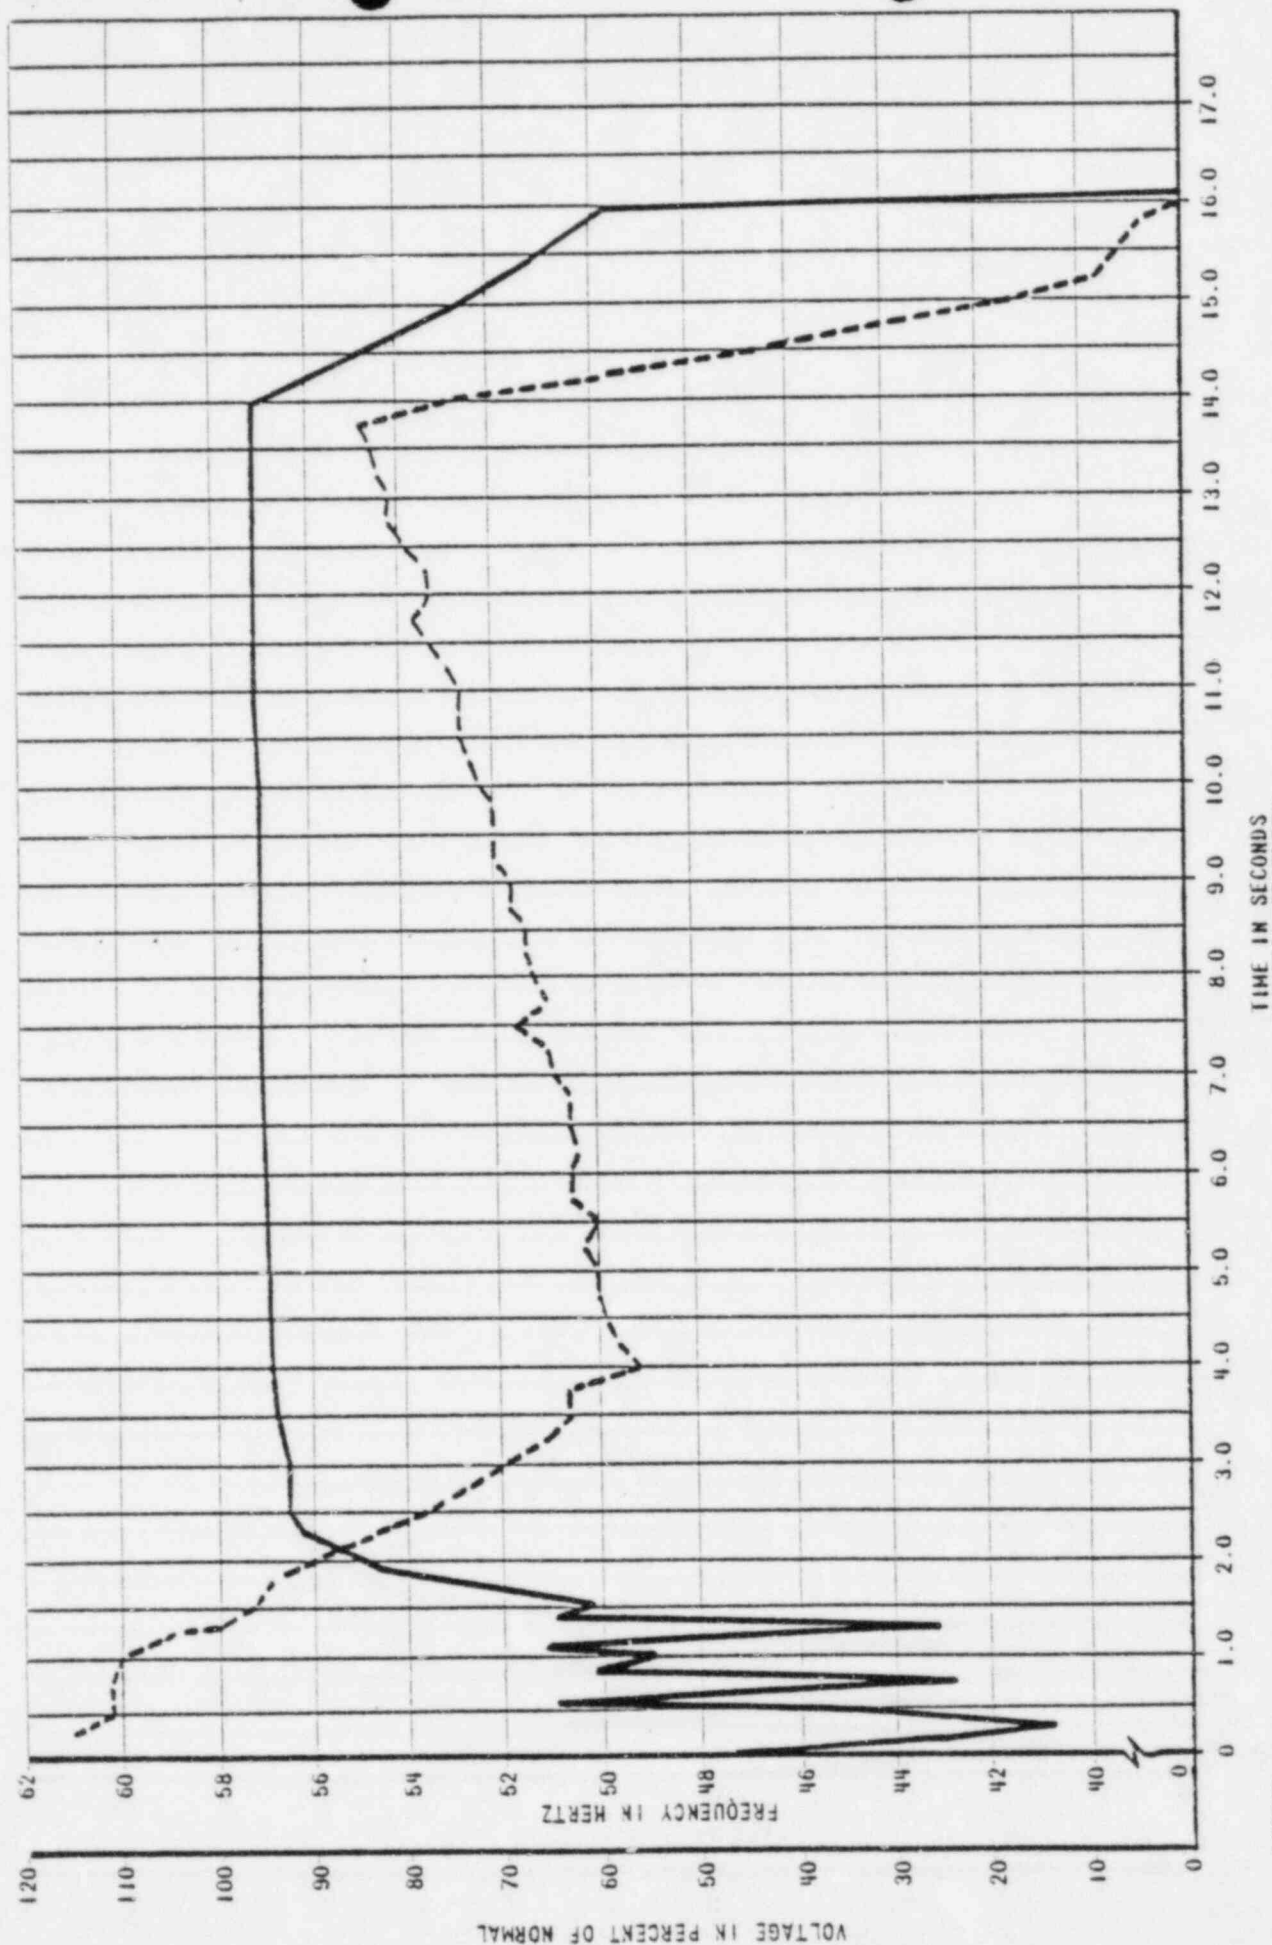
FREQUENCY & VOLTAGE VS TIME
 MEASURED ON THE RANCH LINE TERMINAL
 AFTER THE PRATT & WHITNEY-RANCH 240 KV LINE OPENED
 AT 10:24 AM FOR MAY 16, 1977 DISTURBANCE

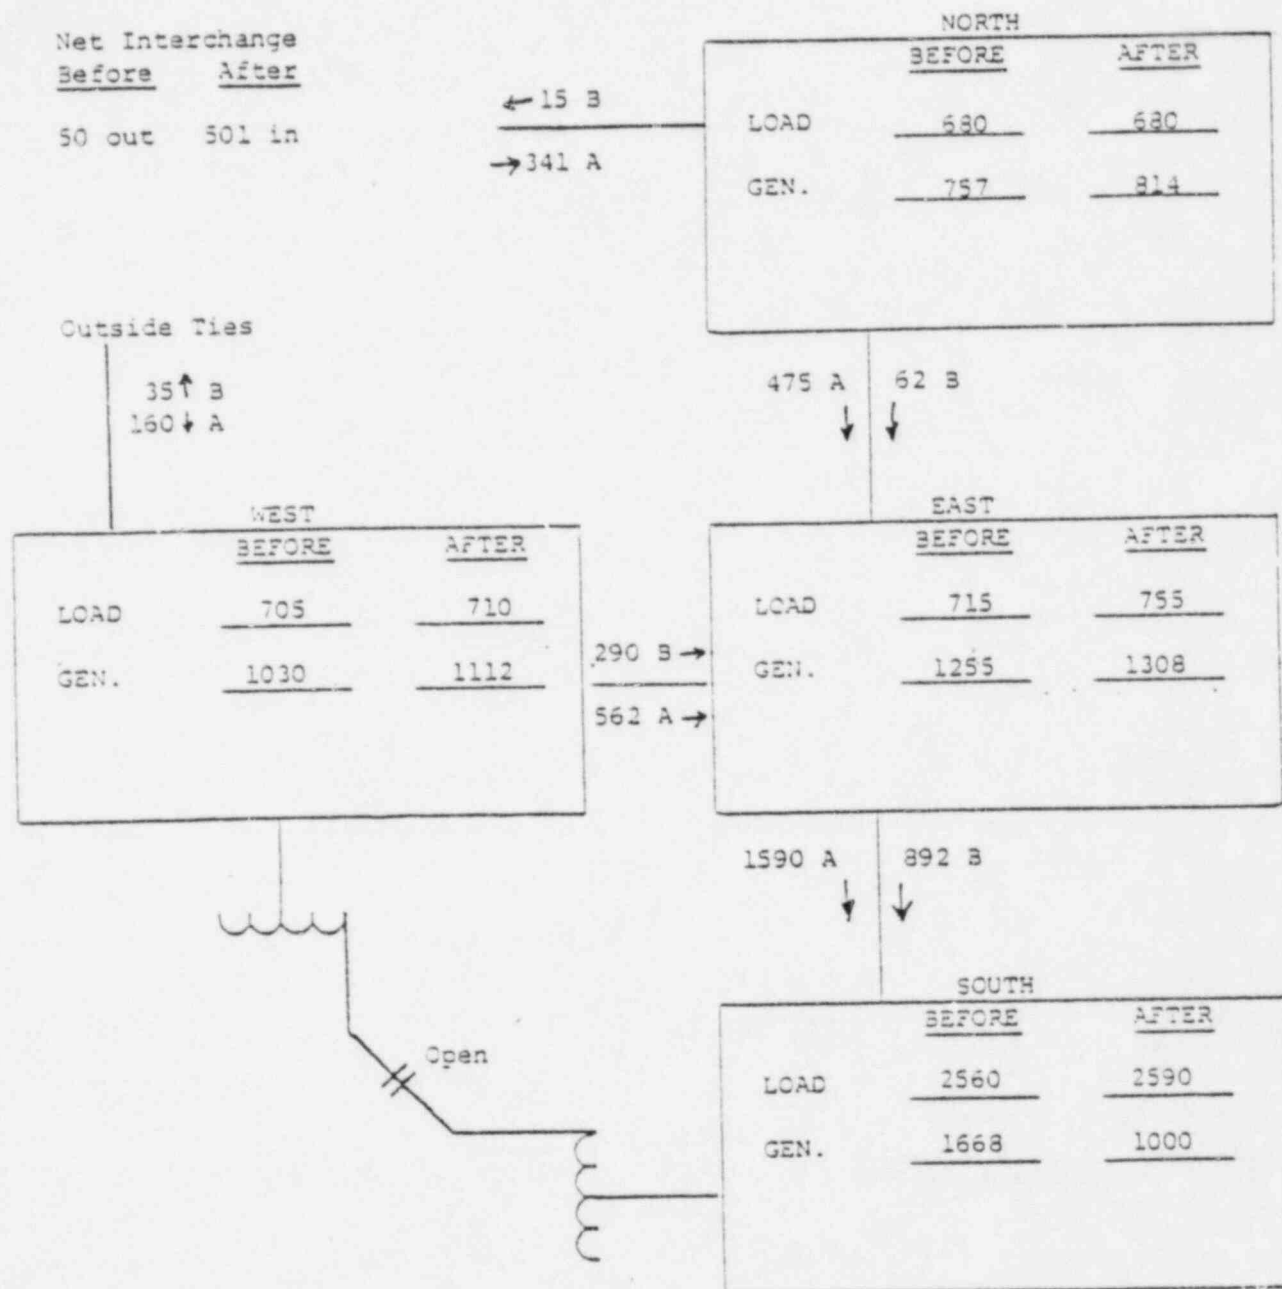
Figure 4

EVENT Loss of Turkey Point #3TIME 10:08 a.m.

SYSTEM	BEFORE	AFTER
LOAD	4660	4735
GEN.	4710	4234

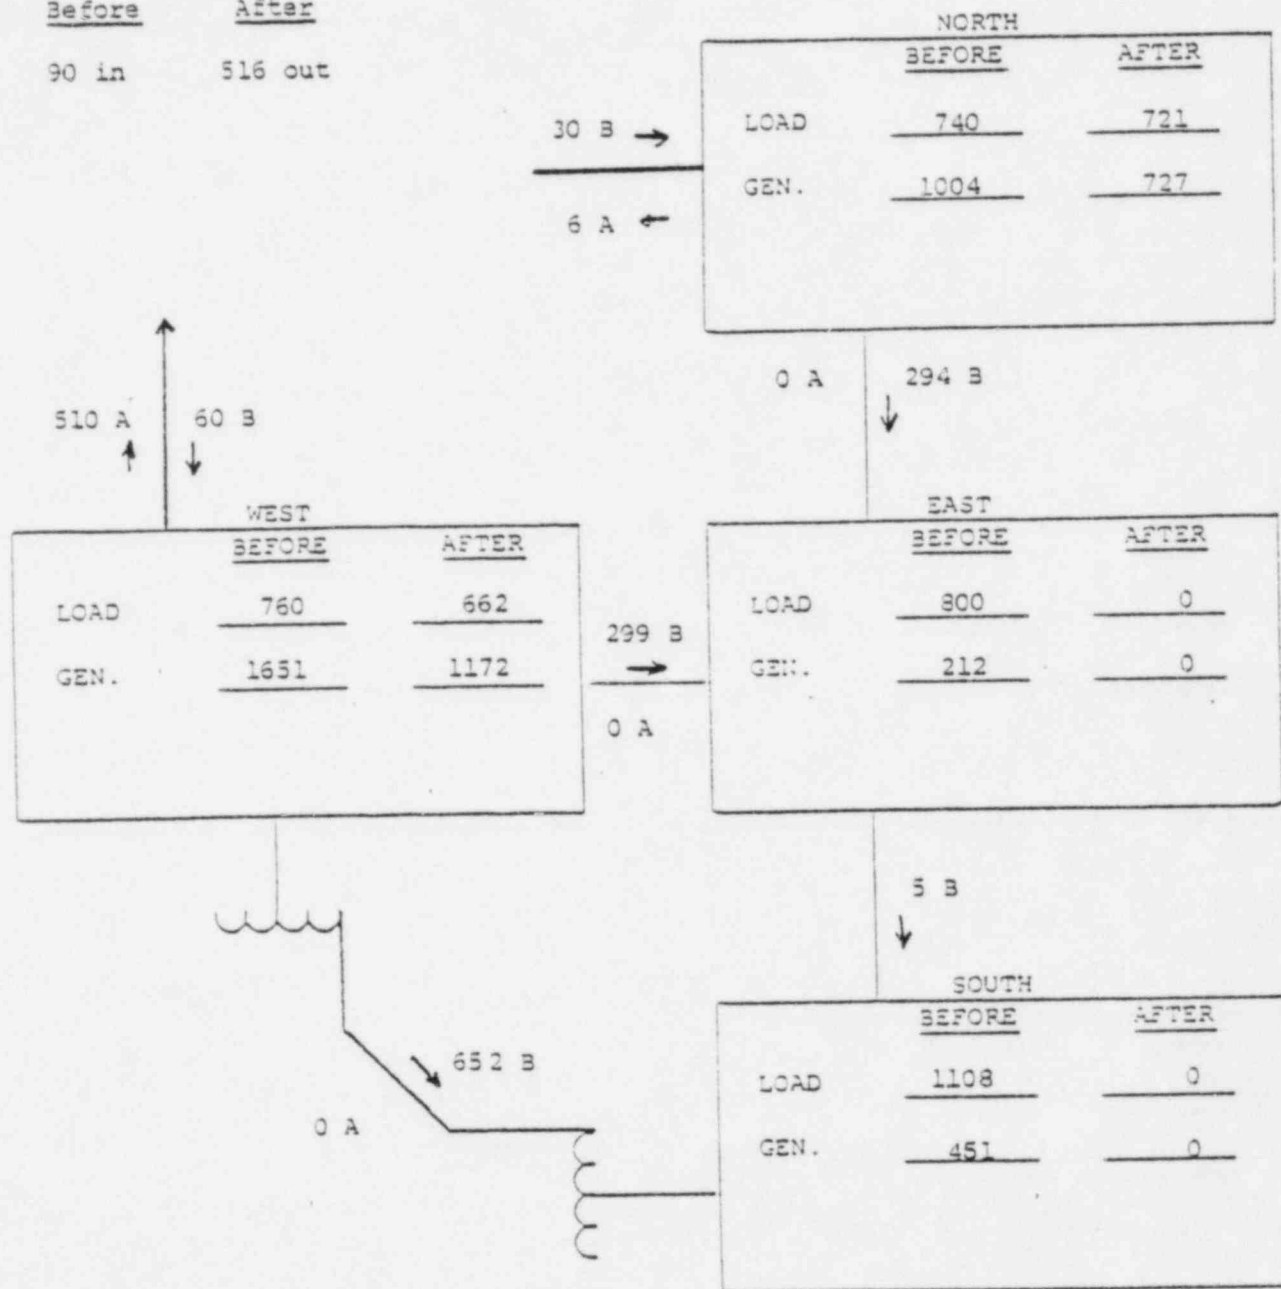
Net Interchange
Before After

90 in 516 out

SYSTEM	BEFORE	AFTER
LOAD	3408	1383
GEN.	3318	1899

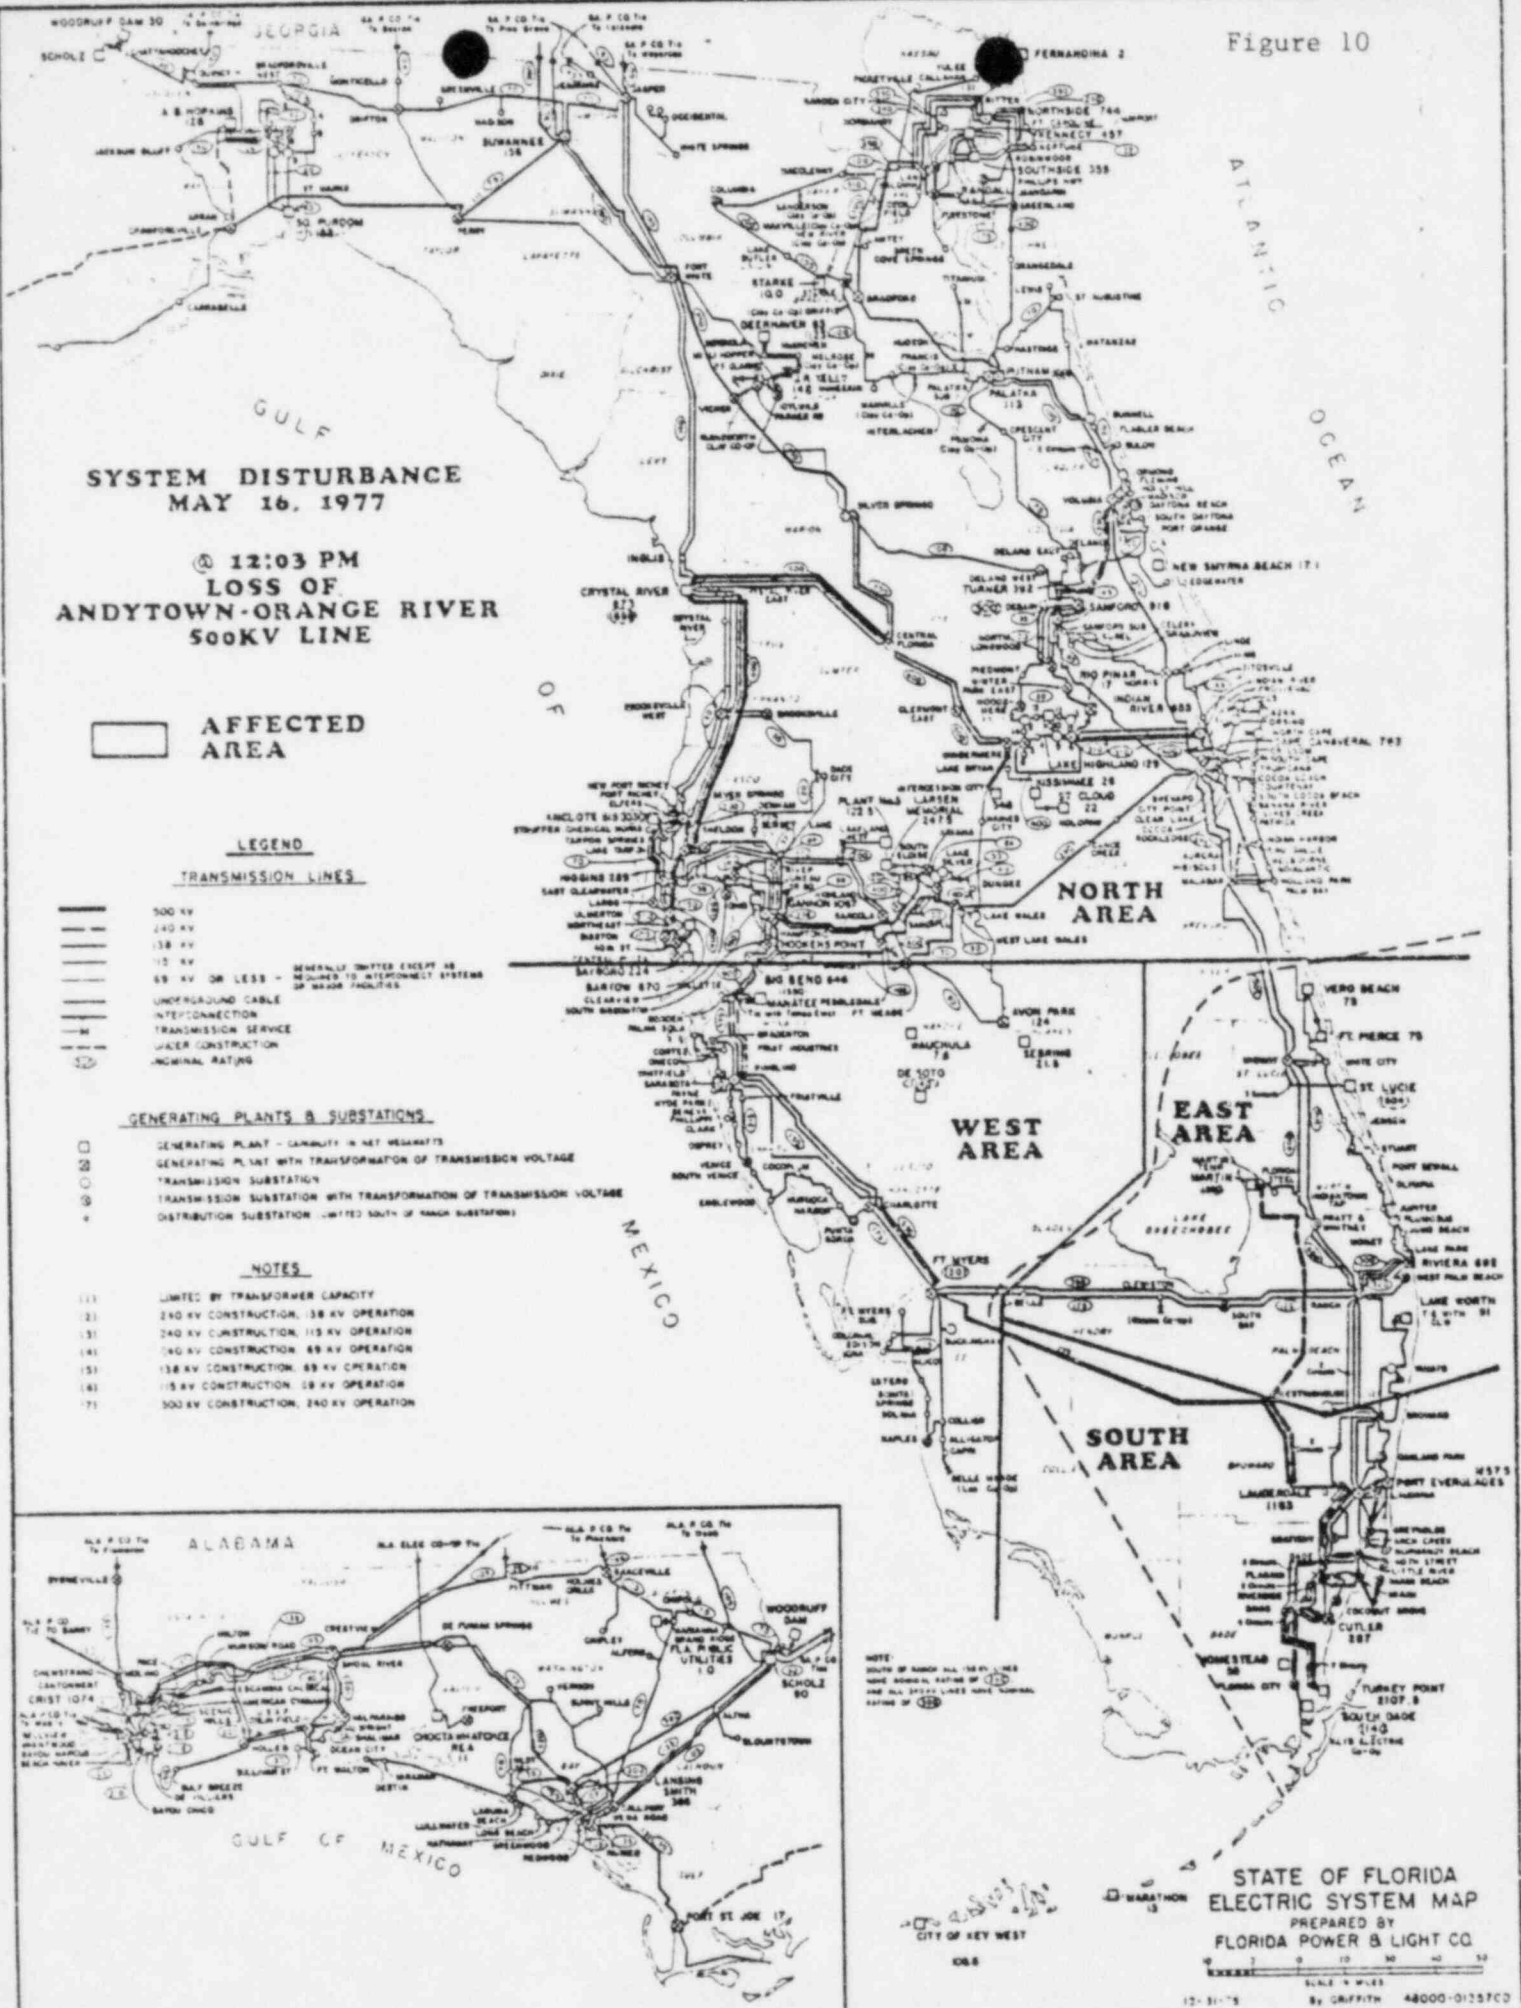
at Ft. Myers and Malabar. See Figure 10 for the area affected. Generation in the affected area, consisting of gas turbines and Riviera Units 3 and 4, was lost.
