Subject: Hydraulic Shock to the Shutdown Cooling
System at Dresden Unit 2

DRESDEN UNIT 2
INCIDENT NO. U2-71-46

HYDRAULIC SHOCK TO SHUTDOWN COOLING SYSTEM

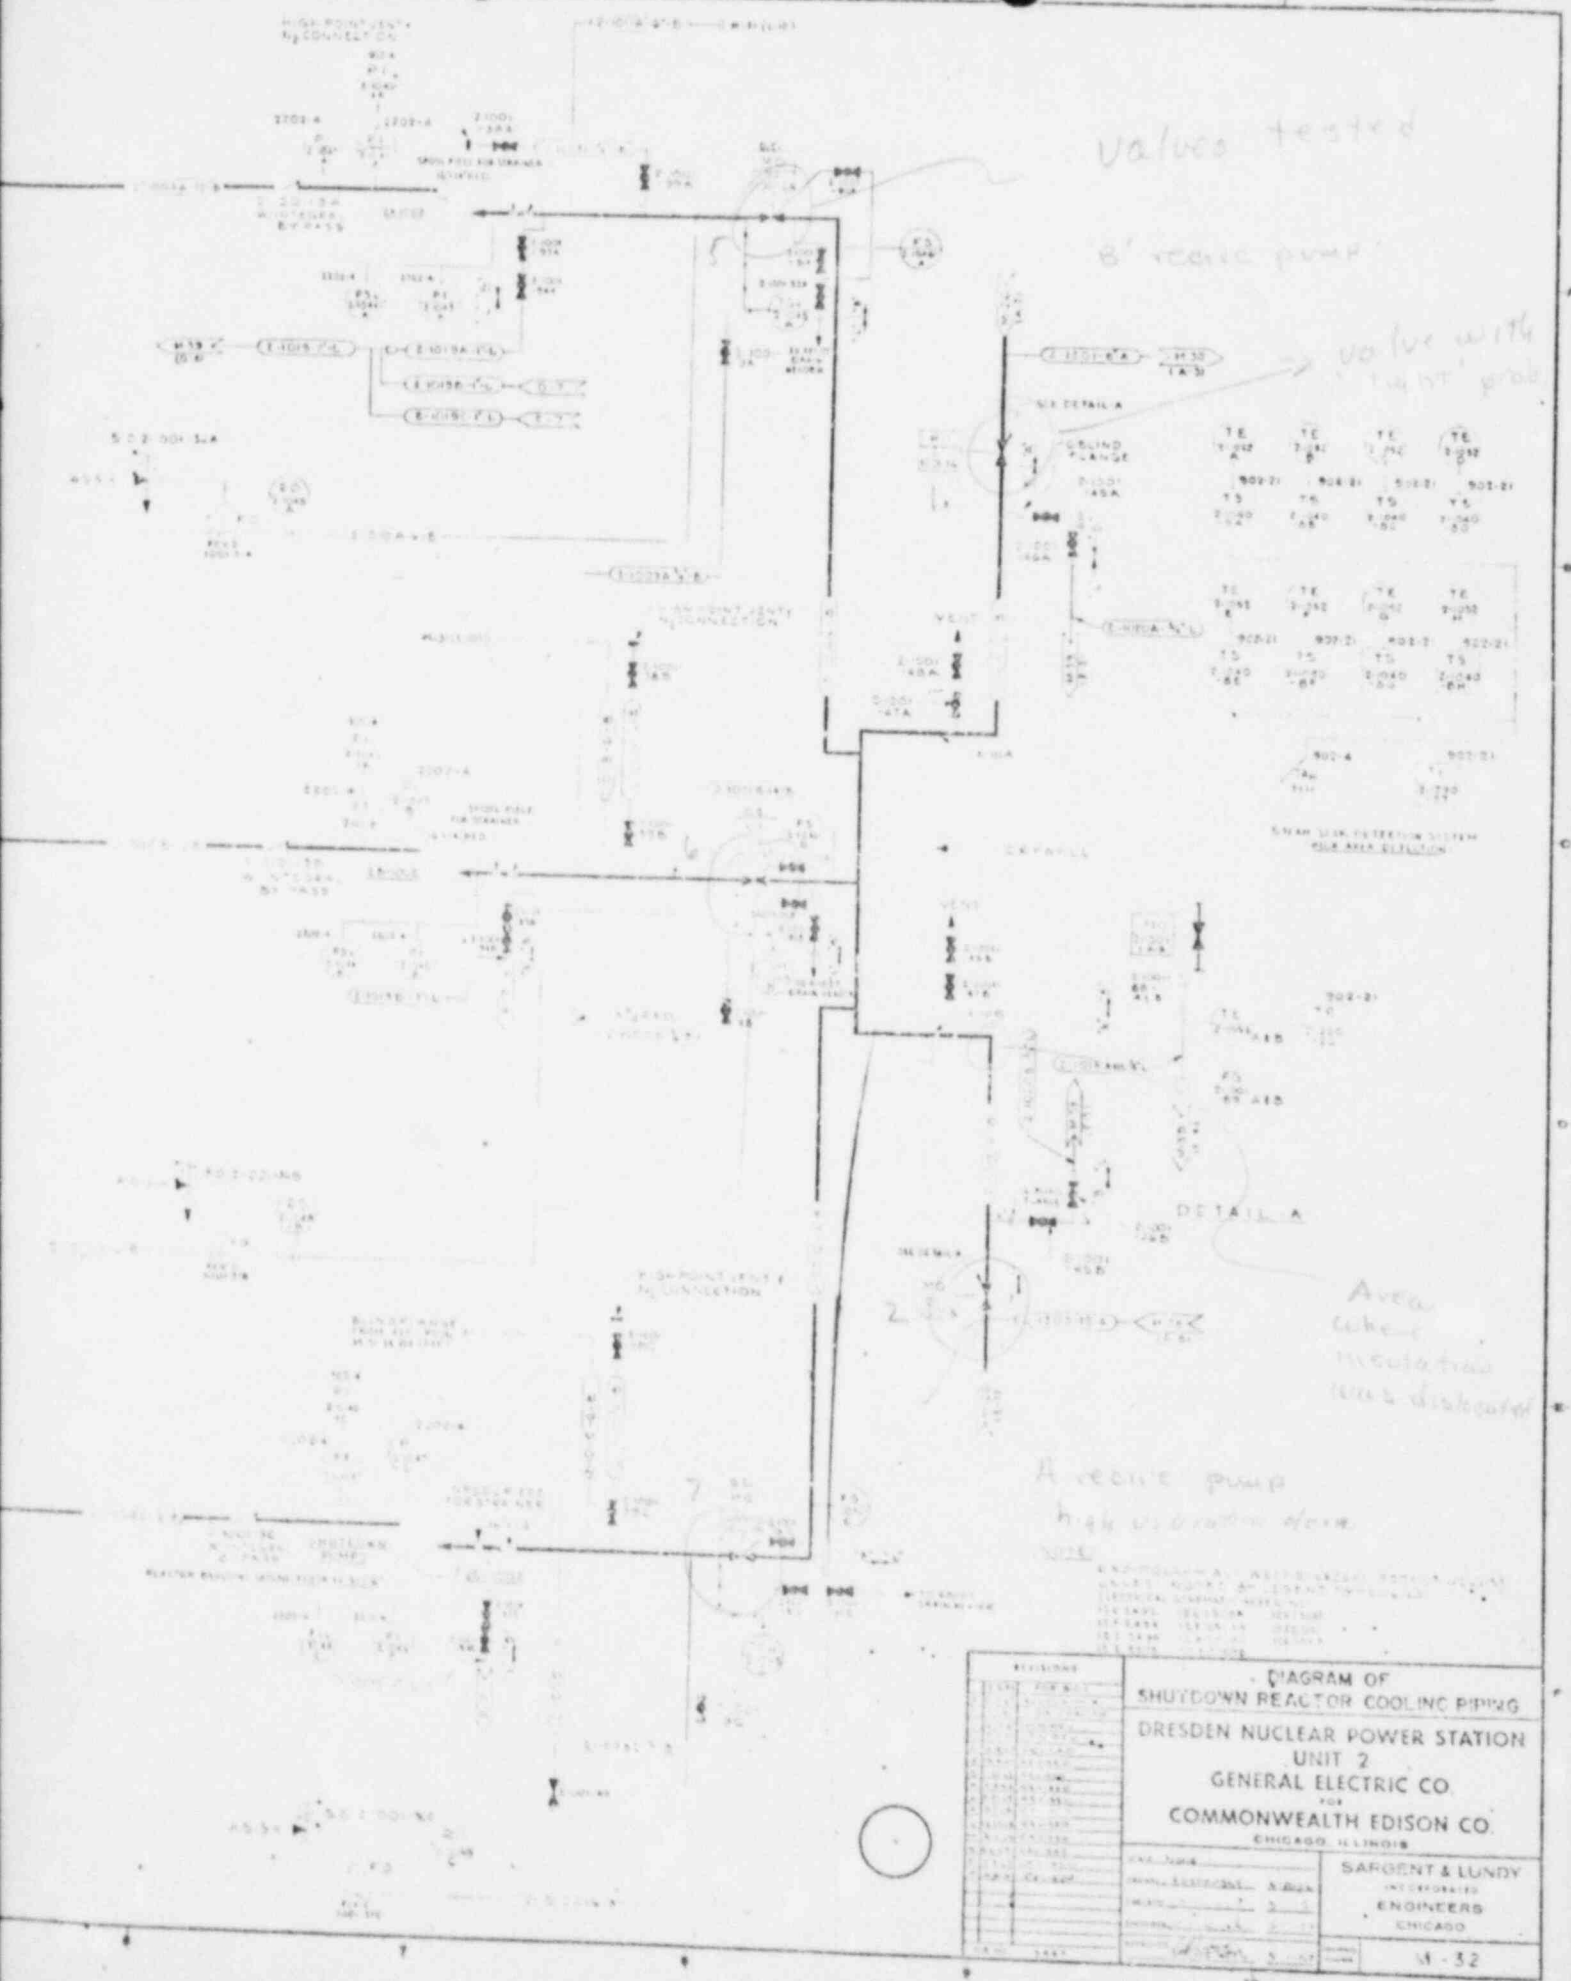
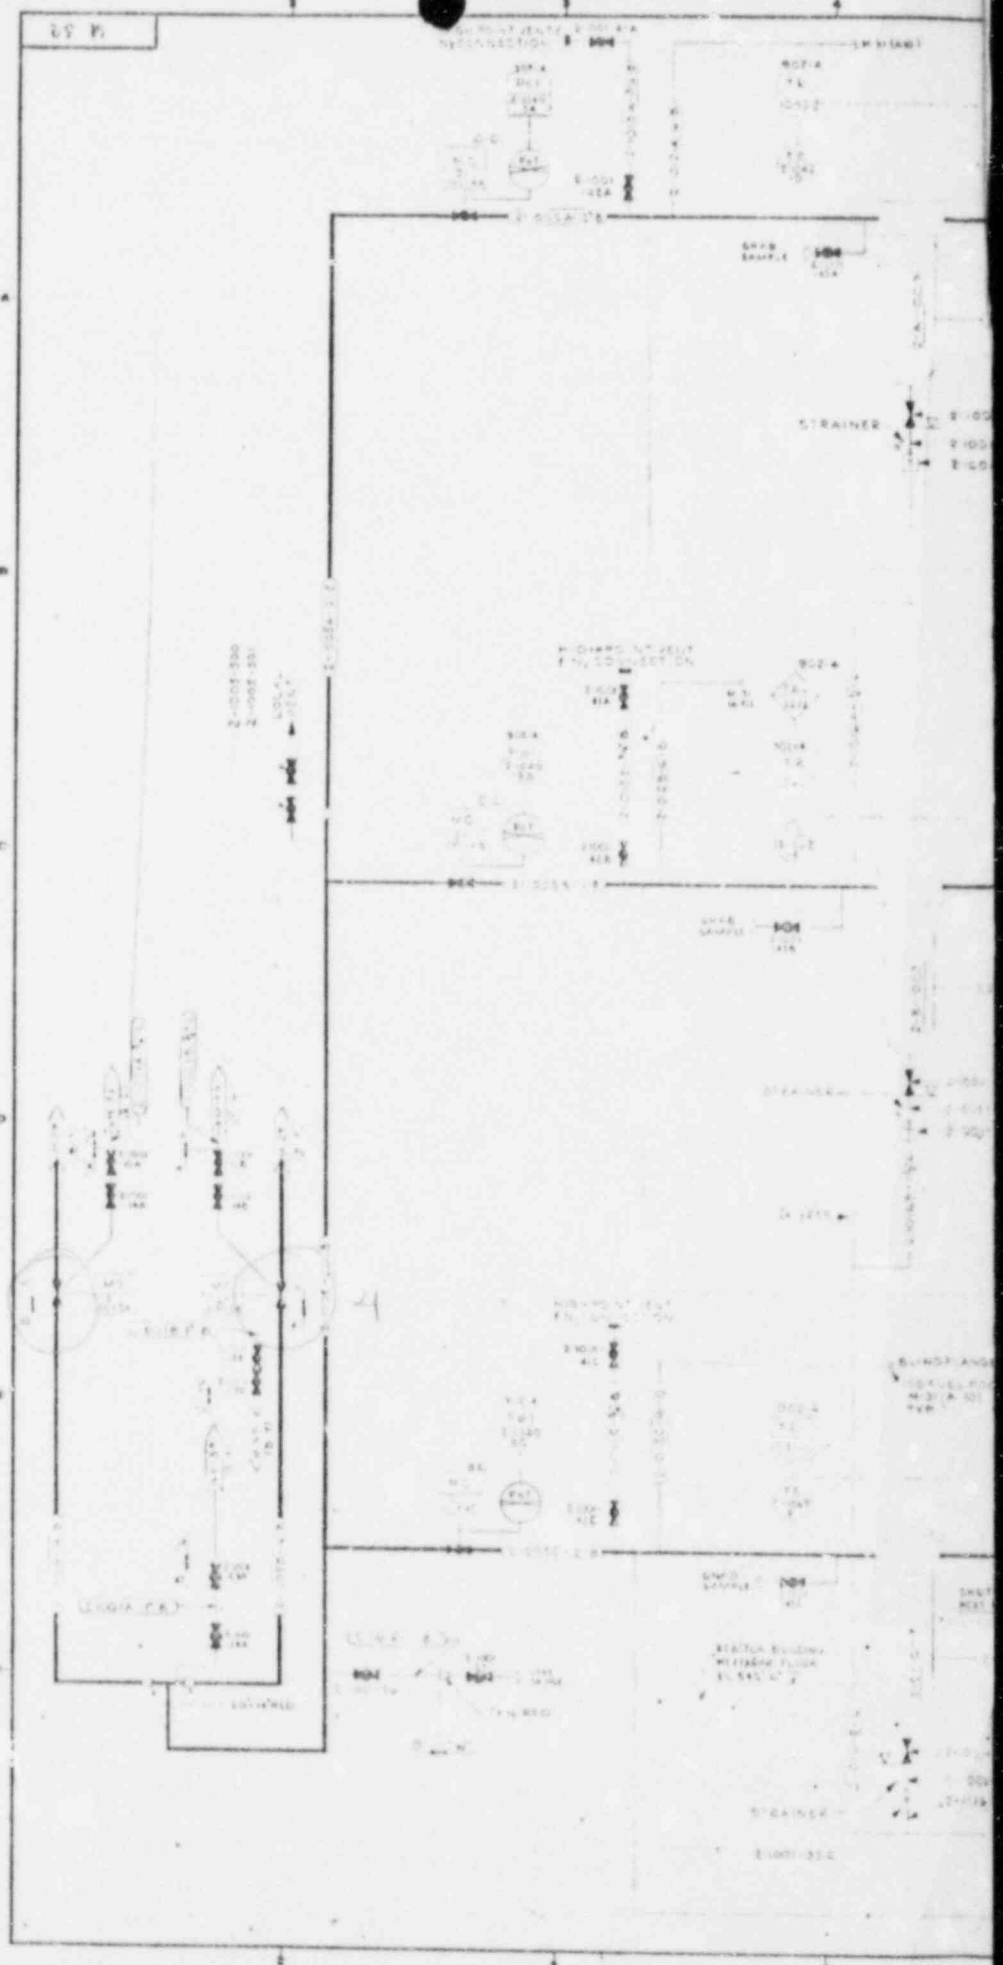
DIAGRAM OF
SHUTDOWN REACTOR COOLING PIPING
DRESDEN NUCLEAR POWER STATION
UNIT 2
GENERAL ELECTRIC CO.
FOR
COMMONWEALTH EDISON CO.
CHICAGO, ILLINOIS

Reviewing the valve operating sequence, it can be hypothesized that between 7-27-71 and 9-38-71 the "B" heat exchanger partially drained due to valve leakage. Since the -1 and -2 valves (see attached figure) remained closed during this period, it is assumed that the header was initially full and became pressurized when the 1A and 1B valves were opened. The opening of 5A and 5B valves had no effect since the LPCI check valves were closed. The opening of the 2A, B & C valves allowed the pressure in the header to be impressed on the A & C heat exchangers. (Pump discharge pressures were noted at 175 and 59 psi respectively, after the incident, whereas B was at 0 psig, and pumps A & C had previously been noted to be at pressures lower than 175 and 50 respectively.) Since the "B" heat exchanger was partially drained, the pressure did not increase, but some flow passed through the pump (warming of the lines were noted following the incident) and into the partially drained heat exchanger. check

The 2B valve is in a vertical section of piping and when fully opened might have allowed an air bubble to form in the suction header assuming the header had been sufficiently depressurized. However, it is more likely that the header was still partially pressurized (since "C" shutdown pump increased to 50 psi and suction valve was opened after "B"), and that partial venting of the header to the void in the "B" heat exchanger allowed some hot water in the header to flash to steam as the pressure was dropped to 50 psi. This flashing resulted in a steam bubble in the header which was collapsed when the 1A valve was opened. Opening Valve 1A allowed water to rush in the header toward the 1B valve (close to the "A" recirculating water pump) resulting in a mild thrust at that

end of the pipe (verified by the dislocated insulation). This would account for the "A" recirculation pump high vibration.
