TURKEY POINT PLANT  
DOCKET NOS. 50-250 AND 50-251  
UNIT TRIPS - APRIL 25, 1974

FLORIDA POWER & LIGHT COMPANY  
TURKEY POINT UNIT NOS. 3 & 4  
UNIT TRIPS - APRIL 25, 1974

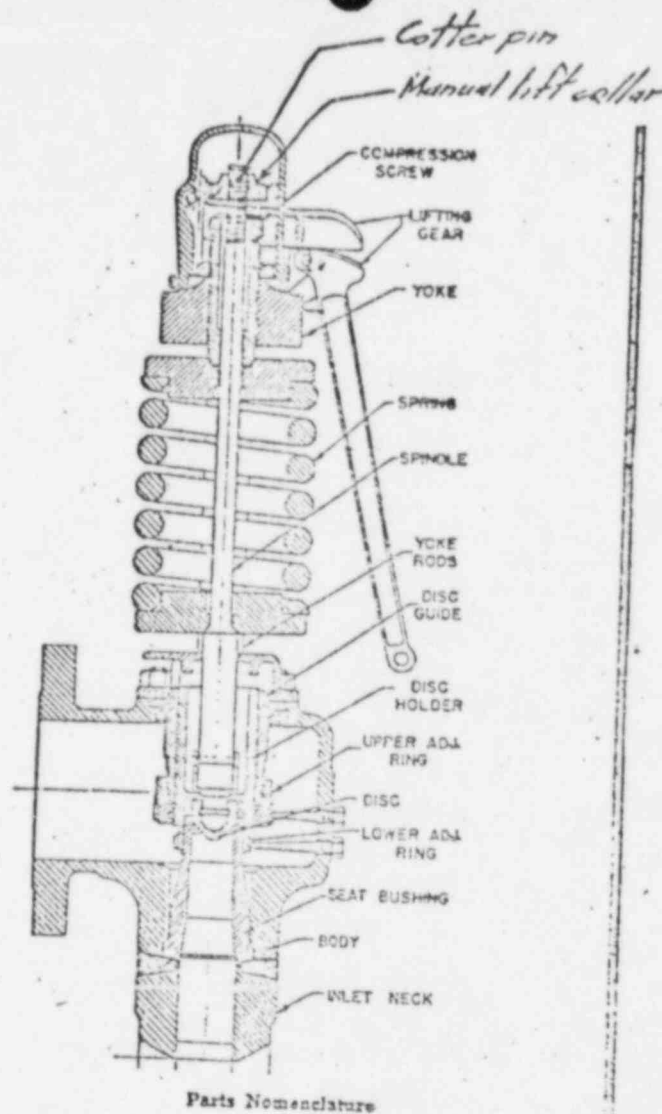
FIGURE 1

About five minutes after No. 4 reactor tripped, the 1085 psig safety valve on No. 4A Steam Generator main steam line header lifted and did not reseal. Immediate operator actions included additional boration of the reactor coolant system to ensure that adequate reactor shutdown margin was maintained. Feedwater flow to No. 4A Steam Generator was controlled to maintain adequate water level while efforts were made to close the safety valve. When the manual lifting device was removed from the safety valve, the safety valve reseated. (Refer to Figure 1 for details)

*TURKEY POINT PLANT - MAIN STEAM  
SAFETY VALVE*

The failure of the safety valve to reseat after opening was found to be caused by the loss of a cotter key in the safety valve topworks. This cotter key locks the manual lift collar in proper position on the safety valve spindle. When the cotter key vibrated out, the manual lift collar vibrated down and made contact with the manual lifting device. When the safety valve operated, the manual lift collar rotated further down the spindle. This physically prevented the safety valve from reseating as the steam pressure decreased.

The safety valve was resealed by removing the manual lifting arm.

The safety valve was repaired by returned the manual lift collar to its original position, installing a new cotter key, and replacing the manual lifting arm. The safety valve is now operable.
