ABNORMAL OCCURRENCE NO. 250-74-6

TURKEY POINT UNIT NO. 3

REDUCED PERFORMANCE OF SAFETY INJECTION SYSTEM PUMP  
DUE TO ENTRAPPED AIR

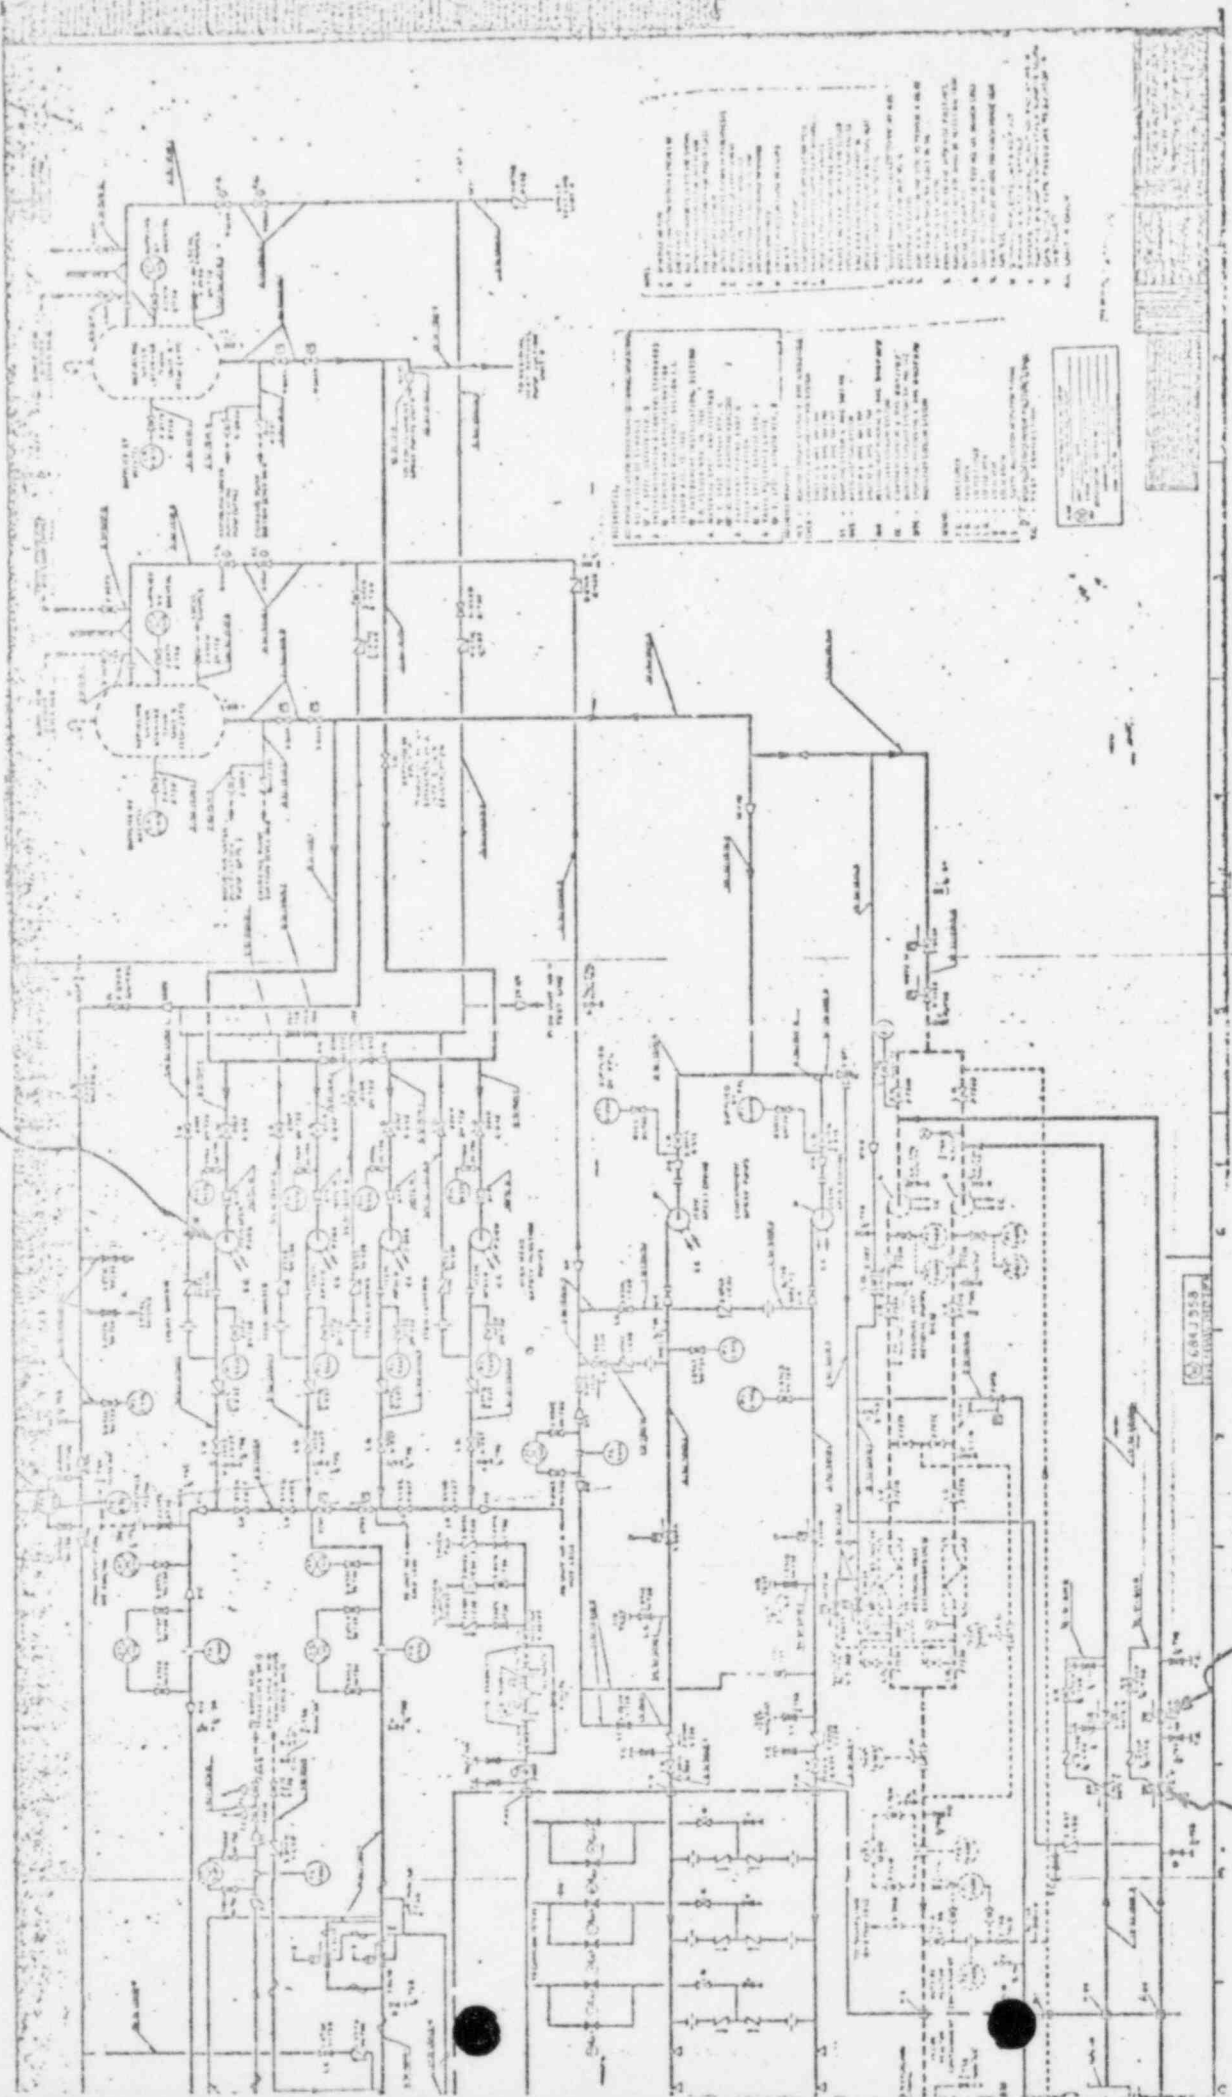
Attachment 1 to  
AO 250/74-6

The exact cause of the air in-leakage could not be determined. However, subsequent investigation revealed that the most likely cause of the in-leakage was from maintenance recently performed on the safety injection system. On March 25, 1974, a modification was performed on valve 3-860A which is the residual heat removal (RHR) pump suction stop valve from the

containment post accident recirculation sump. The valve modification required draining of the line between 3-860A and 3-861A (see attachment). On April 10, 1974, valve 3-861A was cycled according to the Safety Injection System Periodic Test OP4104.1 which could have allowed the trapped air to enter the RHR system piping. Operating logs indicate that the 3A SIS pump was run periodically between April 10 and May 3, 1974, to add water to the accumulators. This could have drawn the trapped air in the RHR piping into the 3A SIS pump by way of the common suction piping.

The safety injection system (SIS) and residual heat removal (RHR) system piping and pumps were also vented to ensure that these systems were free from trapped air. Appropriate work documentation has been initiated for the installation of additional vent lines and valves in approved locations in the SIS and RHR systems.
