SUBJECT: REPORT OF ABNORMAL OCCURRENCE PER SECTION 6.6.A OF THE TECHNICAL  
SPECIFICATIONS  
FAILURE OF 2-203-3C ELECTROMATIC RELIEF VALVE TO OPERATE

Report Number: 50-237/75-41

Facility: Dresden Nuclear Power Station, Morris, Illinois

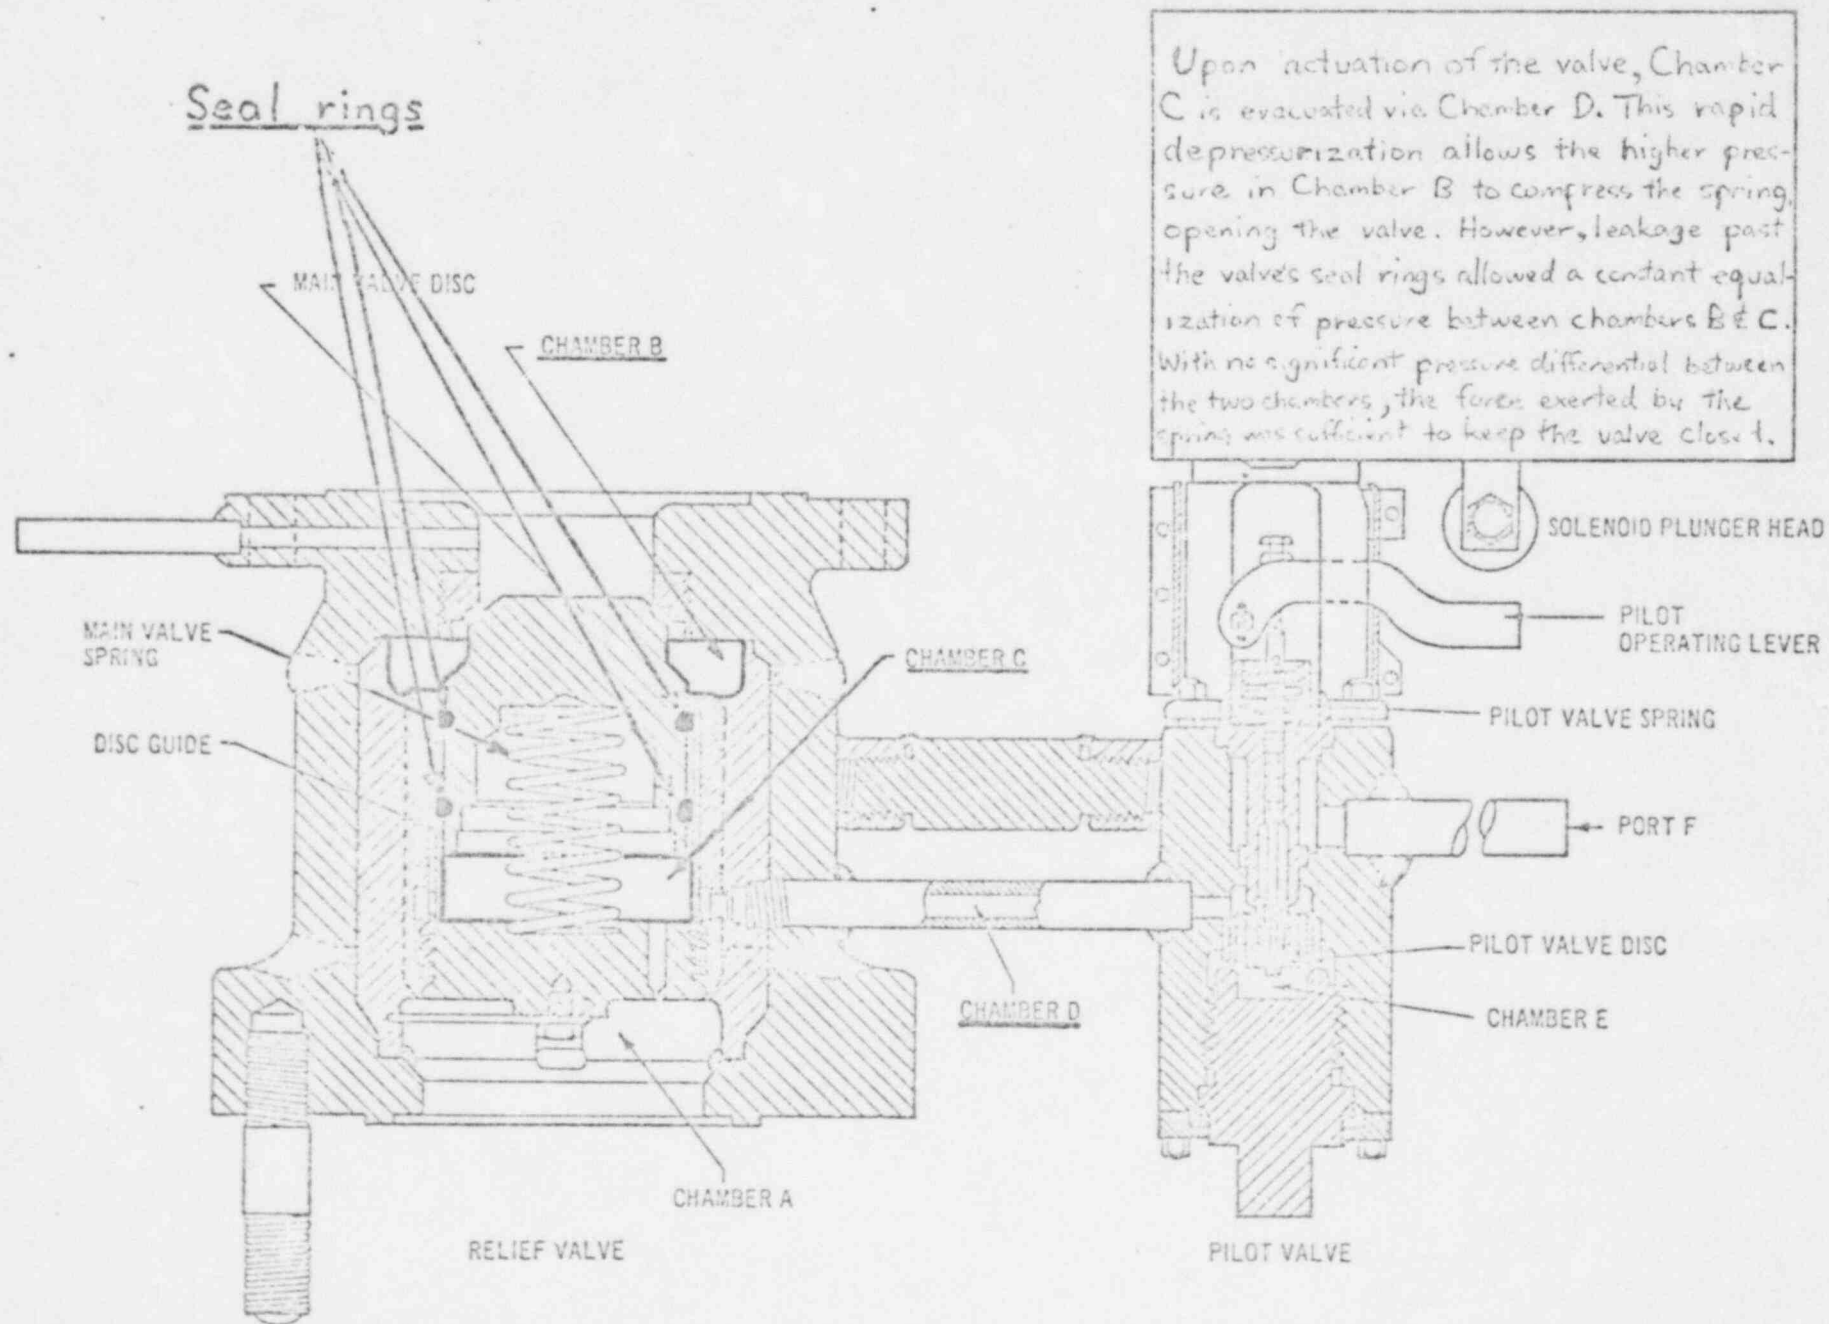
Figure 27-3. RELIEF VALVE (CROSS SECTION)

The failure of both electromatic valves 3C and 3B appeared to be due to leaking seal rings in the valve. This leakage caused a loss of pressure differential within the valves, eliminating the motive force necessary for valve operation (see enclosed diagram). A Dresser Valve representative was present during disassembly of the failed valves, and he concurred with the opinion that the worn seal rings were the probable cause of failure on both valves.

Upon actuation of the valve, Chamber C is evacuated via Chamber D. This rapid depressurization allows the higher pressure in Chamber B to compress the spring, opening the valve. However, leakage past the valve's seal rings allowed a constant equalization of pressure between chambers B & C. With no significant pressure differential between the two chambers, the force exerted by the spring was sufficient to keep the valve closed.

Both electromatics were replaced with rebuilt valves. Successful surveillances on these valves were performed at 150 psig and at rated reactor pressure as the unit was brought back up on June 16, 1975.

Dresser Valve is currently evaluating a new type of seal ring material to prevent recurrences of this nature. Since the cause of failure for valve 3B has now been identified and corrected, this letter will be submitted in lieu of the follow-up report referred to in report no. 75-32.
