Subject: Oyster Creek Station, Docket No. 50-219
Special Report of Investigations and
Repair of In-Core Flux Monitor Penetration

REPORT OF INVESTIGATIONS AND REPAIR OF
IN-CORE FLUX MONITOR PENETRATION

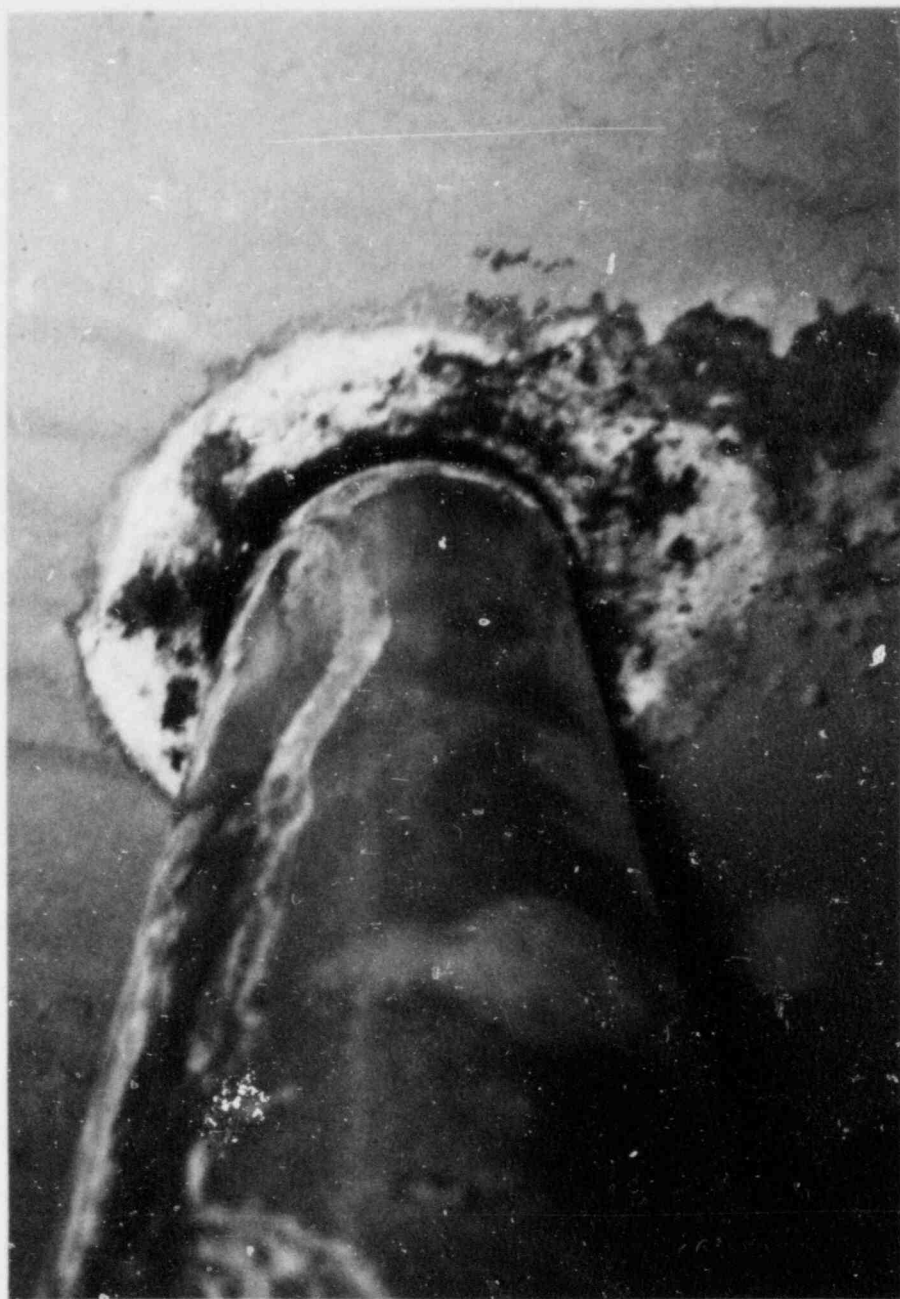
FIGURE 3

Visual examination of the lower head area also revealed evidence of a white deposit about 1/2 to 1-inch wide around the periphery of in-core penetration 28-05 on the outer surface of the manganese-molybdenum head and the stainless steel housing. Examination of the other penetrations of the lower head area, including in-core housings and control rod drive penetrations, revealed no evidence of leakage and no other unusual indications with the exception that a small amount of light colored deposit similar in appearance to that found at in-core penetration 28-05 was observed around the periphery of CRD penetration 18-47. The amount of deposit was much less than in the case of in-core penetra-

tion 28-05. A photograph of location 28-05 while at pressure is shown in Figure 3. A second photograph taken later at ambient pressure, which also includes a view of a control rod drive housing, is shown in Figure 4. Control rod drive housing 18-47 is shown in Figure 5. No leakage or weepage was observed during the leak test of the reactor vessel at any of the in-core or CRD housings other than at in-core housing 28-05 mentioned previously.

PHOTOGRAPH OF IN-CORE PENETRATION 28-05
VIEWED FROM BOTTOM OF VESSEL LOWER HEAD

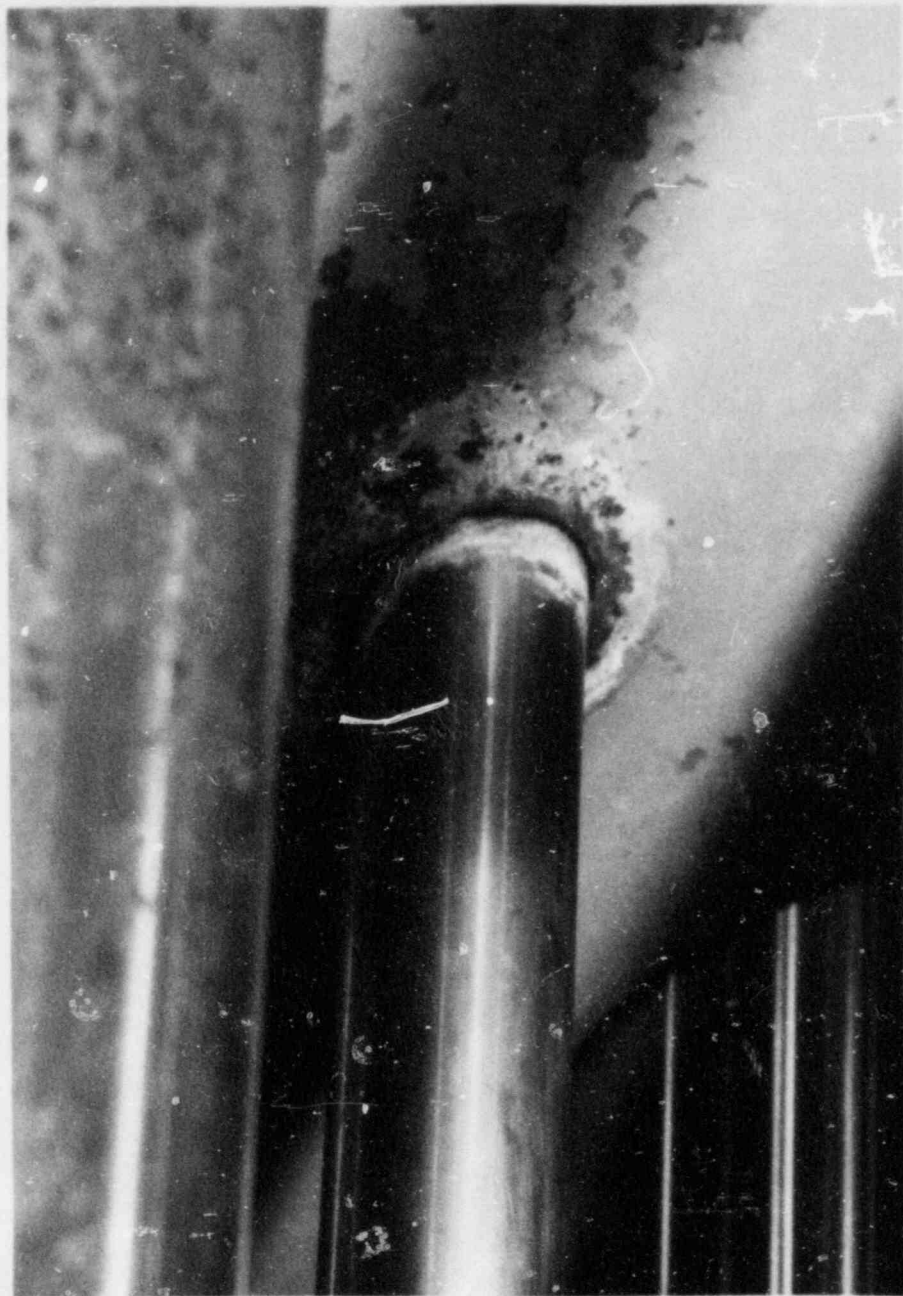
FIGURE 4

PHOTOGRAPH OF IN-CORE HOUSING 28-05
VIEWED FROM BOTTOM OF LOWER VESSEL HEAD.
TYPICAL CRD HOUSING PENETRATIONS ALSO SHOWN

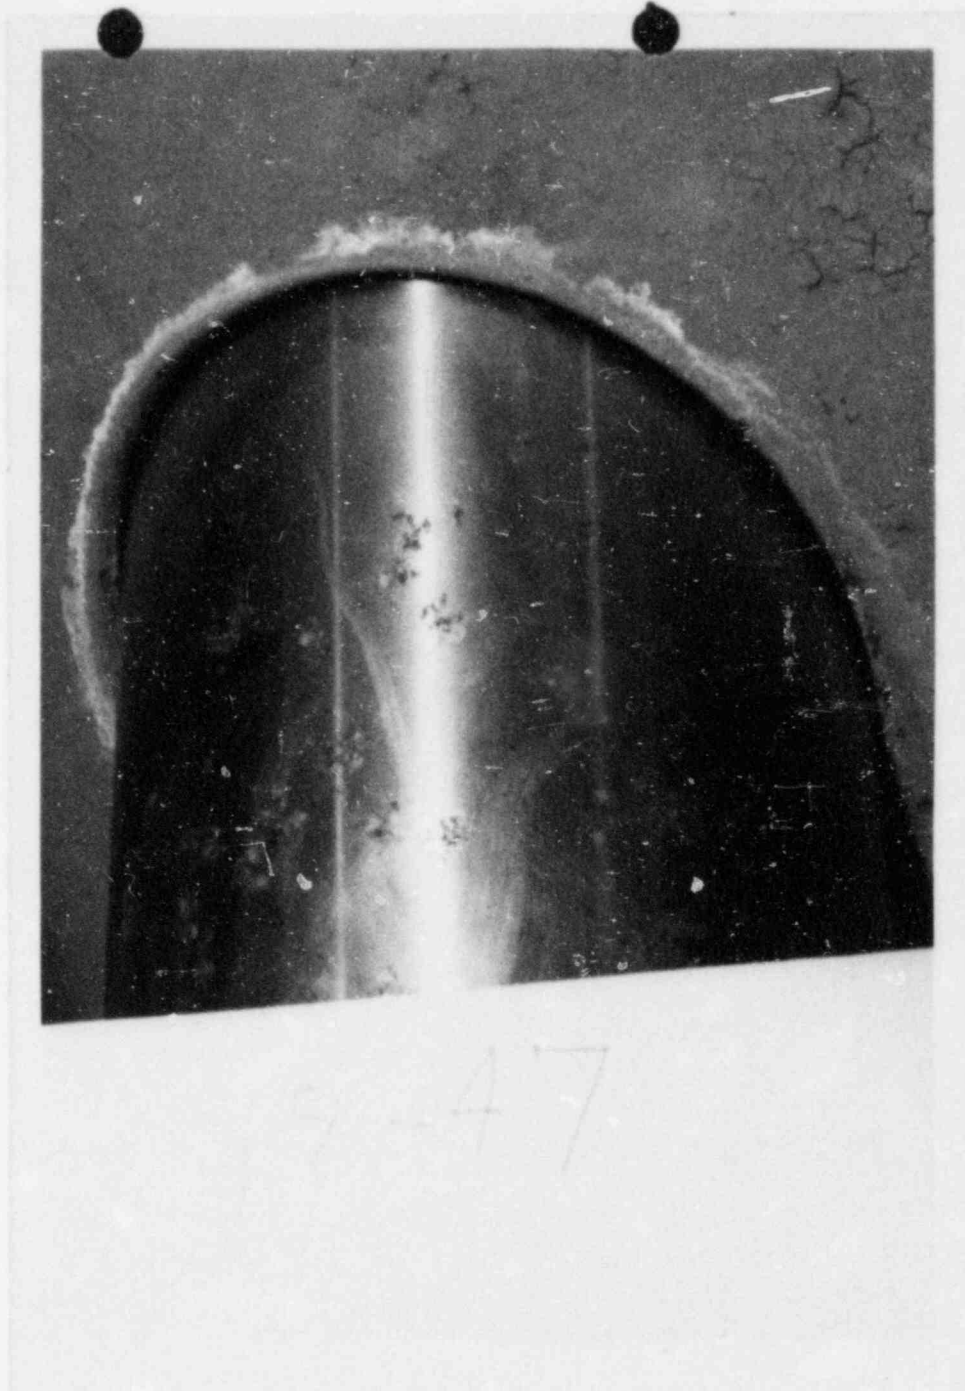
FIGURE 5

Re-examination of the CRD housing and field weld at location 18-47 during this outage showed no indications of defects in either the housing or field weld.

PHOTOGRAPH OF CRD PENETRATION 18-47
AS VIEWED FROM BOTTOM OF LOWER VESSEL HEAD
