Subject: Abnormal Occurrence Report No. 50-219/74/28

OYSTER CREEK NUCLEAR GENERATING STATION
FORKED RIVER, NEW JERSEY 08731

Abnormal Occurrence
Report No. 50-219/74/28

Abnormal Occurrence Report No. 50-219/74/28

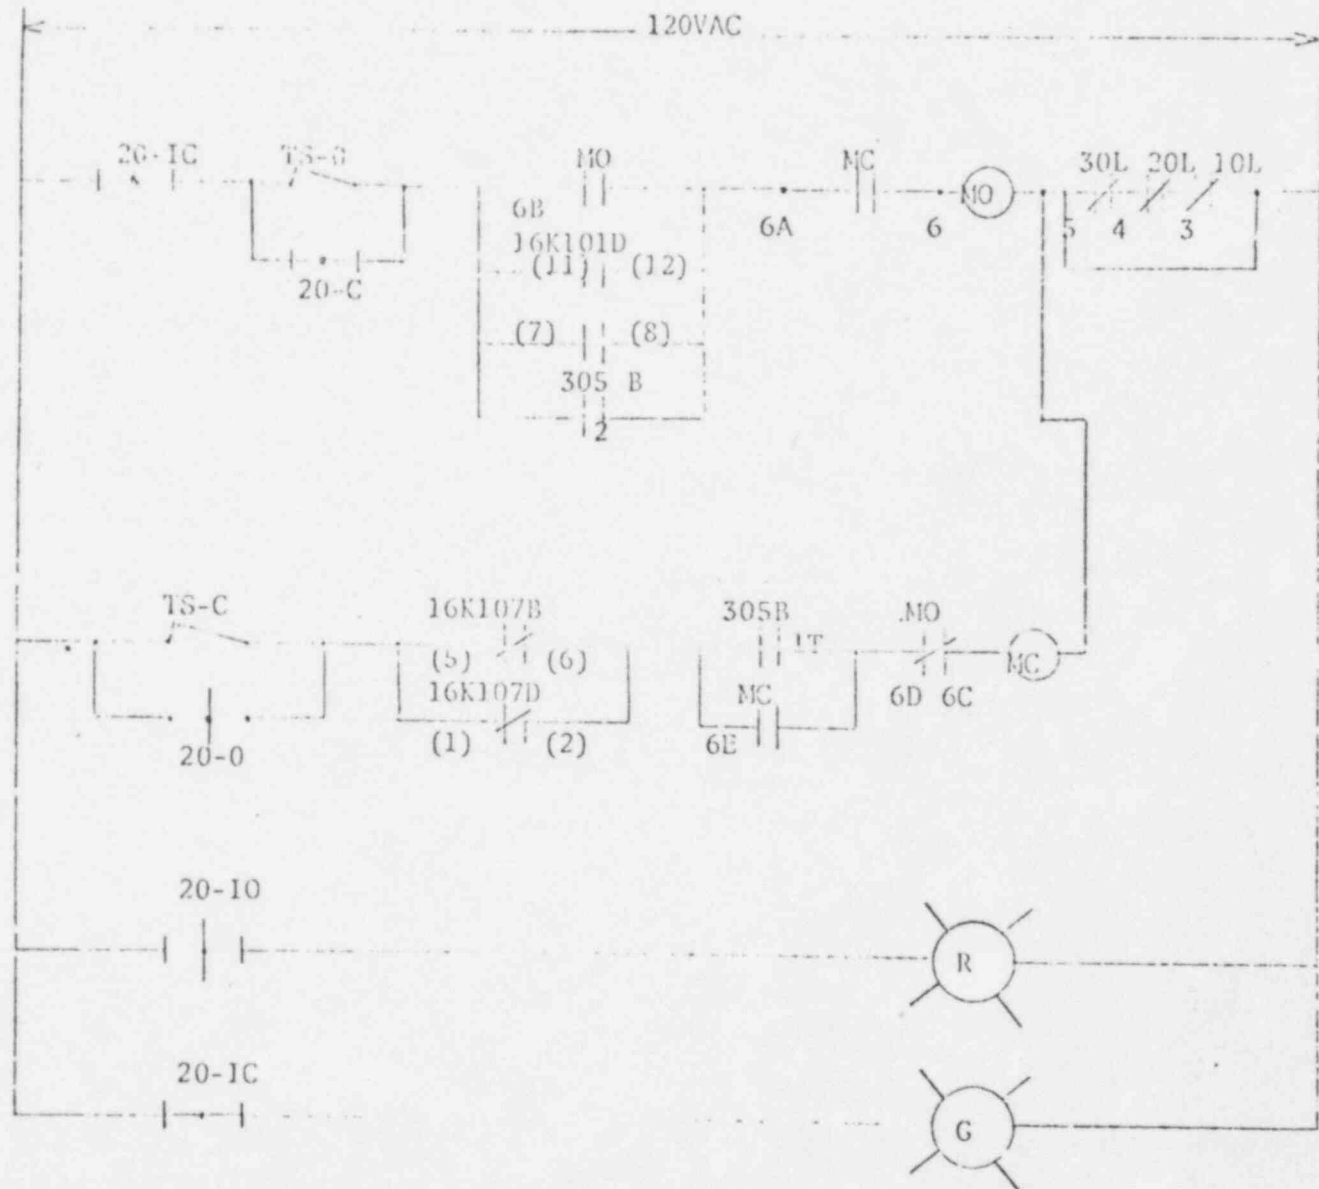
Figure 1

Refer to the attached schematic diagram of the opening and closing control circuitry for V-20-4 (Figure 1). Torque switch TS-0 is provided to interrupt the control circuitry if a mechanical overload occurs during the opening cycle. Position switch 20-C is provided to override the function of TS-0 during the initial stages of the opening cycle. This position switch (20-C) is normally adjusted to open at approximately 10% of valve travel. Investigation of the control circuitry after the abnormal occurrence revealed that 20-C was opening prematurely at 6% to 7% of valve travel. It has, therefore, been concluded that 20-C opened before torque switch TS-0 closed, thereby preventing V-20-4 from opening.

Position switch 20-C was readjusted to open at approximately 10% of valve travel.
