Subject: Dresden and Quad-Cities Stations
Reactor Water Recirculation 4-Inch
Diameter Piping Crack Investigation
Program, NRC Dkts. 50-237, 50-249,
50-254, and 50-265

We have completed the three additional constant-strain-rate tests as discussed in our January meeting. The initial results of the study, together with the procedures, were detailed in my letter to you dated November 26, 1974.

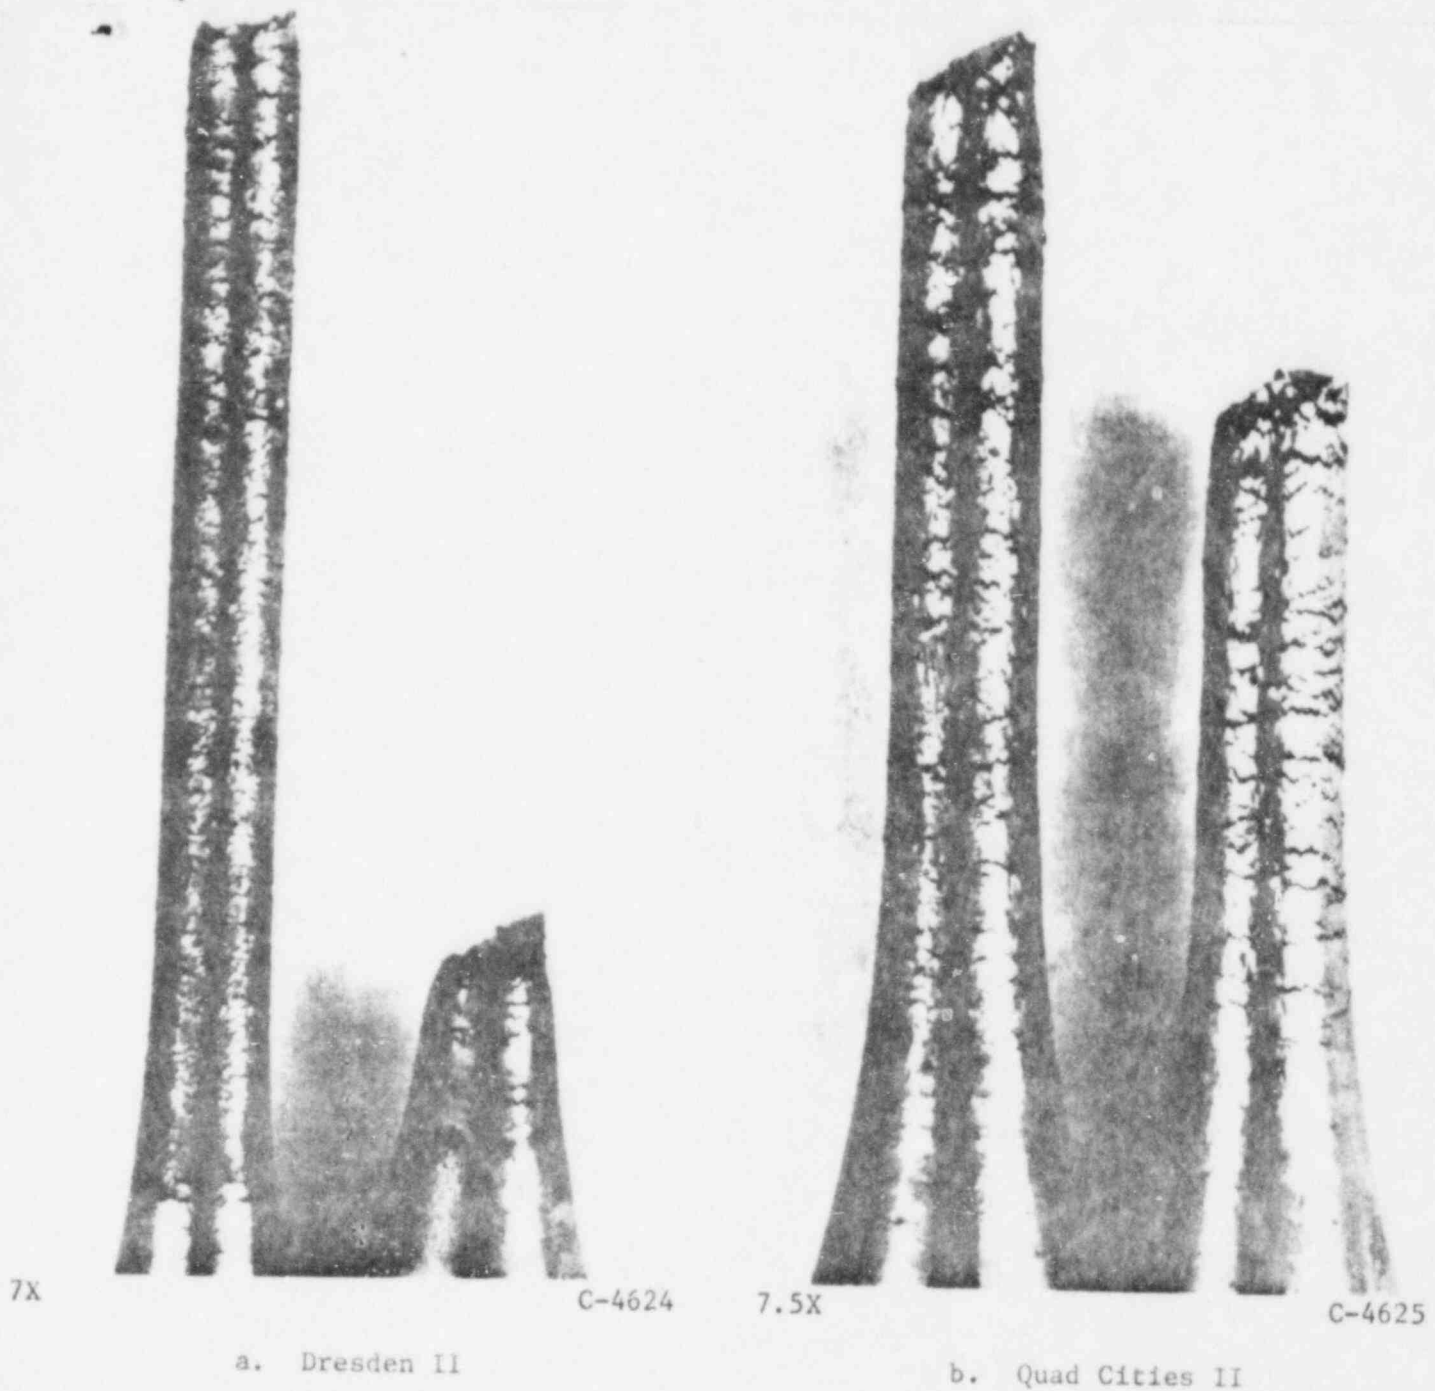
The appearance of the lightly sensitized specimens after test tends to support the data presented in Table 1. Photographs of the two halves of the broken tensile specimens are presented in Figures 1 and 2. These photographs suggest severe cracking. However, the metallographic examination of longitudinal cross sections through these specimens revealed many

FIGURE 1. APPEARANCE OF LIGHTLY SENSITIZED TENSILE SPECIMENS FROM DRESDEN II AND QUAD CITIES II PIPING AFTER PULLED TO FAILURE AT 3×10^{-6} IN./IN.-SEC STRAIN RATE IN 550 F WATER CONTAINING 100 PPM DISSOLVED OXYGEN

Note the many secondary cracks. Compare with Figure 2.

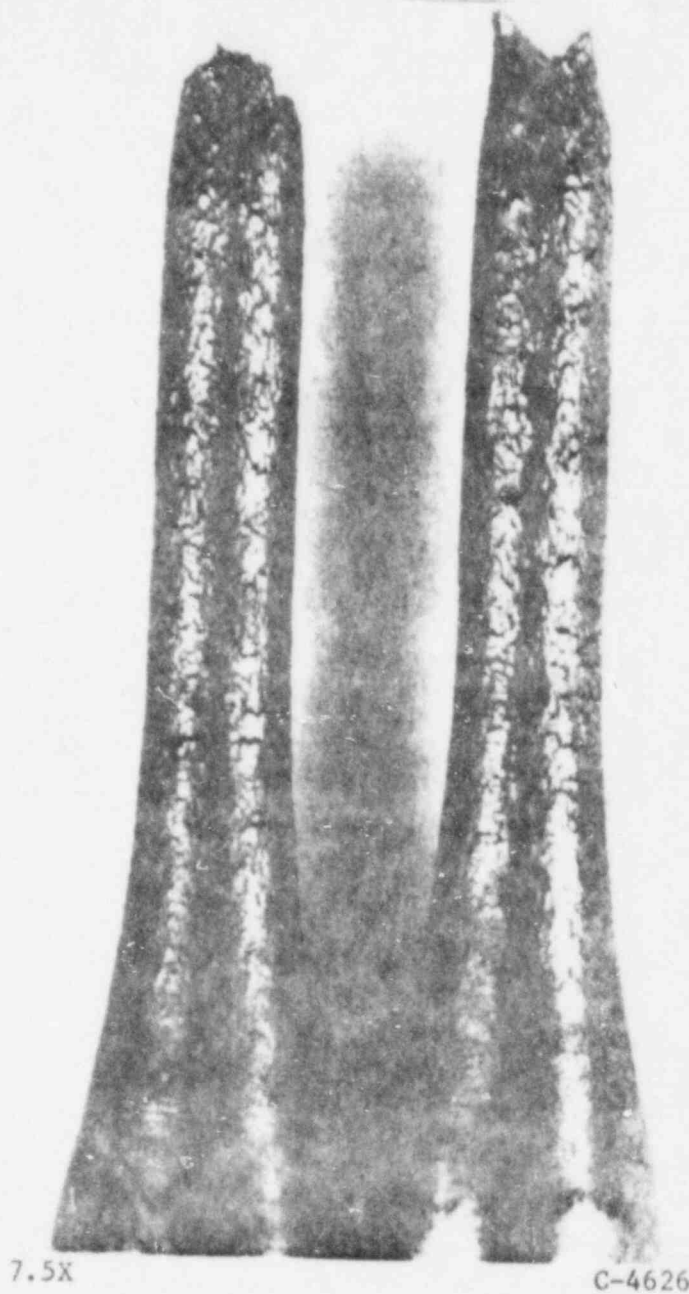
FIGURE 2. APPEARANCE OF LIGHTLY SENSITIZED TENSILE SPECIMEN FROM A BATTELLE HEAT OF TYPE 304 STAINLESS STEEL AFTER PULLED TO FAILURE AT 3×10^{-6} IN./IN.-SEC STRAIN RATE IN 550 F WATER CONTAINING 100 PPM DISSOLVED OXYGEN

Note secondary cracks and ductile necking at the fracture. Compare with Figure 1.

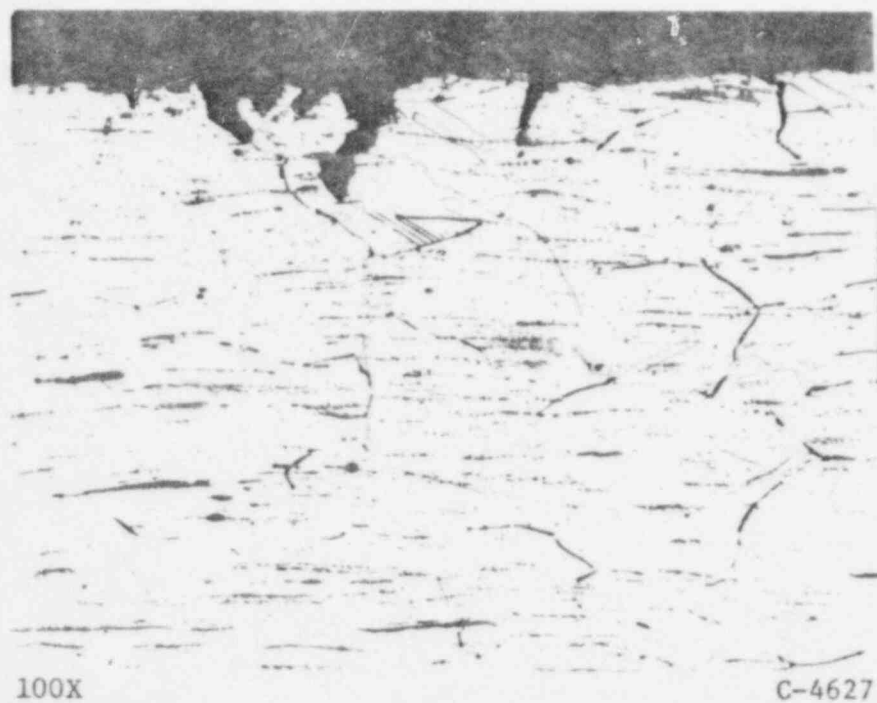
a. Battelle Heat

shallow secondary intergranular cracks with an occasional transgranular wedge. (The latter are often found on crack-resistant mill-annealed material after test.) The Dresden II and Quad Cities II specimens appeared to have more and slightly deeper secondary cracks than the Battelle specimen. Photomicrographs of typical areas are shown in Figure 3.

FIGURE 3. PHOTOMICROGRAPHS OF SECONDARY CRACKS SHOWN IN FIGURES 1 AND 2 (LONGITUDINAL SECTIONS)

Note shallow depth of penetration.
