# Commonwealth Edison Company

Dresden Nuclear Power Station  
R. R. #1  
Morris, Illinois 60450  
March 19, 1973

SUBJECT: LICENSE DPR-19, DRESDEN NUCLEAR POWER STATION, UNIT #2  
SECTION 6.6.C.(1) OF THE TECHNICAL SPECIFICATIONS.

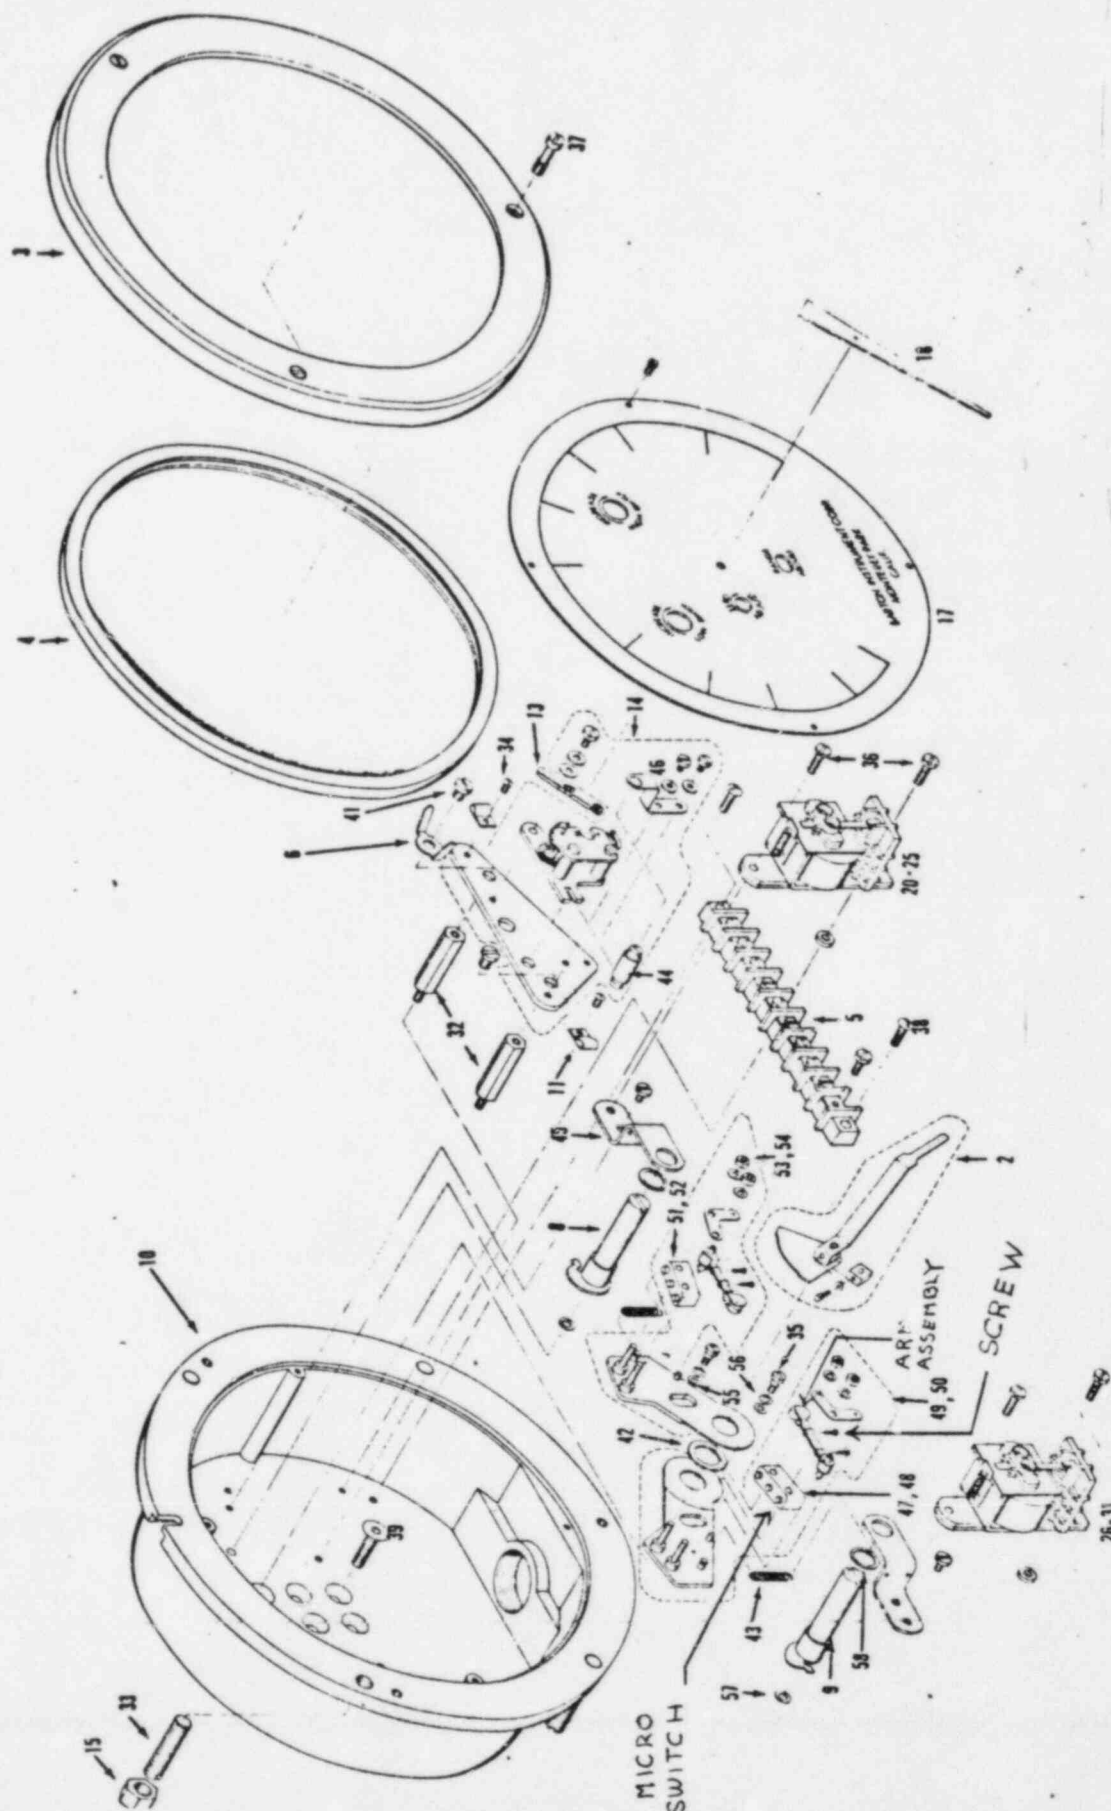
Switch DPIS-2-261-34A failed to operate due to a loose screw on the micro-switch actuating arm. (Figure #1). The function of the screw is to strike the micro-switch plunger when the actuating arm is moved upward by the diaphragm driven cam. The screw apparently vibrated out of position and could no longer make contact with the micro-switch. The records on this particular switch indicate that this screw was found to be loose on one previous occasion. At that time, the screw was tightened.

No record exists of a similar loose screw on any other Barton switch at this site, and in fact the screws are normally very tight and must be moved with a tool. It was concluded that the loose screw in DPIS-2-261-34A was the result of a defective arm assembly which holds the screw.

The arm assembly and screw for DPIS-2-261-34A were replaced and the switch tested satisfactorily. To further assure the screw will not vibrate out, finger-nail polish will be applied to the threads and the screw will be tested for tightness at the next surveillance.
