Northeast
Nuclear Energy

LICENSEE EVENT REPORT (LER)

Millstone Nuclear Power Station Unit 3

Containment Leakage in Excess of Technical Specification Limits Due to Valve Leakage

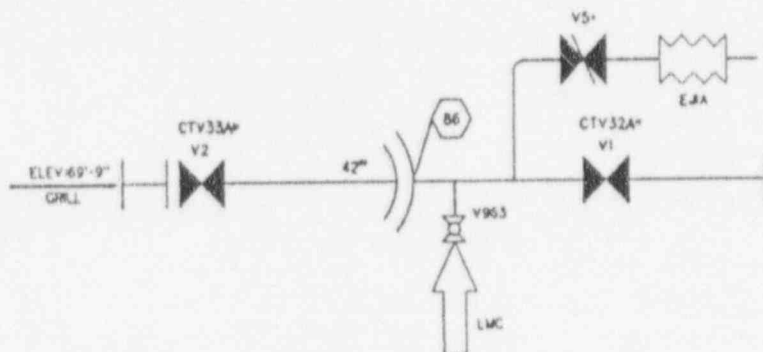
Figure 1, Containment Purge Supply Penetration, #86

The containment purge supply line (42-inch) penetration (#86) has three isolation valves, one inboard (3HVU*CTV33A), one outboard (3HVU*CTV32A), and an additional outboard valve on a 30-inch branch line (3HVU*V5). The combined "as found" LLRT leakage through these three valves was 7,300 SCCM. The large isolation valves cannot be tested independently. However, the branch valve has been determined to have insignificant leakage. See Figure 1.

The apparent cause of the excessive leakage through the 42-inch butterfly isolation valves on the purge supply and exhaust lines, was deterioration of the resilient valve seats. The cause of the deterioration is being investigated. It is believed that the cause is isolated to the current event, as this deterioration has not been observed in the past.

The combined leakage through all of the isolation valves on the 42-inch containment purge supply and exhaust lines was 15,120 SCCM. This total is below the current Technical Specification allowable bypass leakage, L_a of 20,633.9 SCCM. The purge valve leakage had low safety significance. The actual leakage through the penetrations, even assuming a single failure, would be even lower than 15,120 SCCM. This is because the penetration leakage is conservatively assumed to be equal to the sum of the redundant valve leakages, since they cannot be individually tested.

The valve seats for the containment purge supply and exhaust line valves were inspected and two of the four valve seats were found to be somewhat worn. New seats were installed on all four 42-inch valves and they were tested satisfactorily. The valves are large diameter butterfly valves which require precision seating to maintain low leakage rates. These valve seats will continue to be replaced every other refueling or each refueling as needed, to maintain acceptable low leakage.

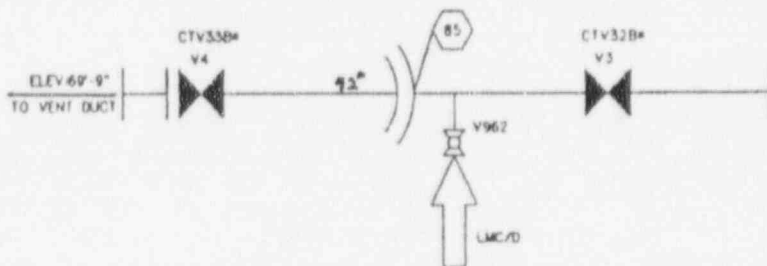
Figure 2, Containment Purge Exhaust Penetration, #85

The containment purge exhaust line (42-inch) penetration (#85) has one inboard valve (3HVU*CTV33B) and one outboard valve (3HVU*CTV32B). The combined "as found" LLRT leakage through these two valves was 7,820 SCCM. The valves cannot be tested independently. See Figure 2.

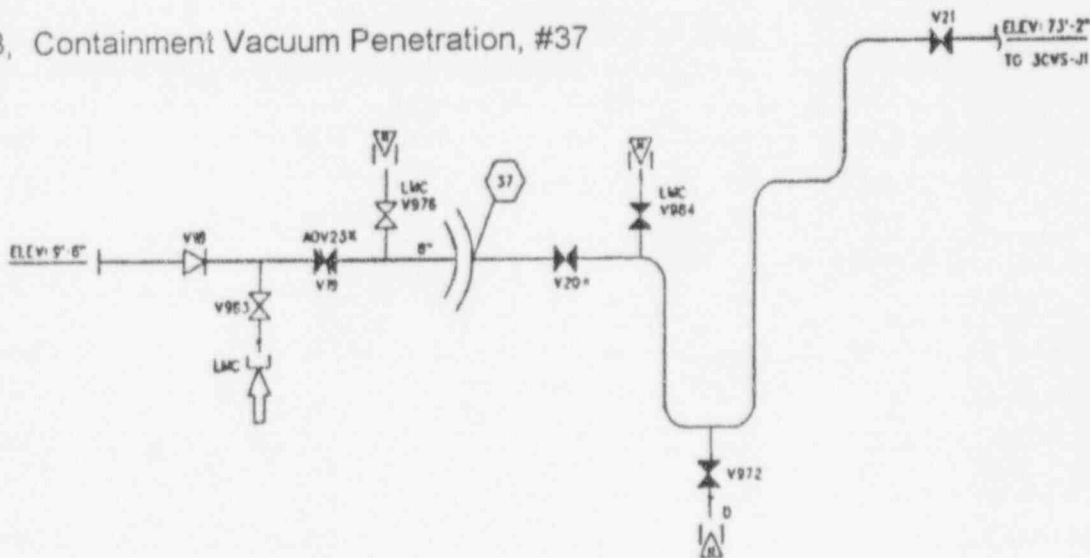
Figure 3, Containment Vacuum Penetration, #37

The containment vacuum line (8-inch) penetration (#37) has one inboard valve (3CVS*AOV23) and one outboard valve (3CVS*V20). The "as found" LLRT leakage through the inboard valve was 27 SCCM, which maintained penetration integrity, while the outboard valve was found to have 11,970 SCCM leakage. See Figure 3.

The cause of the excessive leakage through the 8-inch outboard vacuum line valve was inadequate design. The valve is a hard-seated gate valve which historically had similar leakage, and, therefore, is being replaced during the current refueling outage.

The "as found" bypass leakage through the outboard containment vacuum isolation valve was 11,970 SCCM. This would have been limited by the operable inboard valve which was isolated to only 27 SCCM. A single failure of the inboard valve would have resulted in the combined total of these bypass leakages, slightly exceeding the Technical Specification Limit.

The containment vacuum line outboard isolation valve is being replaced during the current refueling outage. The 8-inch hard seated gate valve is being replaced with a soft seated butterfly valve, which is a better design for this application.
