SUBJECT: REVISION TO ABNORMAL OCCURRENCE REPORT ON DRESDEN UNIT 2 CORE SPRAY
INJECTION LINE THROUGH-Wall CRACK

10" CORE SPRAY NOZZLE

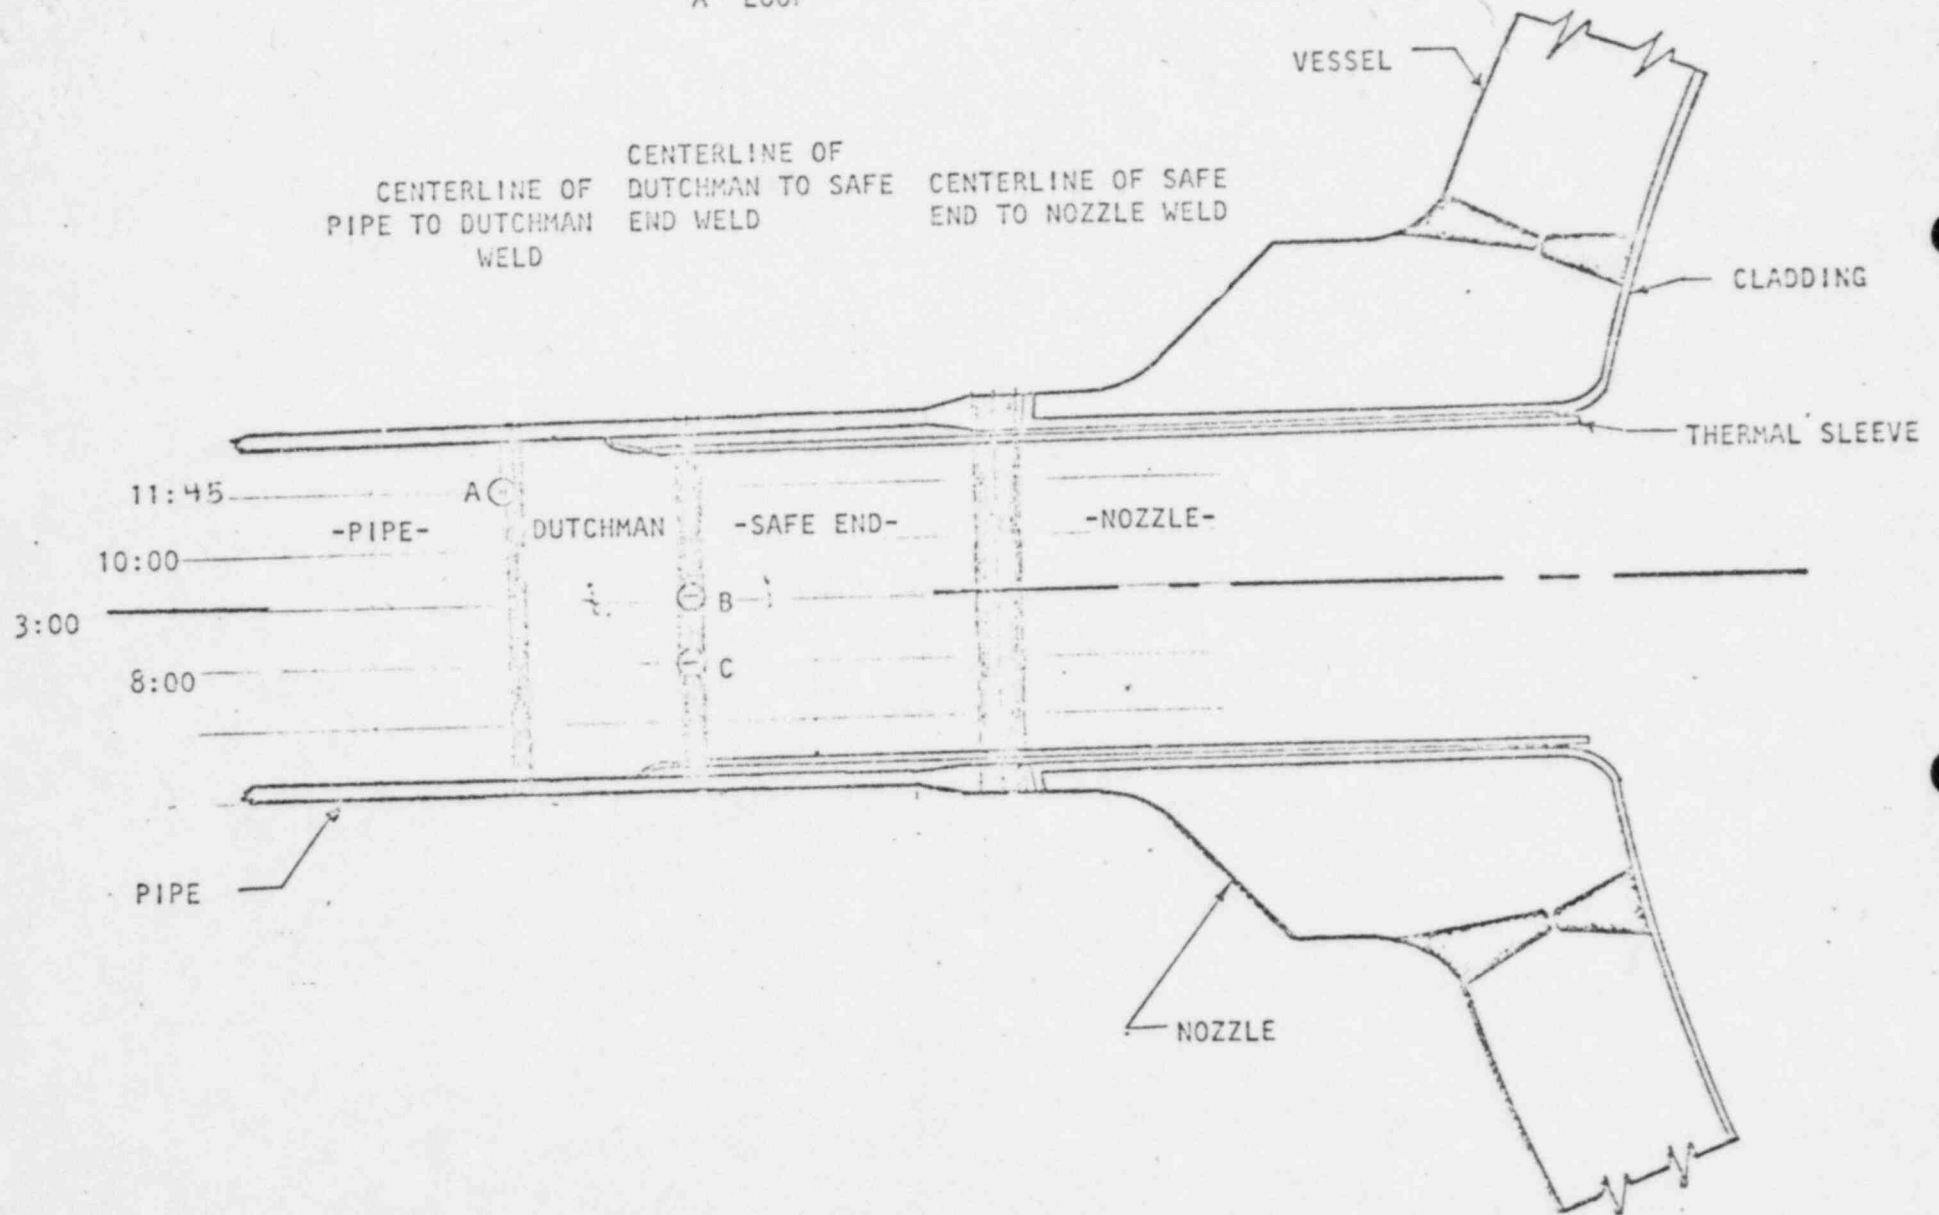
"A" LOOP

- A⊙ - Location of weeper approx. 1/8" on pipe side of weld at 11:45
 B⊙ - Location of crack approx. in centerline of Dutchman to Safe End weld at 3:00-9/16" in Length.
 C⊙ - Location of crack approx. in centerline of Dutchman to Safe End weld at 8:00-5/8" in Length.

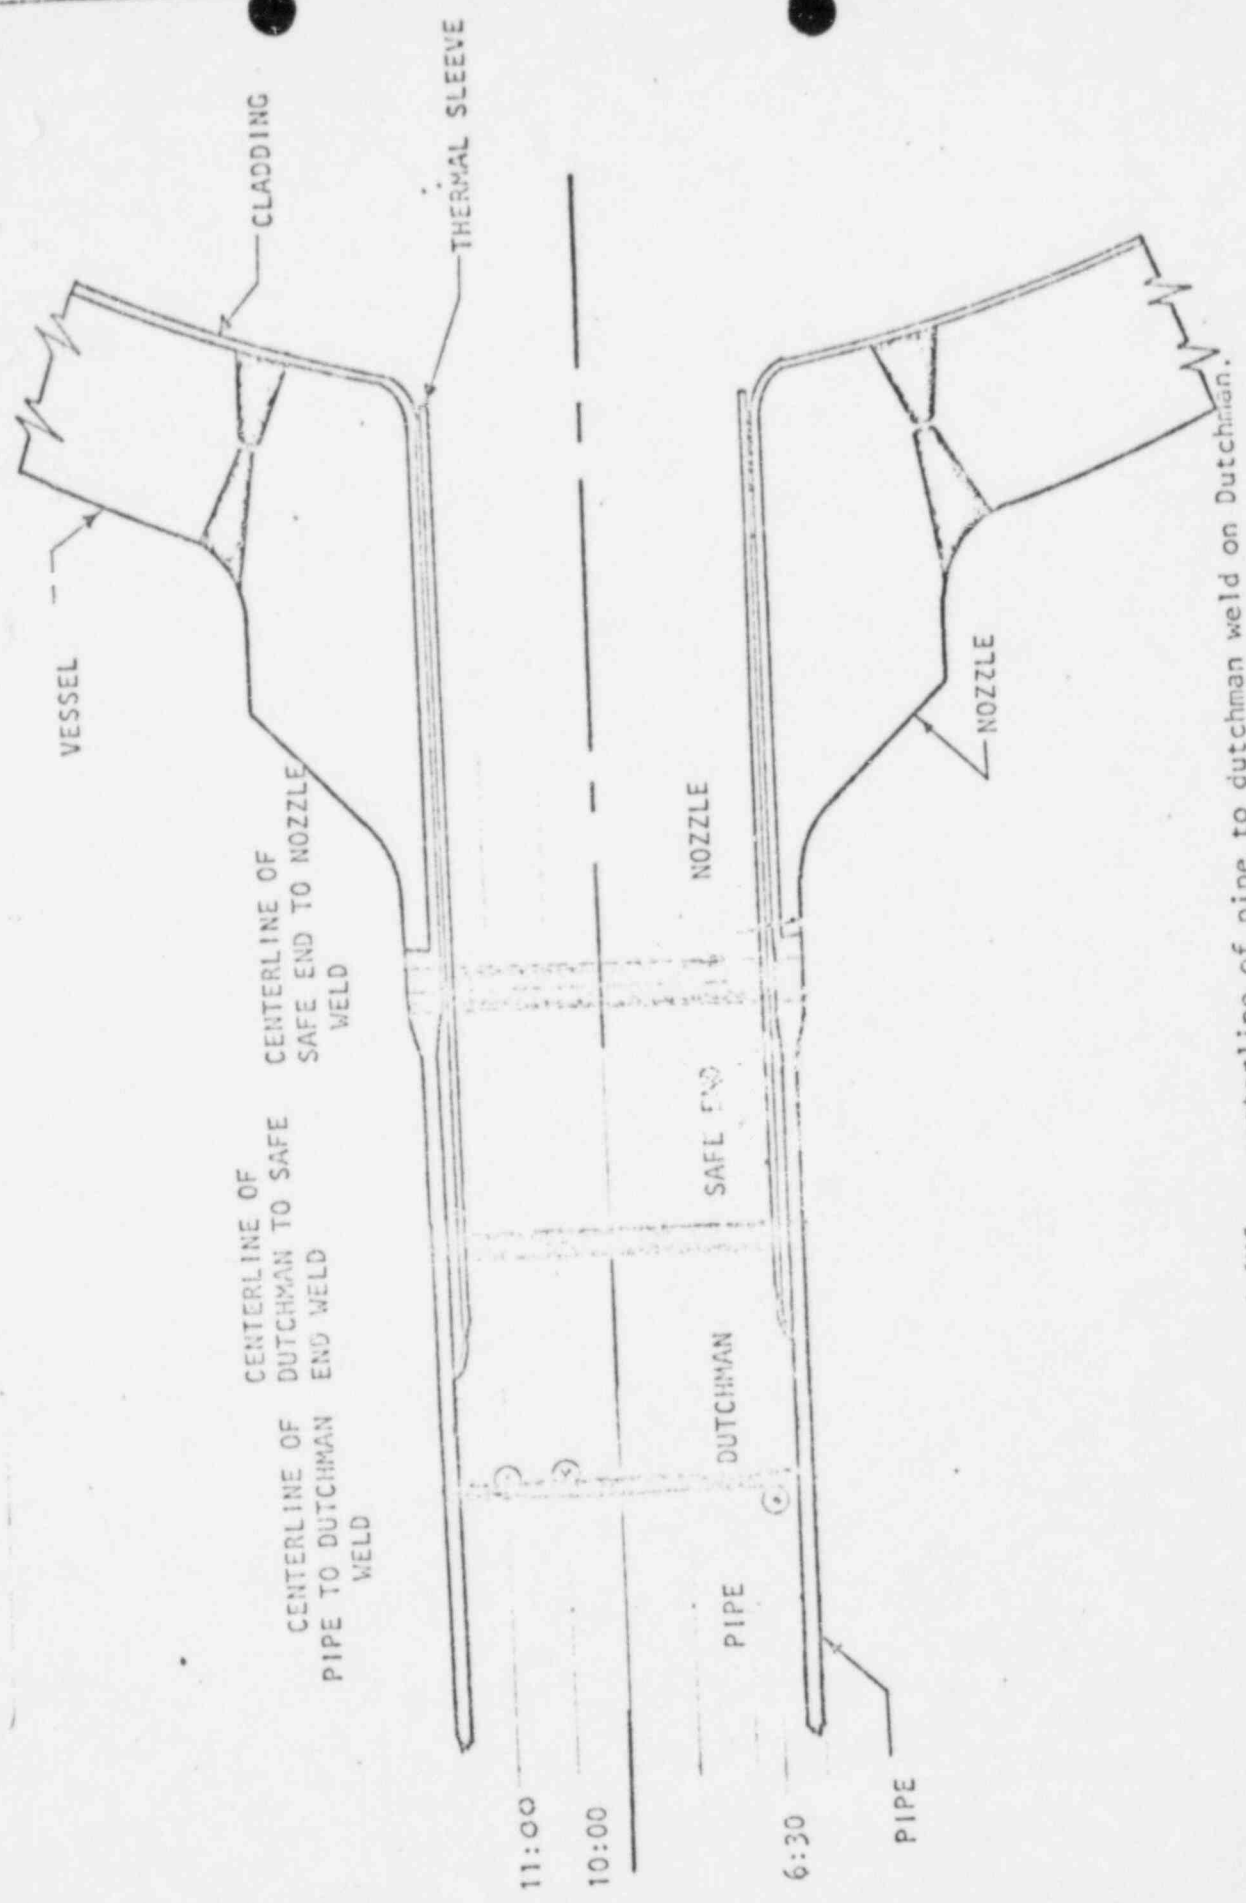
"b" LOOP

- ②- Location of weeper indication approx. 5/16" from centerline of pipe on pipe side.
- ③- Location of PT indication approx. 5/8" from centerline of weld on pipe side.
