DESCRIPTION OF PRESENT STATUS OF STEAM GENERATORS

ROCHESTER GAS AND ELECTRIC CORPORATION

R. E. GINNA NUCLEAR POWER PLANT UNIT NO. 1

March 21, 1974

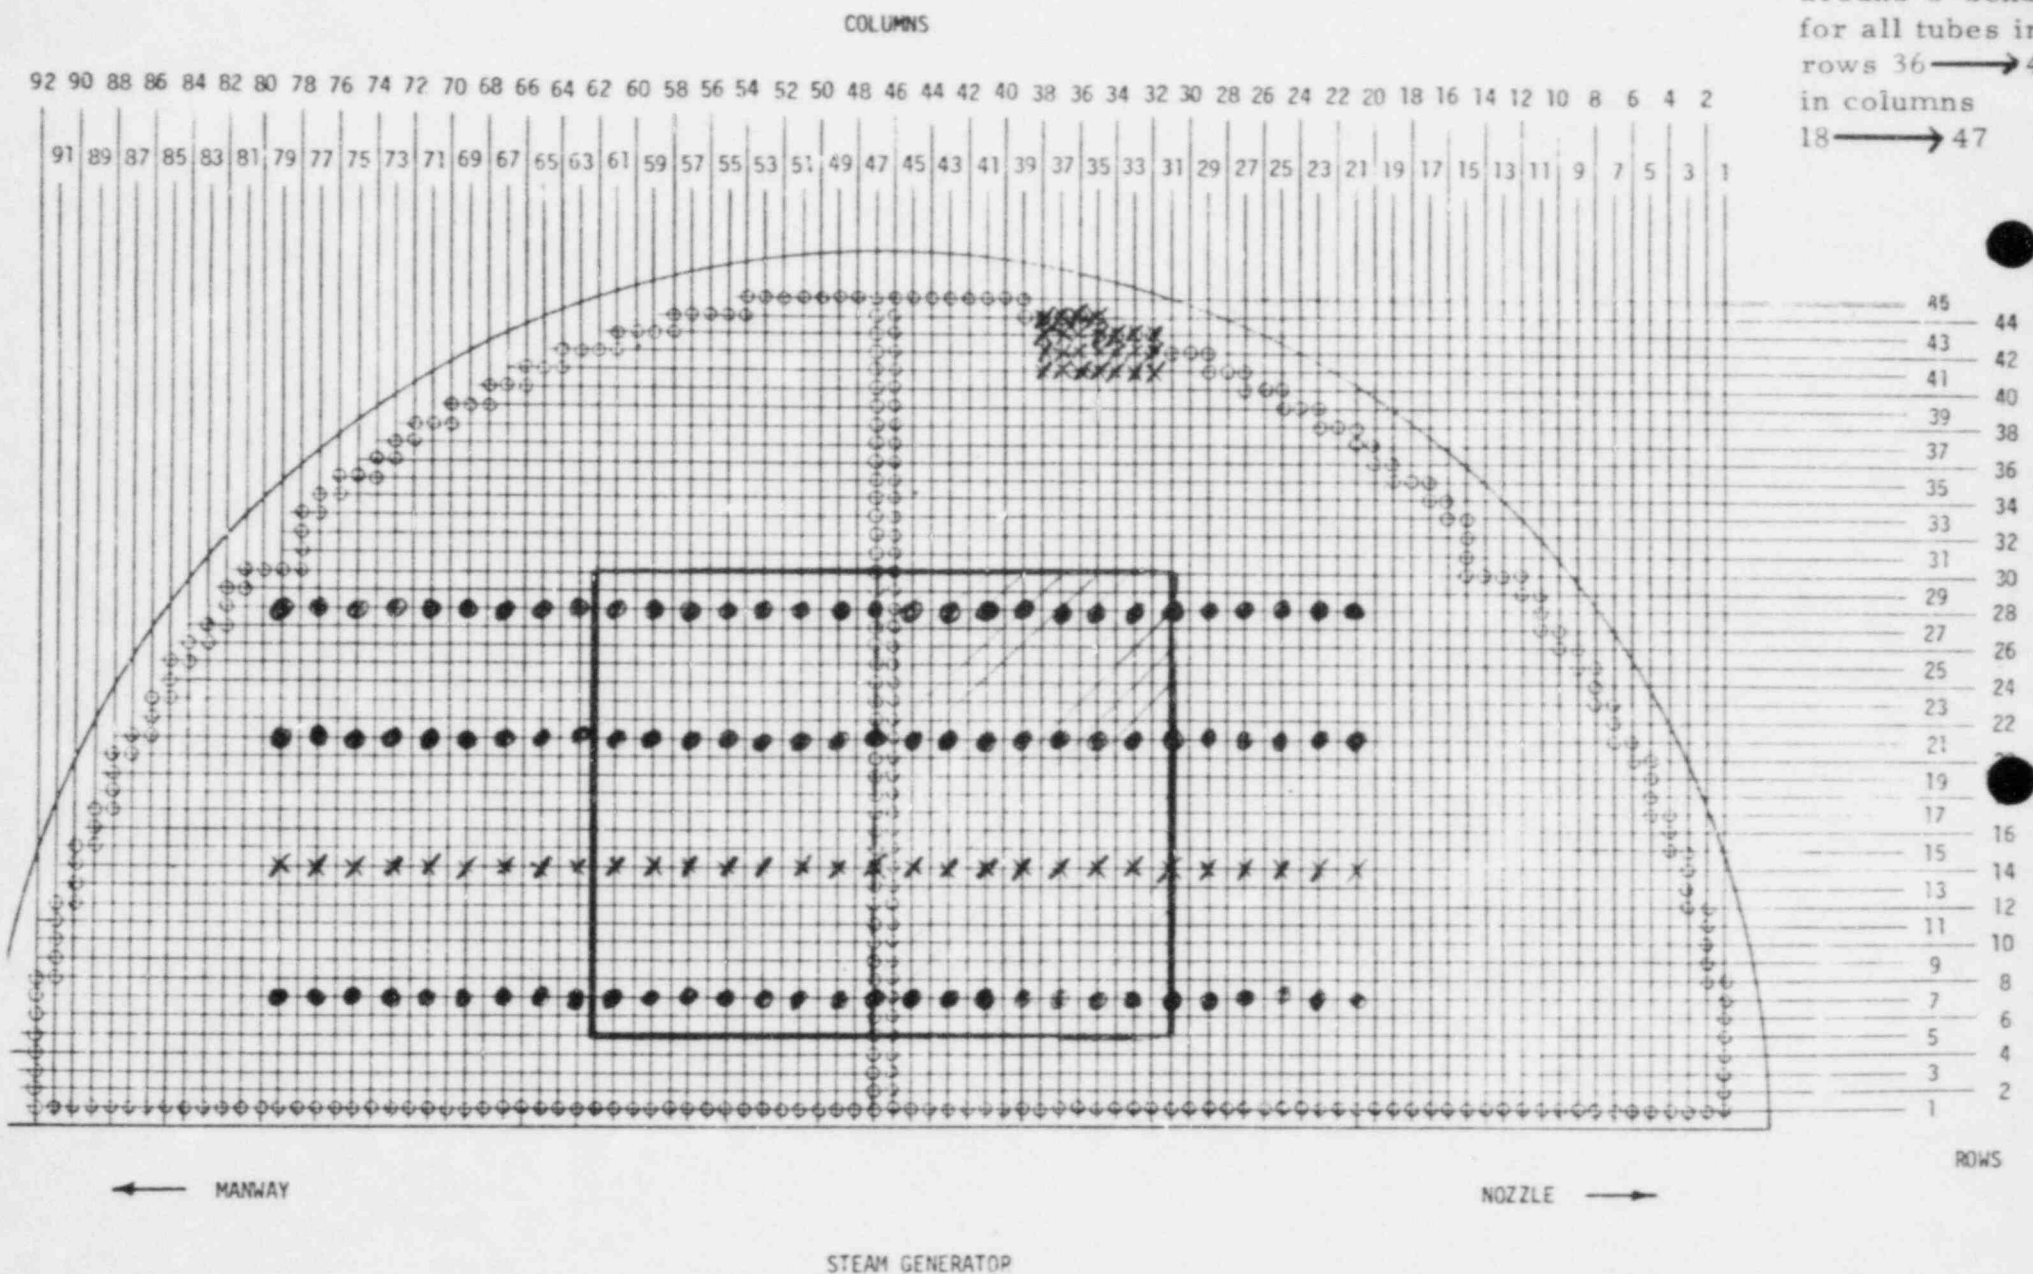
Figure 1

The initial eddy current (EC) test program for both steam generators (S.G.) consisted of inspection of 1098 hot leg side tubes and 516 cold leg side tubes. The inspection pattern is shown graphically in Figures 1 and 2. This pattern was established to give a comprehensive inspection of those areas of the generator where from past experience defects might be expected and to avoid unnecessary deliberate radiation exposure to personnel. The results of the EC tests indicated that a significant number of tubes having localized deterioration exist in "A" S.G. hot leg. Based on the experience of other facilities and on the pattern of deteriorated tubes, a larger area of inspection was selected. It was expected that this expanded program would examine all the deteriorated tubes in the "A" S.G. hot leg. At the conclusion of the expanded program, the decision was made to examine all the tubes. No deteriorated tubes were found during this phase of the examination program. The results of the EC inspection are given on Table 1 and the location of the defects are illustrated on Figures 3 through 6. The scope of the EC examination in "A" S.G. cold leg and "B" S.G. hot leg and cold leg was not increased because:

Inspection Pattern S. G. Hot Leg

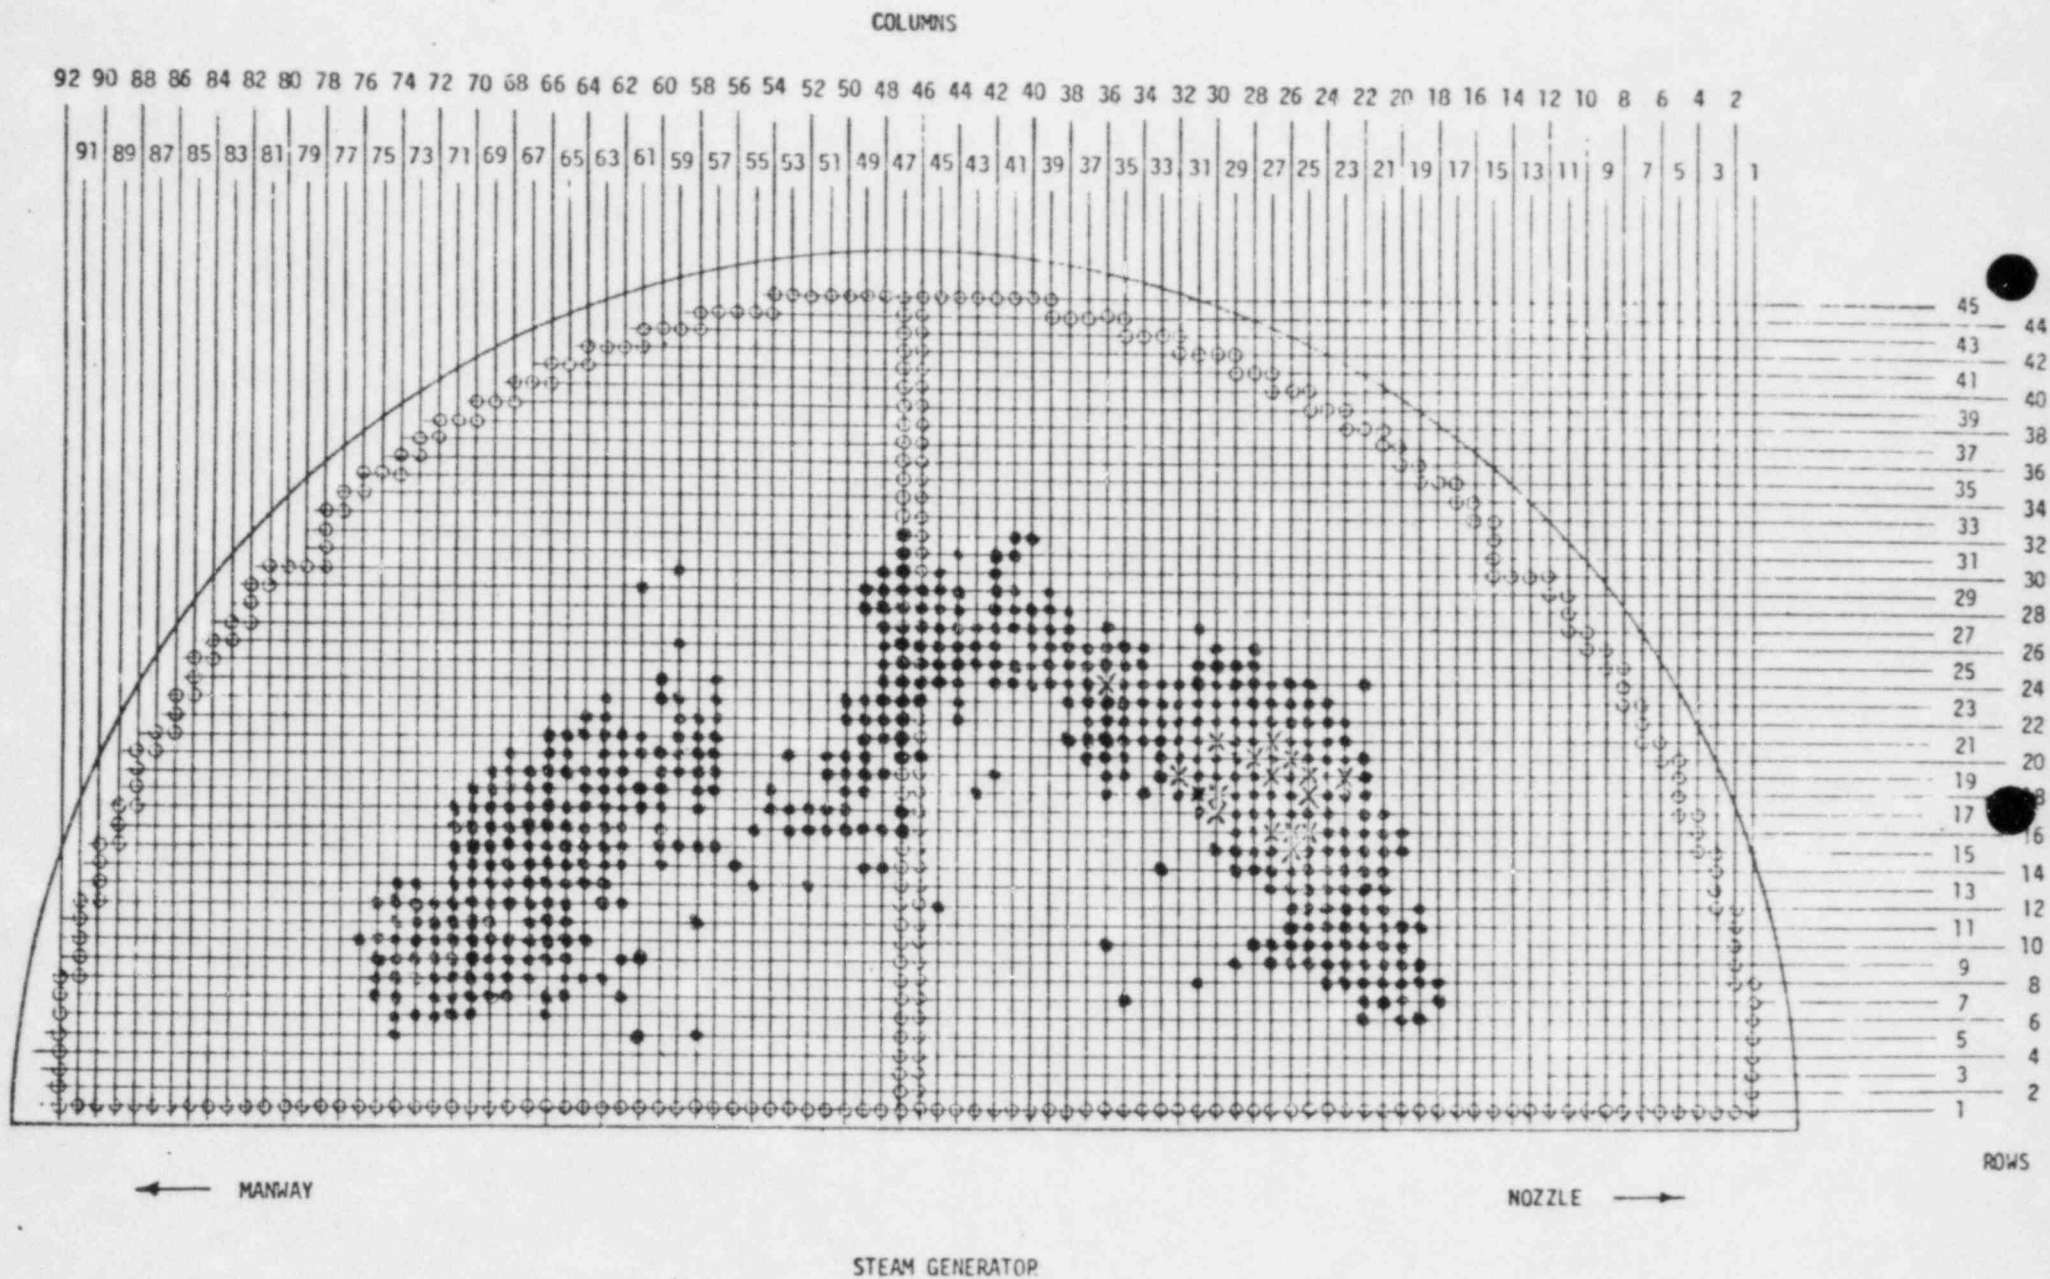
Figure 3

"A" S. G. Hot Leg

• - Deteriorations  $\leq 20\%$  to  $< 50\%$

x - Deteriorations  $\geq 50\%$

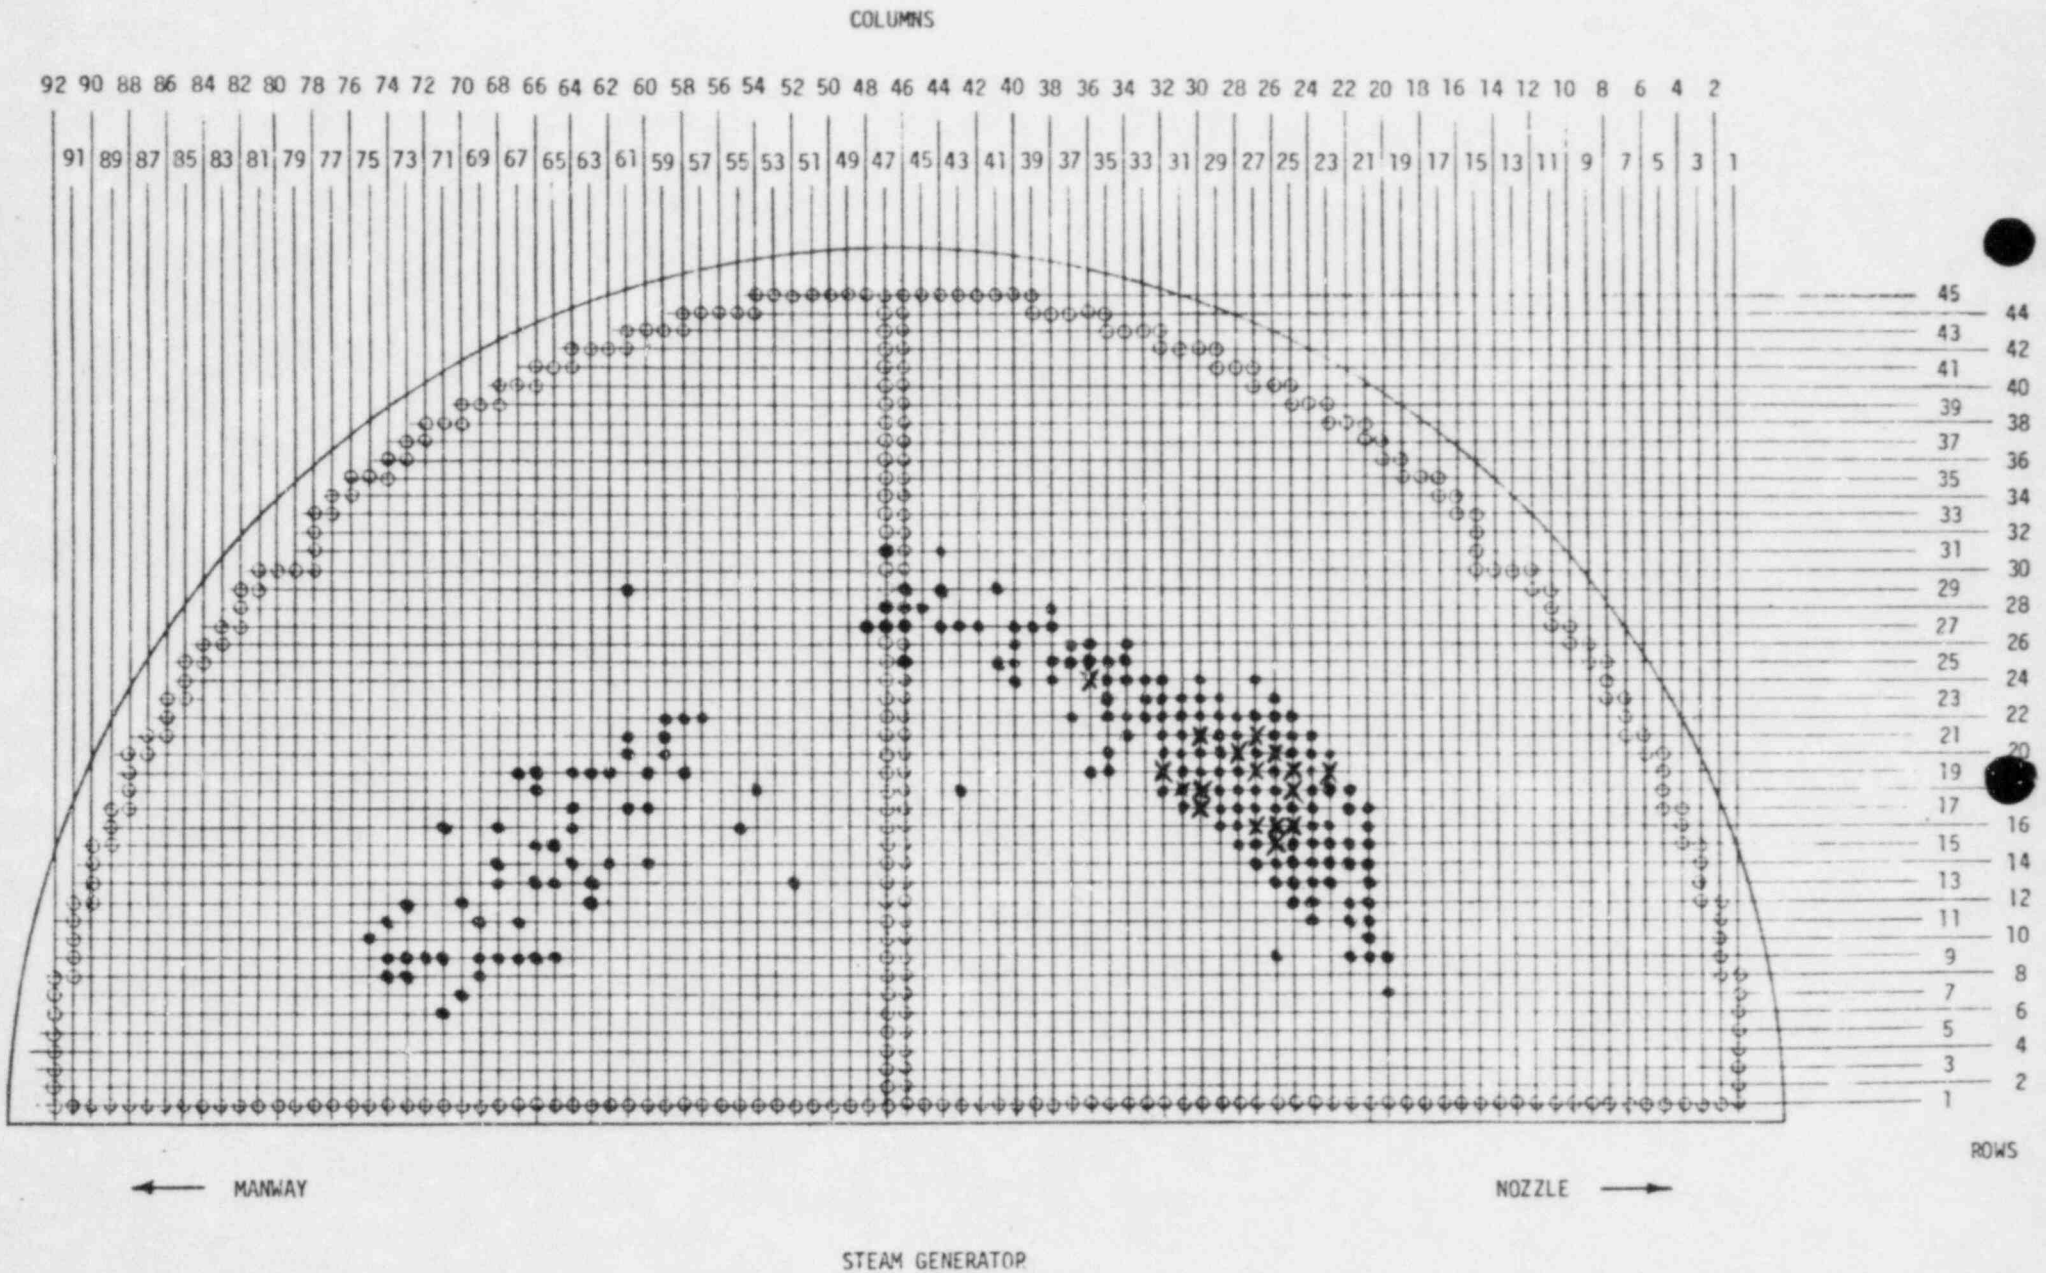
Figure 4  
"A" S. G. Hot Leg

• - Deteriorations  $\geq 20\%$  to  $< 50\%$   
X - Deteriorations  $\geq 50\%$

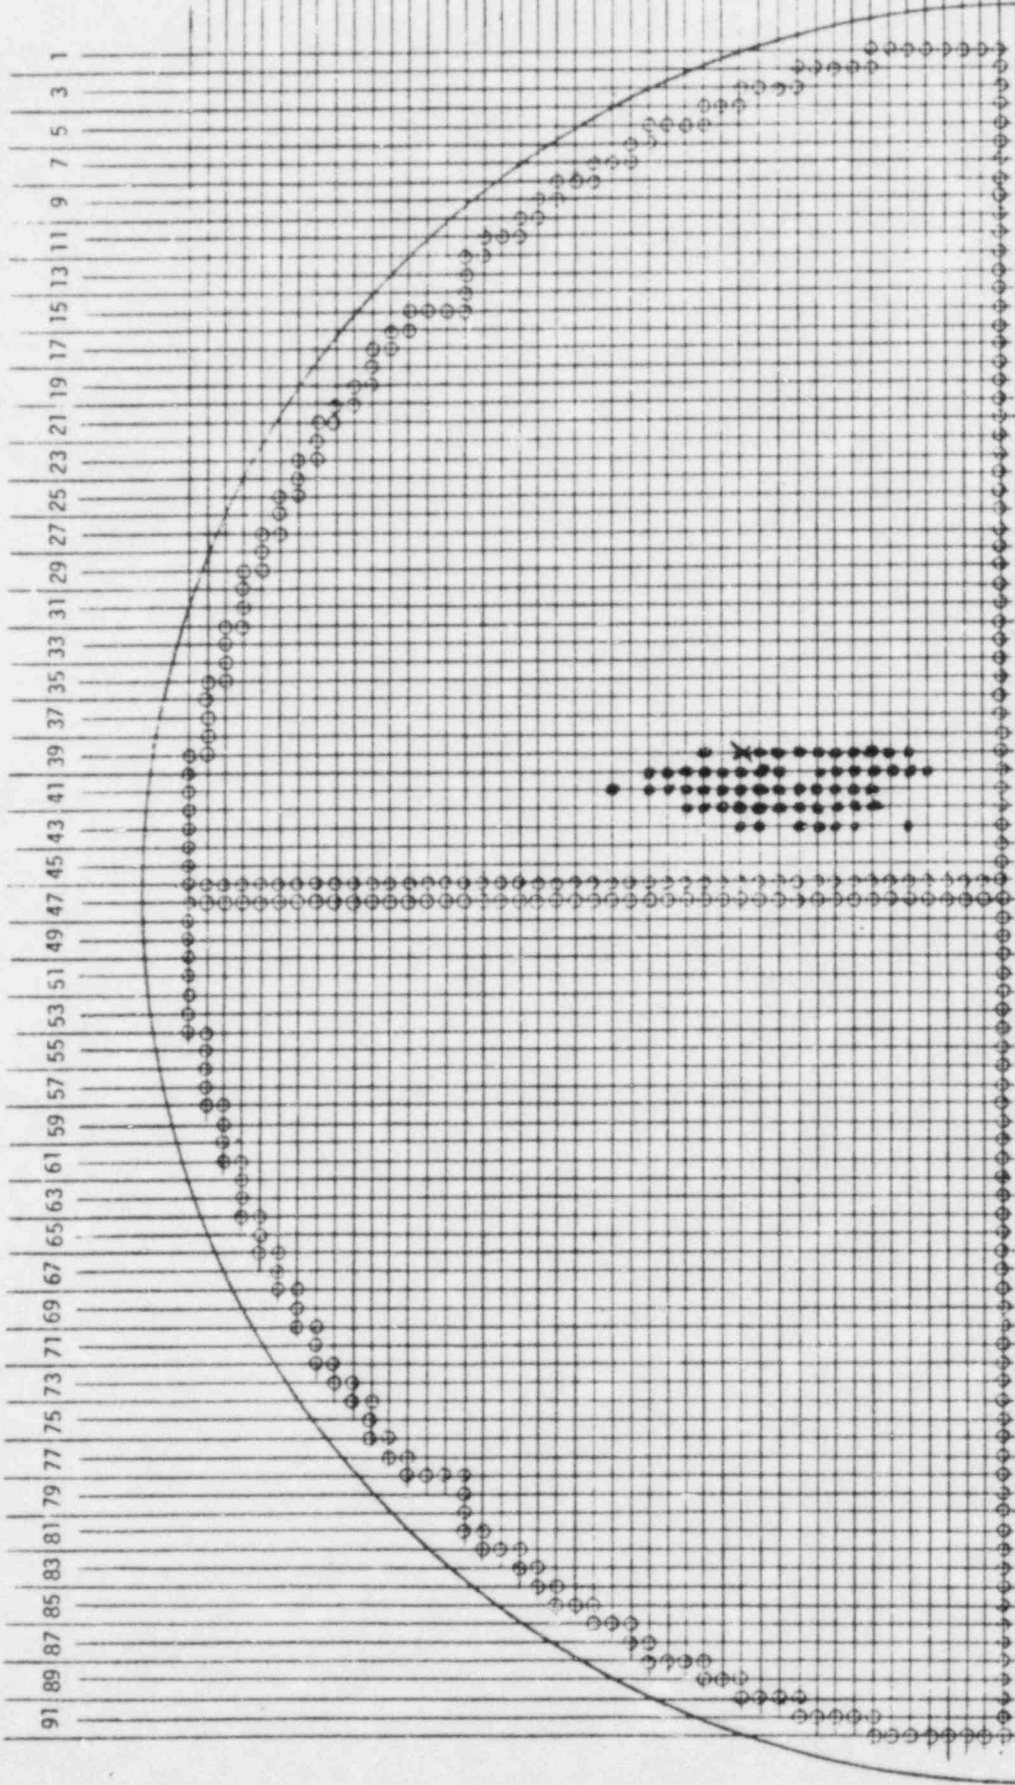
Figure 5

• - Deterioration  $\ll 20\%$

X - Deterioration  $< 20\%$

"A" S.G. Cold Leg

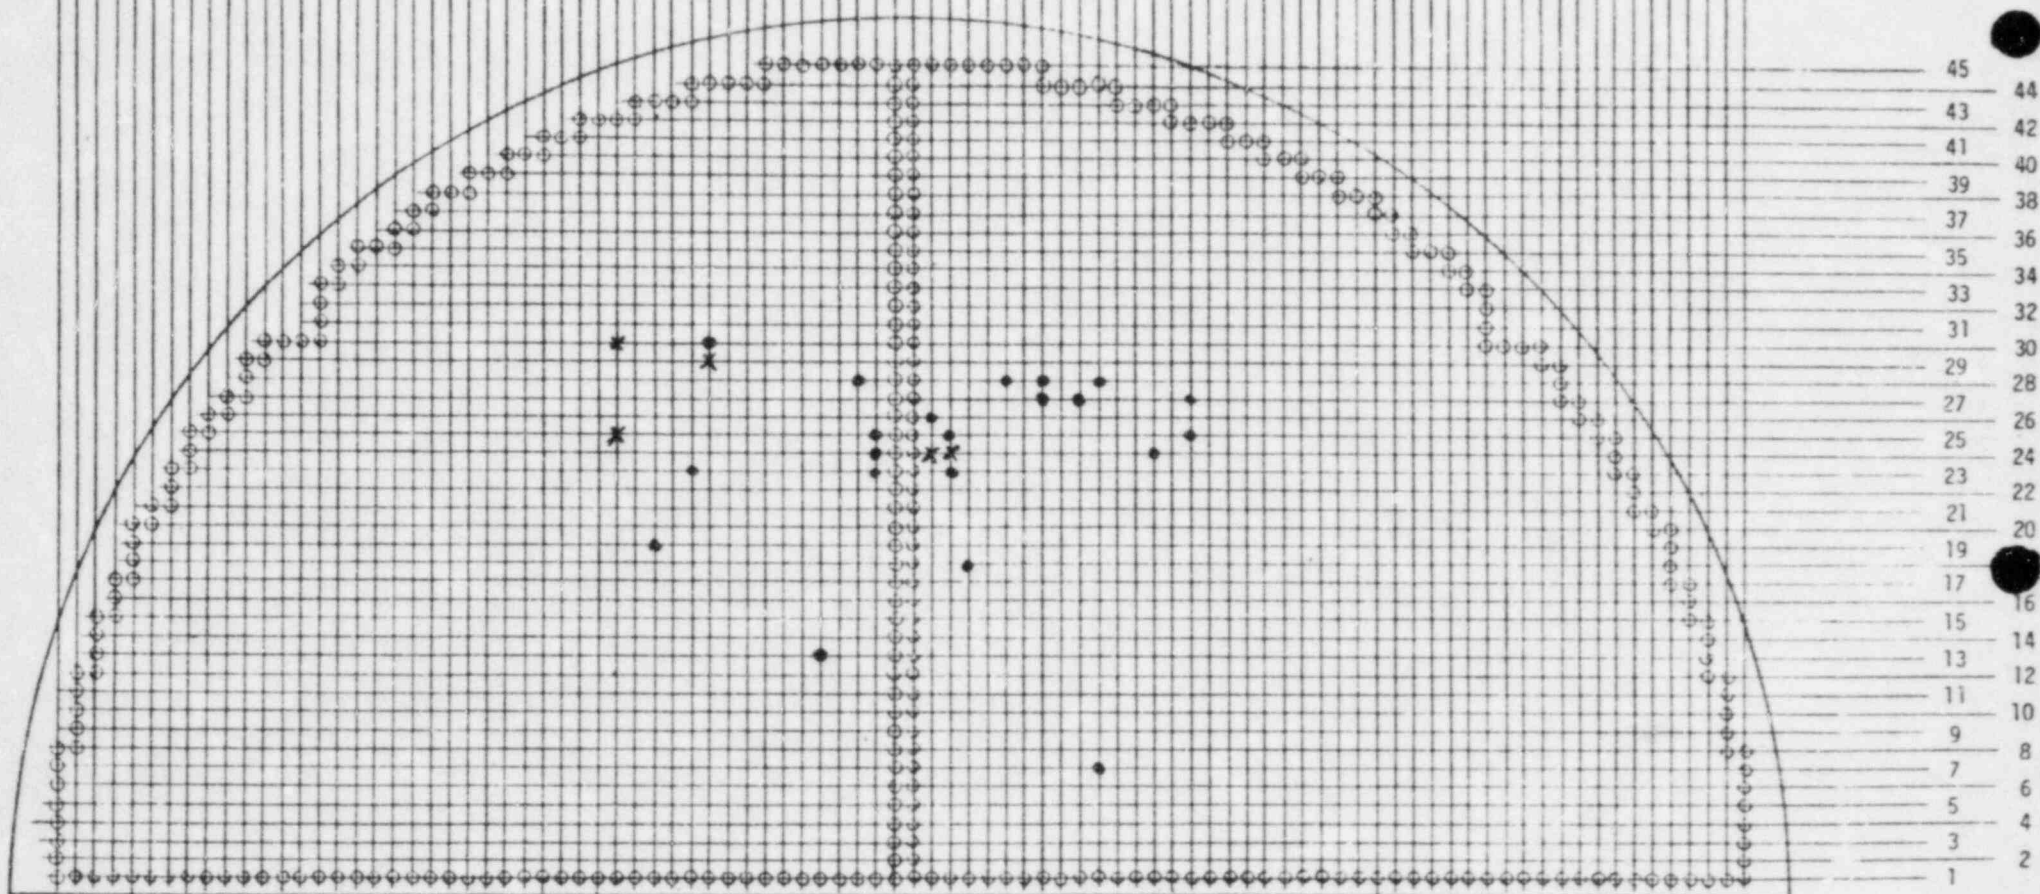
Figure 6

"B" S. G. Hot Leg

• - Deterioration  $< 20\%$

X - Deterioration  $\geq 20\%$  to  $\leq 26\%$

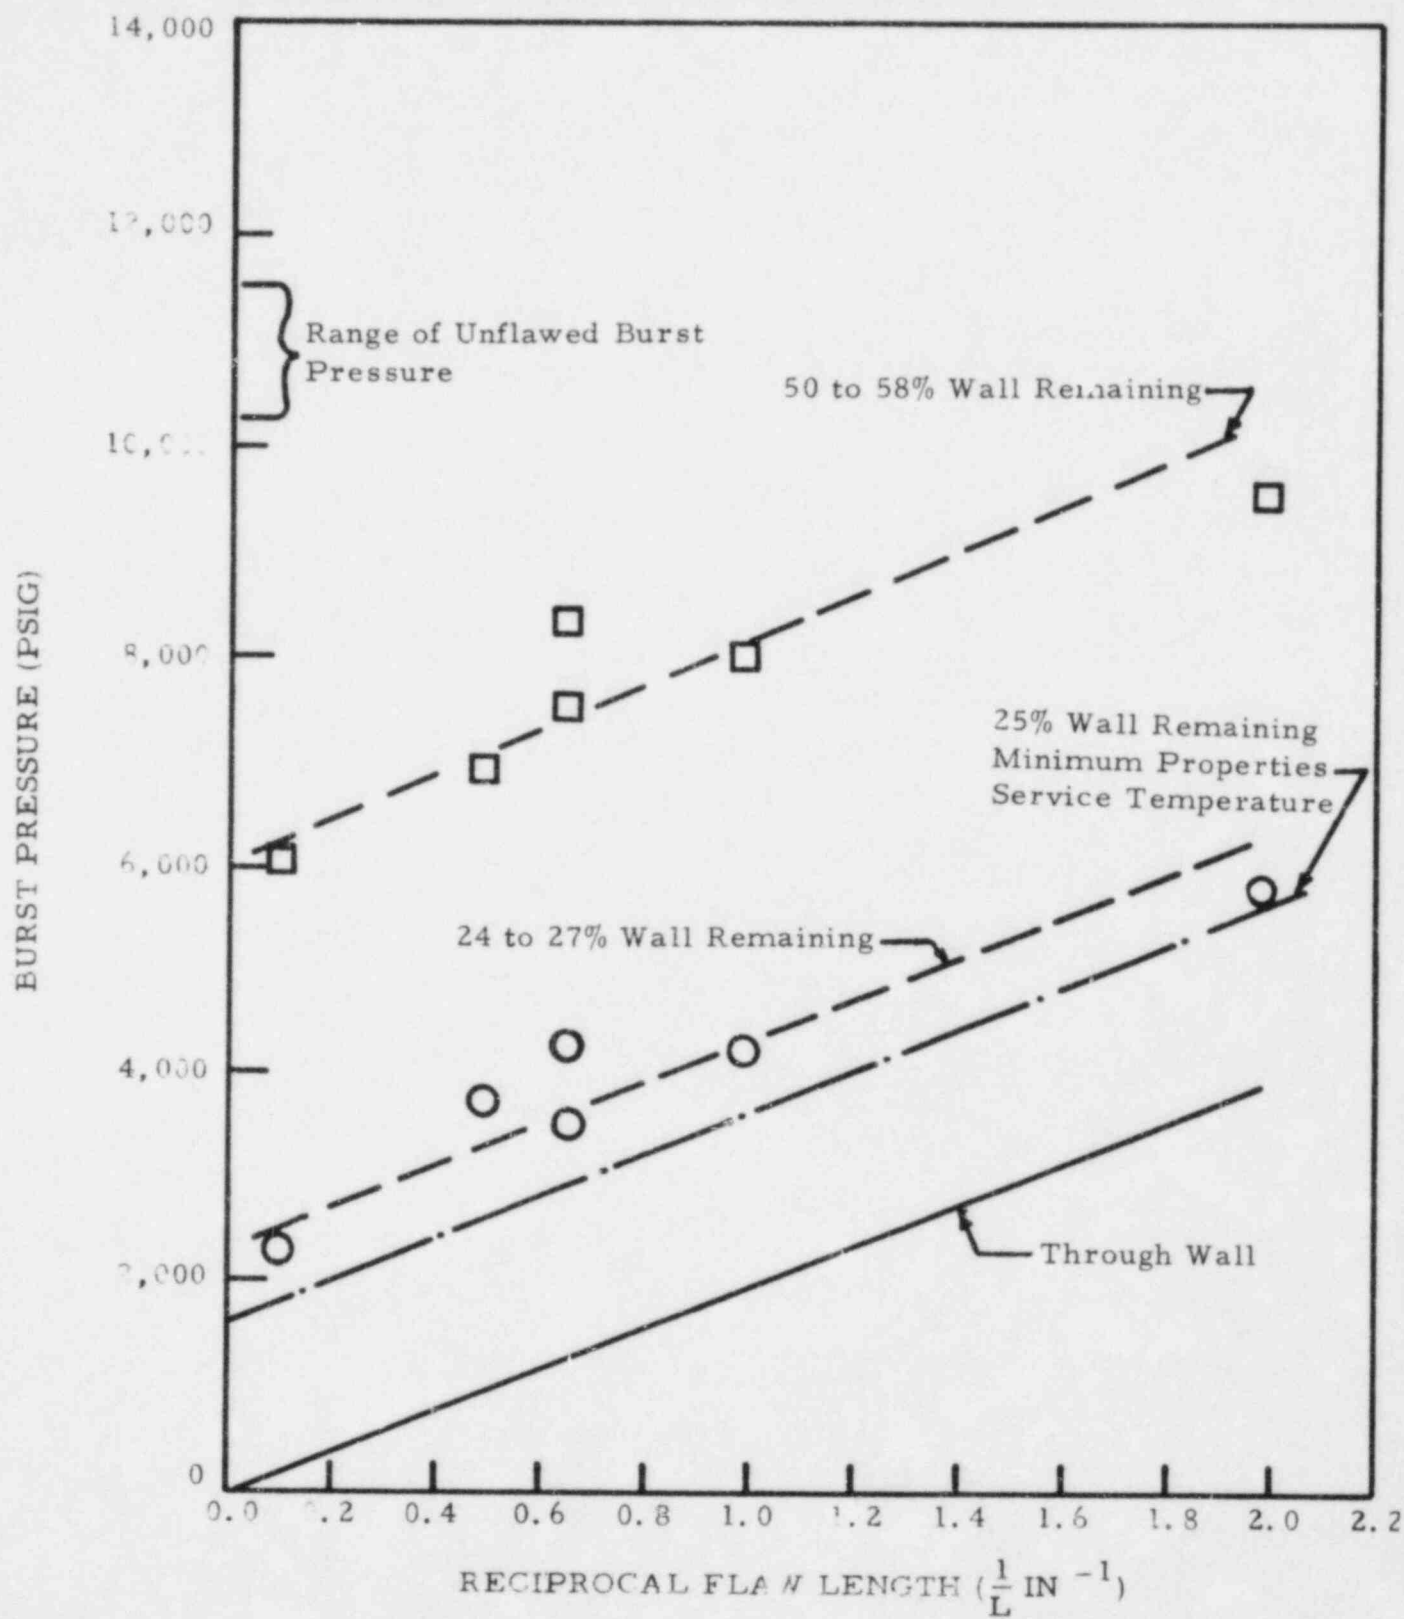
Figure 7 Room Temperature Burst Pressure 7/8" Tubes with Machined Flates

It will be noted from this data, that the burst pressures at room temperature are in the range of 4200 to 3700 psi for tubing with 1 to 2 inch long flaws, and with approximately 25% of the original wall remaining. The burst pressure increases to about 6000 psi when the flaws are in the 1/2 inch long range. In comparison for normal tubing the burst pressure is approximately 11,000 psi.

The effect of service temperatures and minimum code allowable properties are also indicated on Figure 7 for 25% wall remaining. It will be noted that the strength of the tube to withstand internal pressure is very substantial even with as little as 25% of the tube wall remaining.

Referring to Figure 7, the curve indicated as minimum tube properties at service temperature with 25% wall, it will be noted that with a 2 inch long flaw the tubing will withstand 2500 psi internal pressure. Shorter defect lengths and nominal material properties would increase the allowable pressure loading on the tube.
