Commonwealth Edison

Dresden Nuclear Power Station  
R. R. #1  
Morris, Illinois 60450  
January 27, 1975

SUBJECT: REPORT OF UNUSUAL EVENT PER SECTION 6.6.C OF THE TECHNICAL SPECIFICATIONS  
FEEDWATER SPARGER FAILURES  
AEC DOCKET NUMBER 50-237

Facility: Dresden Nuclear Power Station, Morris, Illinois

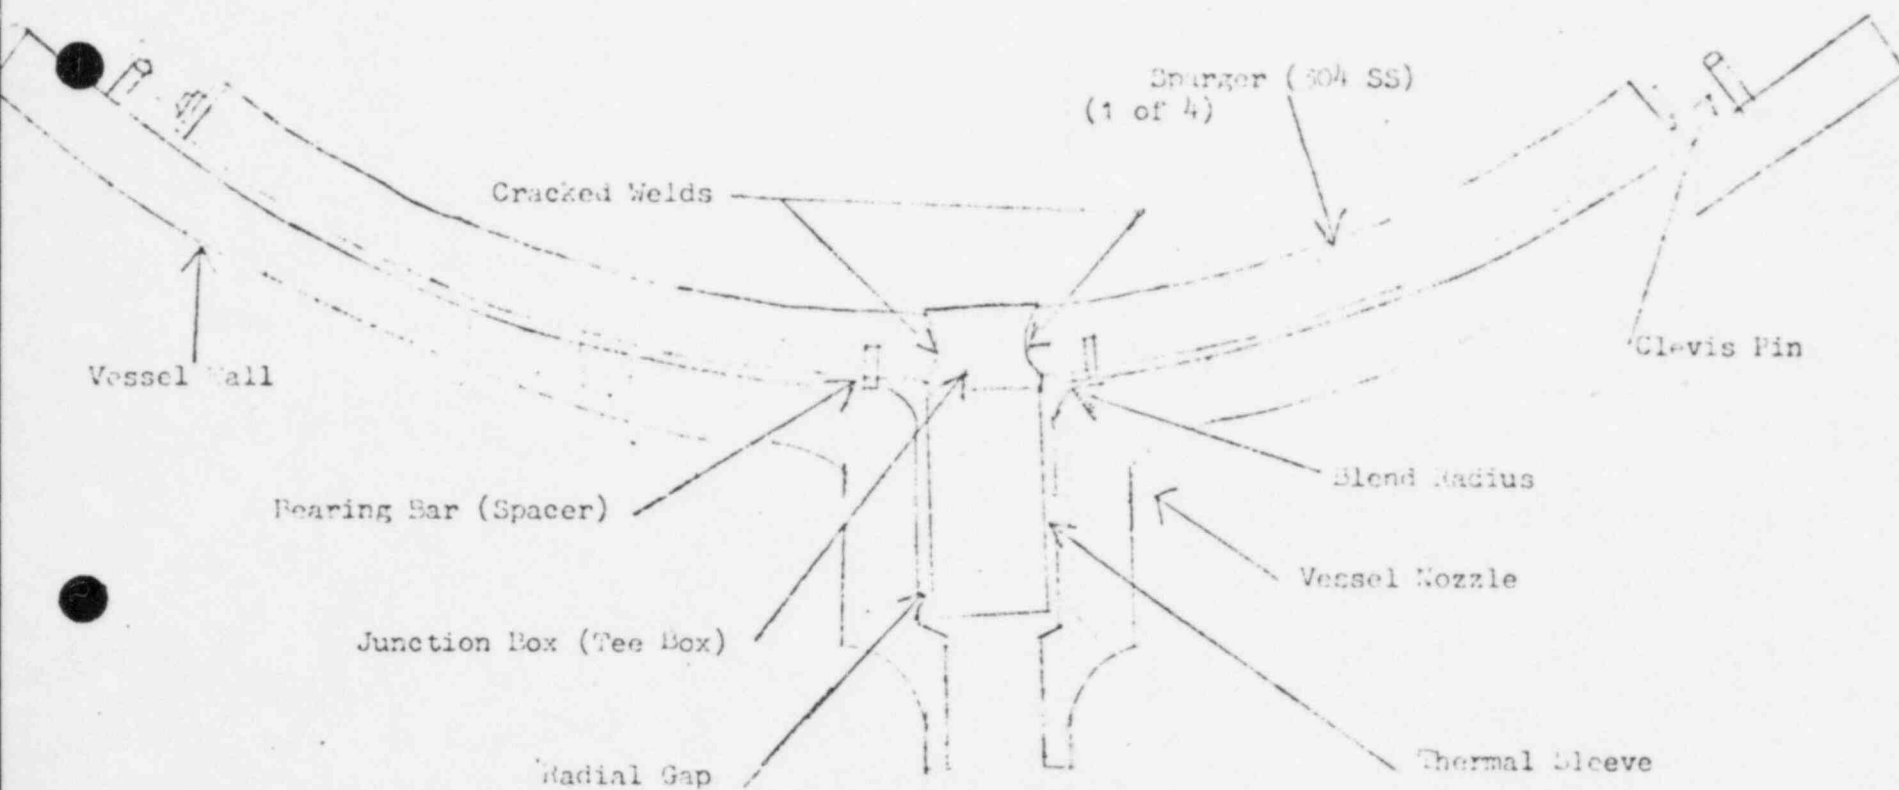
Figure I

The inspection revealed two cracks. The first crack was located on the upper part of the right side header pipe to junction box weld area of the southwest quadrant sparger. The crack (see Figures I and II) appeared to be relatively straight, extending about 90 degrees around the pipe circumference. The second crack was located on the upper part of the left side header pipe to junction box weld area of the northeast quadrant header. This crack (see Figures I and II) appeared to be a little more jagged than the first crack, near the weld area and extending about 200 degrees around the pipe circumference.

The cracks were found in the area where six inch schedule 40 header pipes are welded to the junction box pipe (see figures I, II, and III). The spargers are made of 304 stainless steel (schedule 40).

Old Dresden II Feedwater Spargers

Note: Sparger arms are not of equal length

The program for corrective action is to 1) liquid penetrant examine the accessible portion of the nozzle blend radius of each feedwater nozzle, 2) further inspect the old Dresden 2 spargers and determine the actual radial gap when they are removed, 3) replace all four Dresden 2 spargers this outage with new spargers of the new design (very similar to the Design 4 spargers in Ref 2), 4) inspect the feedwater spargers during its next scheduled refueling outage and 5) inspect (including a liquid penetrant examination of the nozzle blend radii) the Dresden 3 feedwater spargers during its next scheduled refueling outage.

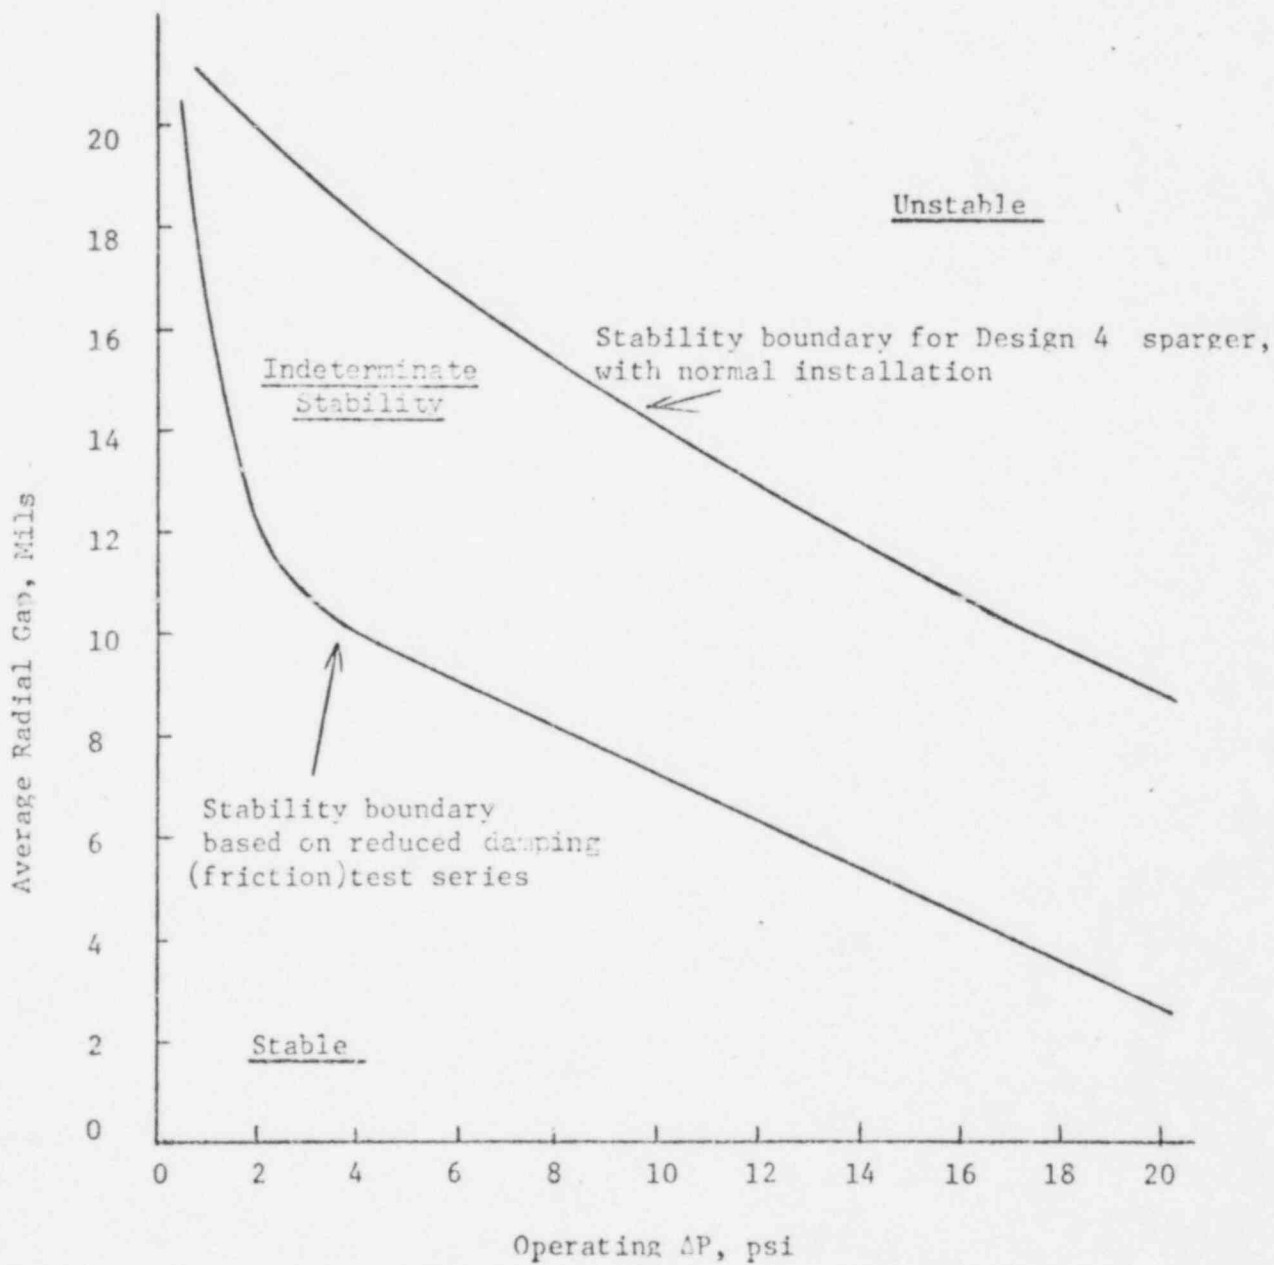
Figure IV. Conditions for Sparger Instability Based on Cold Flow Testing

Numerous full-scale cold-flow tests (Ref. #1) have been conducted at the General Electric test facility in San Jose on feedwater spargers of several different configurations to determine the cause of vibration. Results of these tests (see Figure IV) have shown that unstable flow-induced vibration occurs as a function of the following variables:

- The pressure differential between the sparger inlet and discharge.
- The average radial gap, which permits leakage flow between the inside of the thermal sleeve and the outside of the feedwater nozzle.
- The amount of damping present in the system, particularly at the thermal sleeve-to-nozzle interface.

Although the Dresden 2 thermal sleeve was designed to allow only a 0.003-inch radial gap, the error band of the stability boundaries (Figure IV), the operating pressure drop across the sparger of about 16 psi, and the methods of construction and installation which could produce a much larger radial gap than specified makes it entirely possible that the Dresden 2 spargers experienced flow induced vibration. The actual radial gaps found on another BWR unit with cracked spargers (Ref. #2) were significantly greater than specified. The unusual service and environmental conditions of changing feedwater flow rate, the temperature difference between the feedwater and the water in the vessel, and the movement of water within the vessel also contribute to the problem by producing thermal cycling, thermal stress, and effects on the damping.

The third design feature was incorporated to lower the pressure drop at rated flow from 16 psi for the first designs to 11 psi for the new design which increases the stability margin (See Figure IV).
