SUBJECT: Supplemental Report to Abnormal Occurrence Report No. 50-237/1975-11,
Entitled "Core Spray Injection Line Through-Wall Cracks"

REPORT NUMBER: 50-237/1975-11A

FACILITY: Dresden Nuclear Power Station, Morris, Illinois

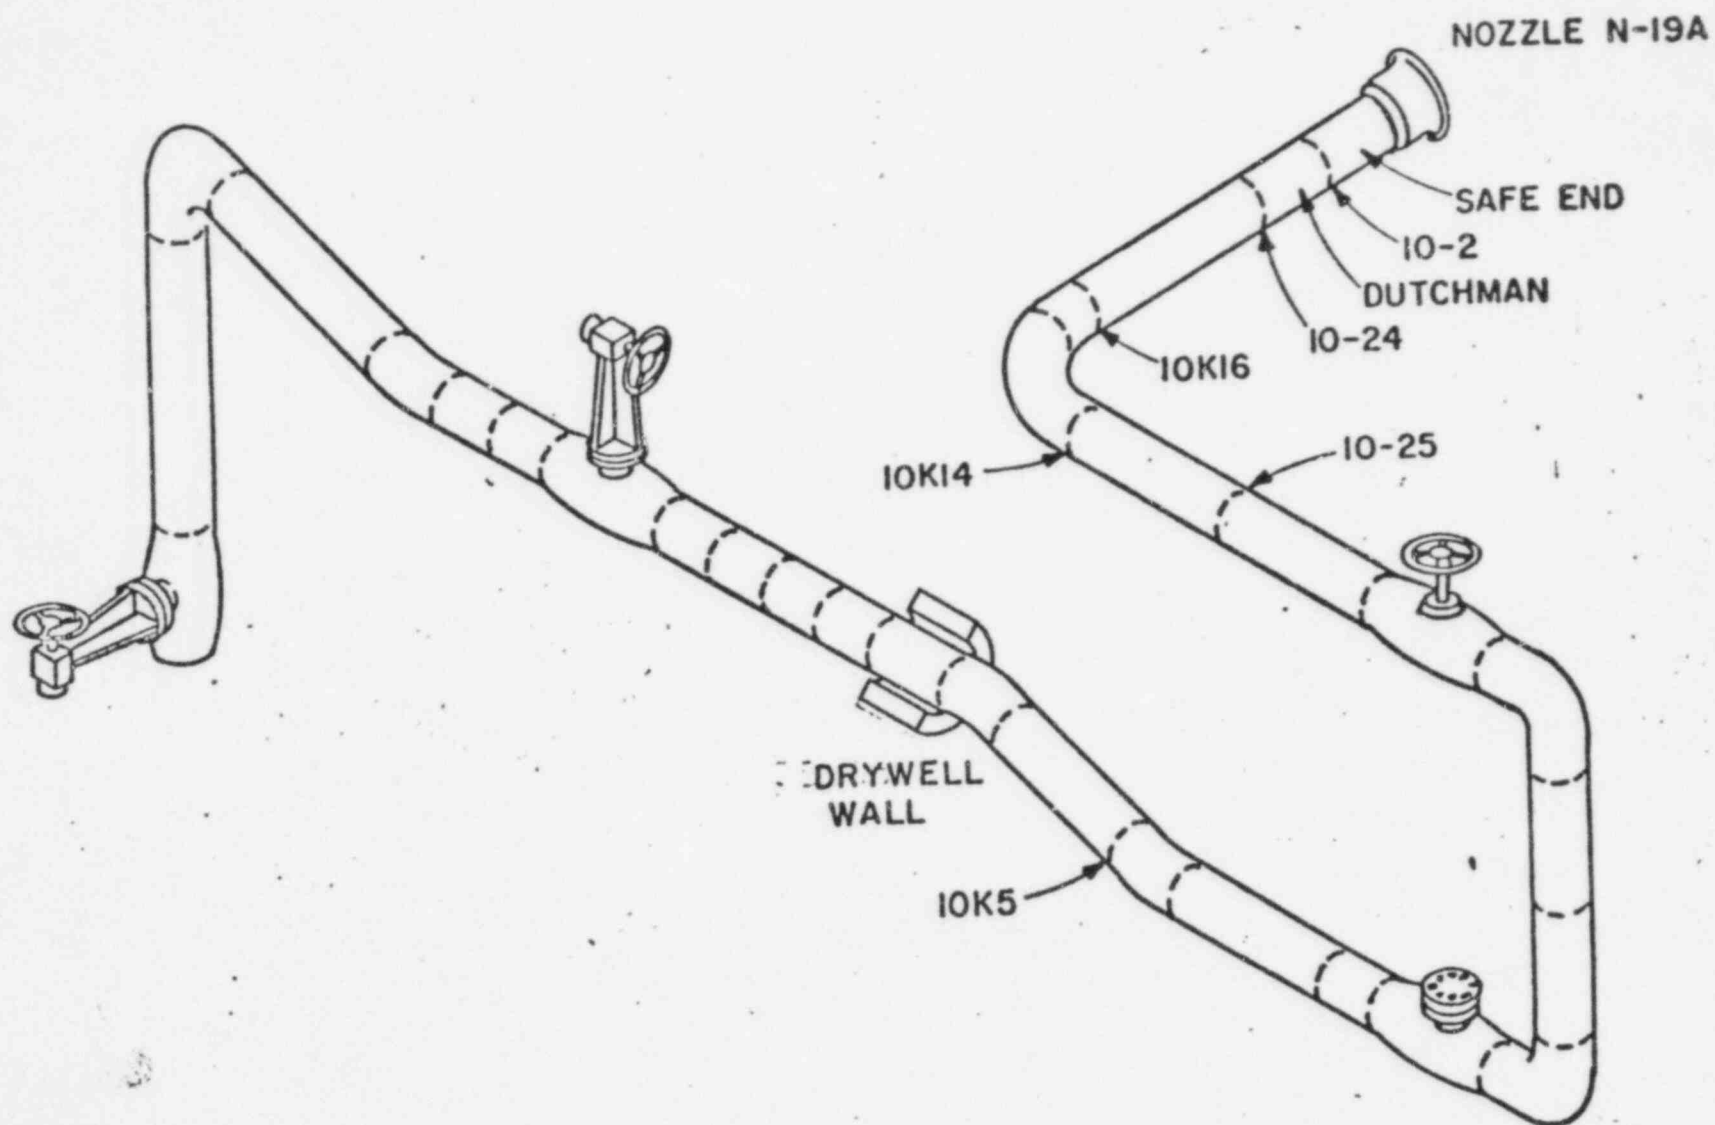
A total of eight weldments were found to be defective in the two loops of the core spray system. Four of the eight welds were examined in detail by Argonne, three others were sent to General Electric, and one was retained by Commonwealth Edison. The attached Table A summarizes the various crack data for all eight defective welds. Figures 1 and 2 give the locations of the cracked joints. Conclusions of the Argonne study are as follows:

- a) The cracks were generally circumferential and were located in the heat-affected zone near the welds

- b) The mode of failure was strictly intergranular stress corrosion, initiating at the I.D. surface and propagating toward the O.D.
- c) Fatigue striations were not observed on the cracked surfaces by scanning electron microscopy
- d) None of the cracks propagated through welds, but were limited to a penetration of about 0.2 inches
- e) The cracks were similar to those found in 4-inch recirculation bypass lines, even in the relative composition of corrosion products.

Fig. 1. Loop A Emergency Core-spray Piping of Dresden-2 BWR. The weldments are indicated by dashed circumferential lines. Crack areas are denoted by arrows and weld identification numbers.

Corrective action taken to prevent recurrence was to replace the stainless steel portion of the core spray piping from the vessel nozzle to the second isolation valve with SA-333 Grade 6 carbon steel, and to replace the reactor vessel core spray safe-ends with SA-182 type 316L stainless steel with I.D. cladding of 308L weld material.

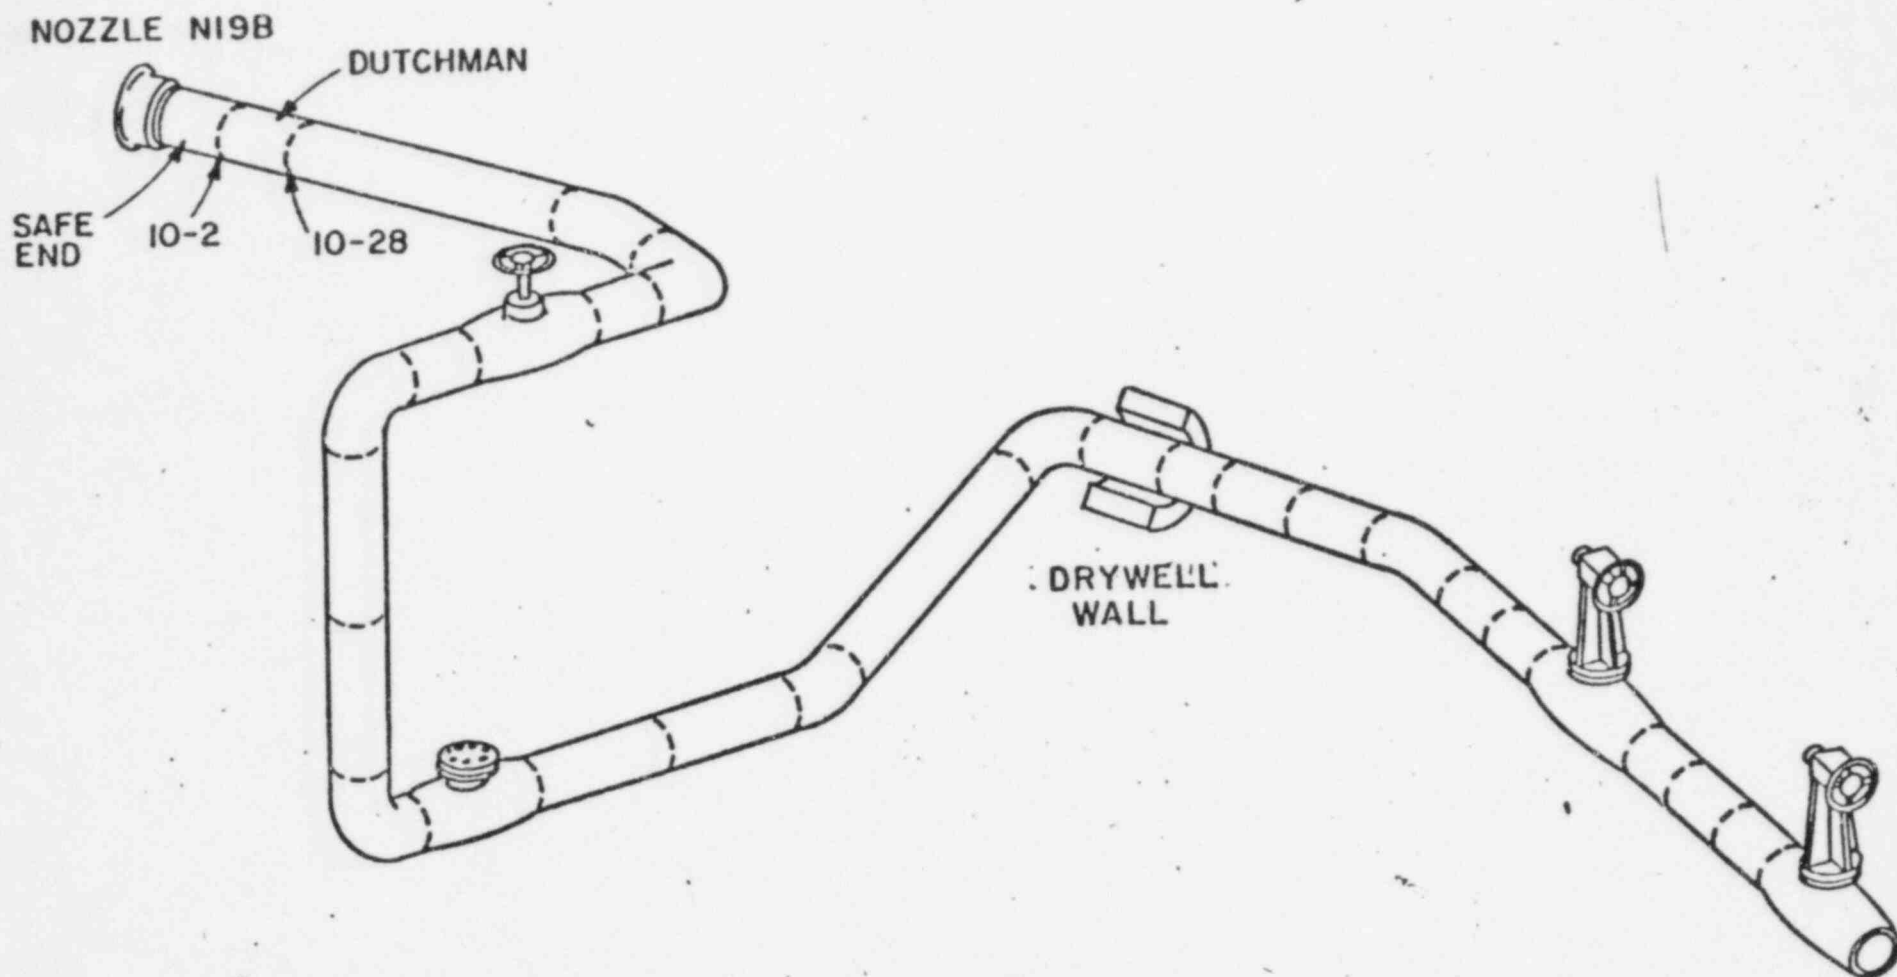
Fig. 2. Loop B Emergency Core-spray Piping of Dresden-2 BWR. The weldments are indicated by dashed circumferential lines. Crack areas are denoted by arrows and weld identification numbers.
