Subject: Oyster Creek Station
Docket No. 50-219
Safety Valve Seat Bushing Cracks

OYSTER CREEK NUCLEAR GENERATING STATION

Safety Valve Seat Bushing Cracks

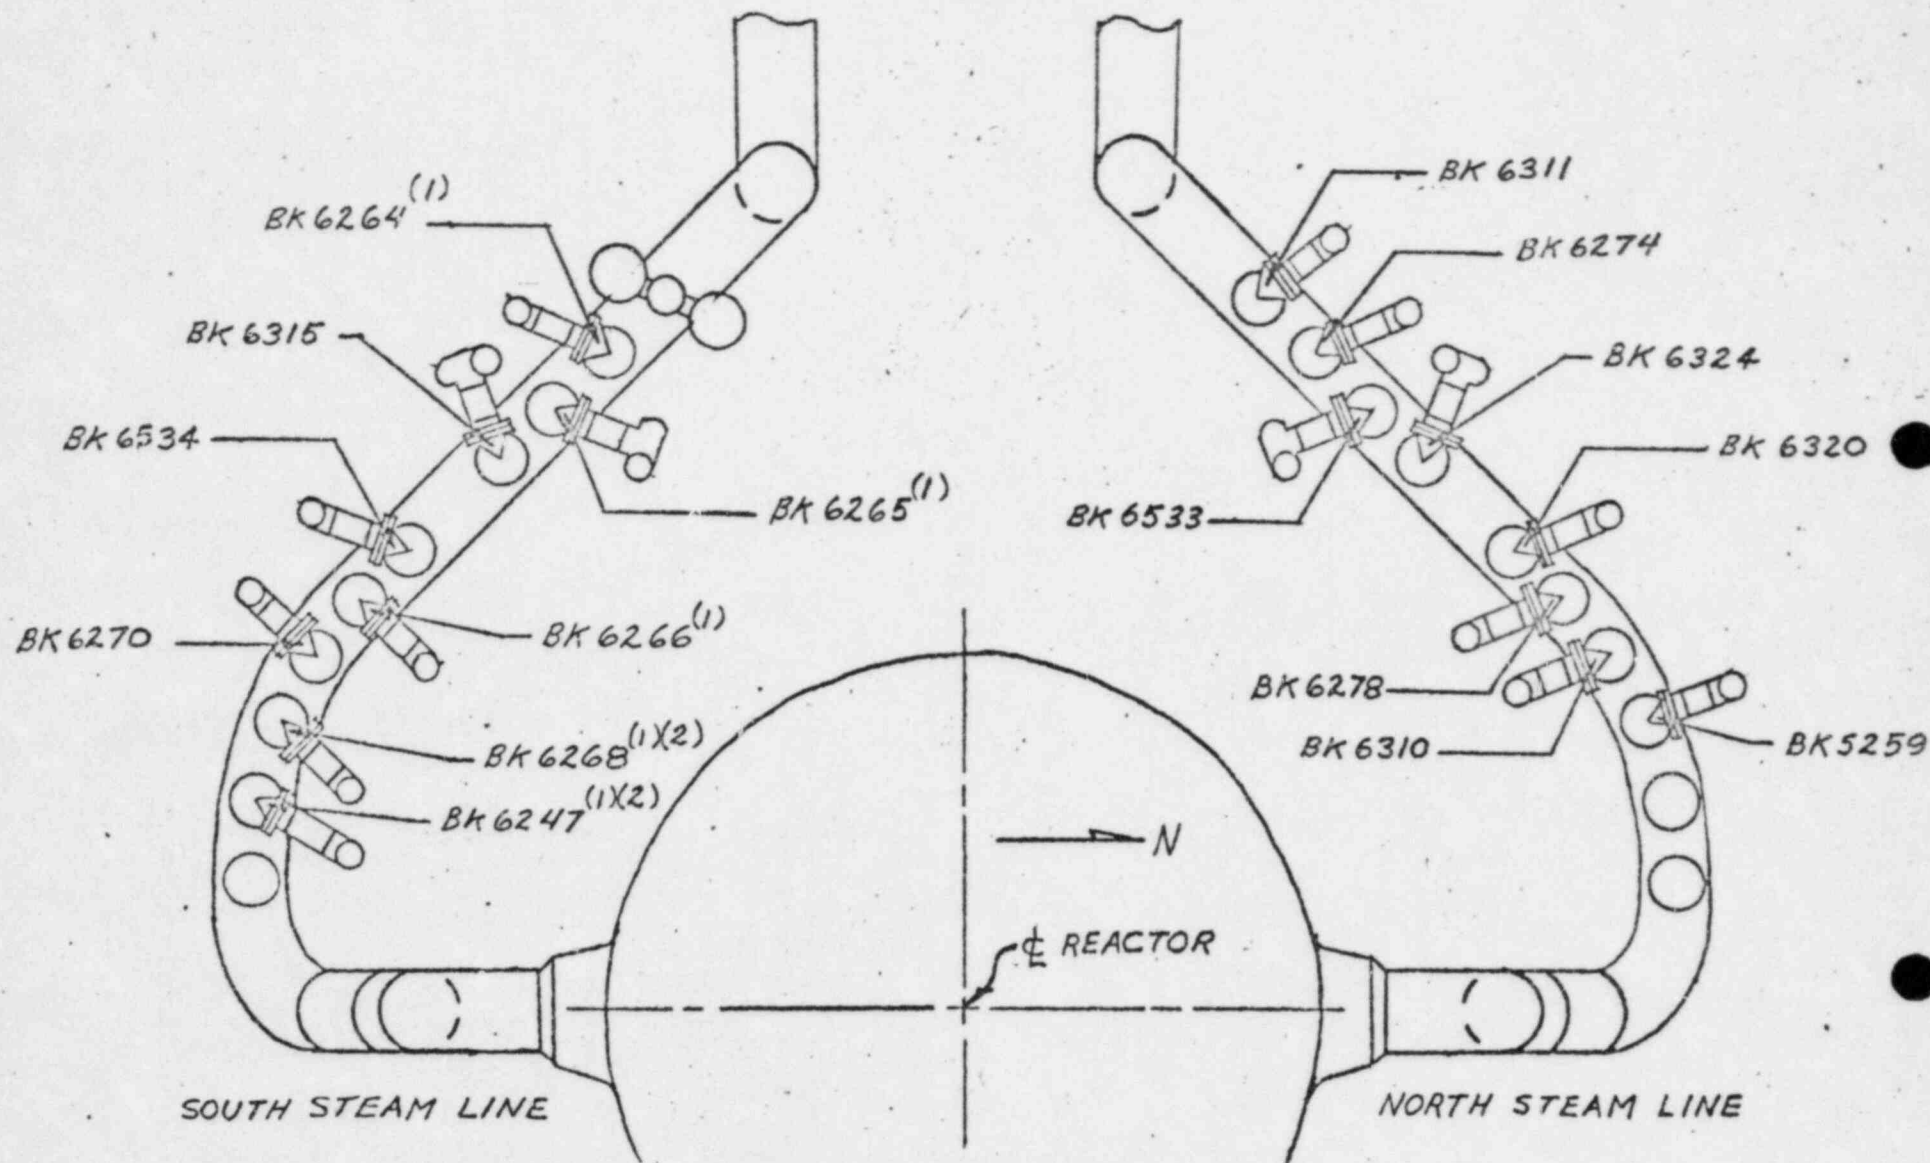
Figure 2. Safety Valves in Service from Aug 1969 to Oct 1971

The location of the valves on the steam lines from plant startup in 1969 to the curtain outage in October 1971 is shown on Figure 2. The location of the valves on the plant from October 1971 to the refueling outage in May 1972 is shown on Figure 3.

The valves with the cracked seat bushings were the valves located closest to the reactor as shown in Figures 2 and 3. Since these valves were not randomly located on the steam line, the steam leakage is believed to be a significant factor in causing the cracking.

(1) Valves Removed Oct 1971 and Inspected

(2) Cracked Seat Bushing

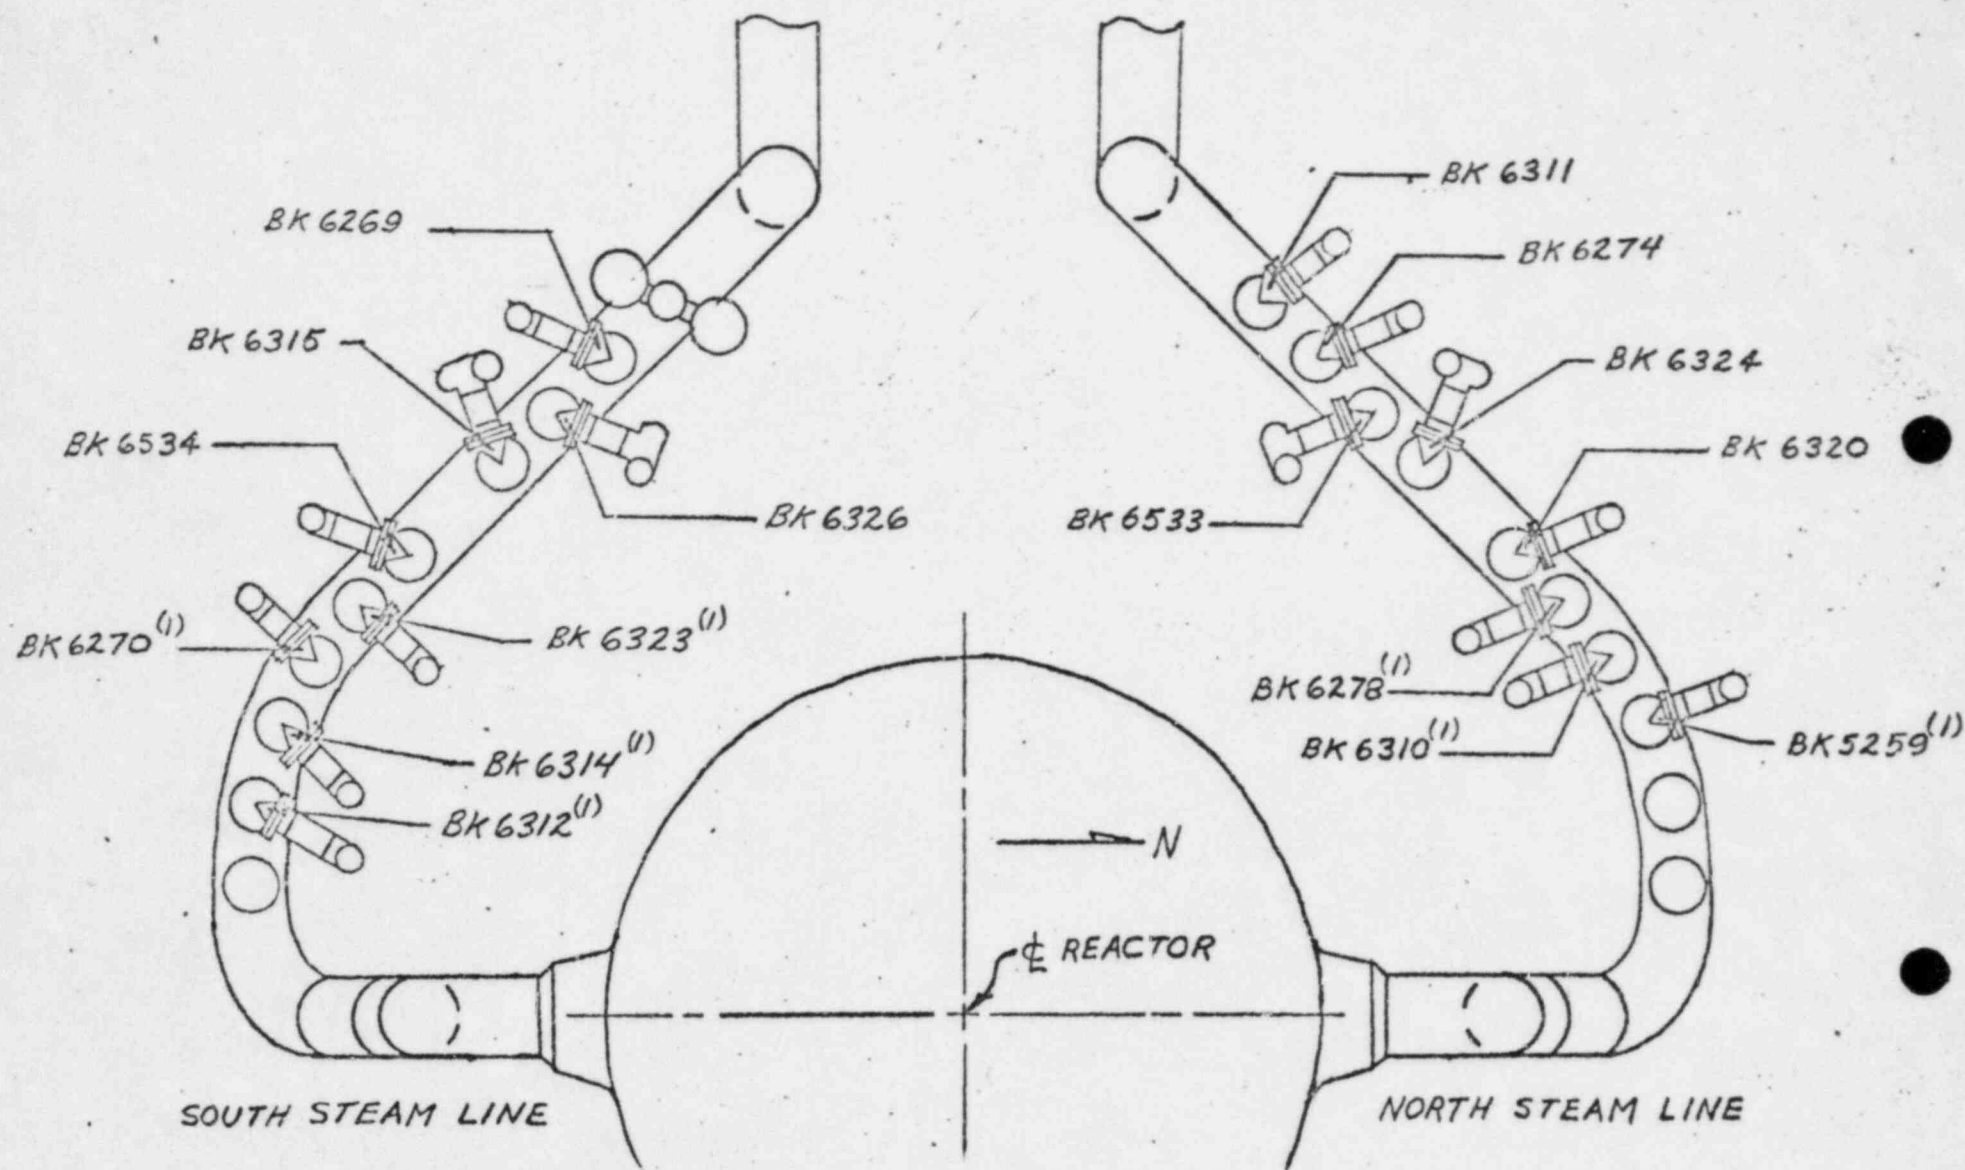
Figure 3. Safety Valves in Service at Reactor Shutdown May 1972

(1) Cracked Seat Bushing
All Valves Removed and Inspected.
