# Jersey Central Power & Light Company

May 1, 1972

Subject: Docket No. 50-219  
Oyster Creek Station  
Safety Valve Seat Bushing Cracks

The purpose of this letter is to provide you with an interim report regarding the discovery of cracks in the seat bushings of two main steam safety valves at the Oyster Creek Station.

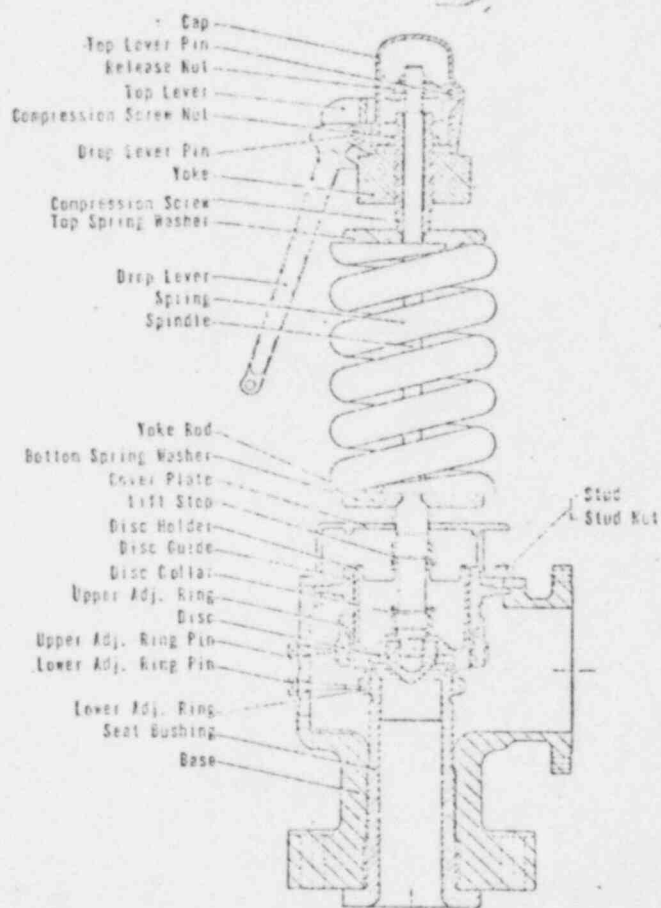
FIGURE I - MAXIFLOW SAFETY VALVE

The Oyster Creek Station has a total of sixteen six-inch diameter spring-loaded safety valves on the main steam lines between the reactor vessel and the isolation valves. A drawing of the safety valve identifying the primary parts is shown in Figure 1. As shown on Figure 1, the seat bushing and the disc are the reactor coolant pressure boundary. The seat bushing is machined from 304 stainless steel. The disc is machined from 422 stainless steel. Both the seat bushing and the disc were ultrasonic and liquid penetrant inspected at the time of manufacture.

The seat bushing from valve serial number BK-6247 had radial cracks at the valve seat and circumferential cracks at the inner radius above the threads. The radial cracks started at the outside surface and extended part way across the seat face.

The circumferential crack extended around a major portion of the circumference. The maximum depth of the circumferential cracks was approximately 120 mils as determined by grinding out the cracks. There was no crack indications on the inside diameter of the seat bushing.

The seat bushing from valve serial number BK-6268 had approximately fifteen radial cracks across the seat, numerous longitudinal cracks on the outer diameter and circumferential cracks at the inner radius above the threads. No crack indications were found on the inside diameter with the exception of those on the seat face, or in the flange area of the part.

Following the liquid penetrant inspection at the station that was performed by Jersey Central Power & Light Company personnel and witnessed by the valve vendor and Jersey Central consultant personnel, the seat bushing from valve BK-6268 was shipped to the Vallecitos Nuclear Center for destructive metallographic examination. Samples examined to date indicate the cracks extend to a maximum depth of 150 mils and are all transgranular. The examination also disclosed that the material is fully annealed and shows no sensitization.
