Commonwealth Edison Company

Dresden Nuclear Power Station
R. R. #1
Morris, Illinois 60450
October 2, 1972

SUBJECT: LICENSE DPR-19, DRESDEN NUCLEAR POWER STATION - UNIT #2

This is to inform you of the results of our investigation into the reduction in flow on the "B" main steam line of Dresden Unit 2. (Ref. letter September 7, 1972).

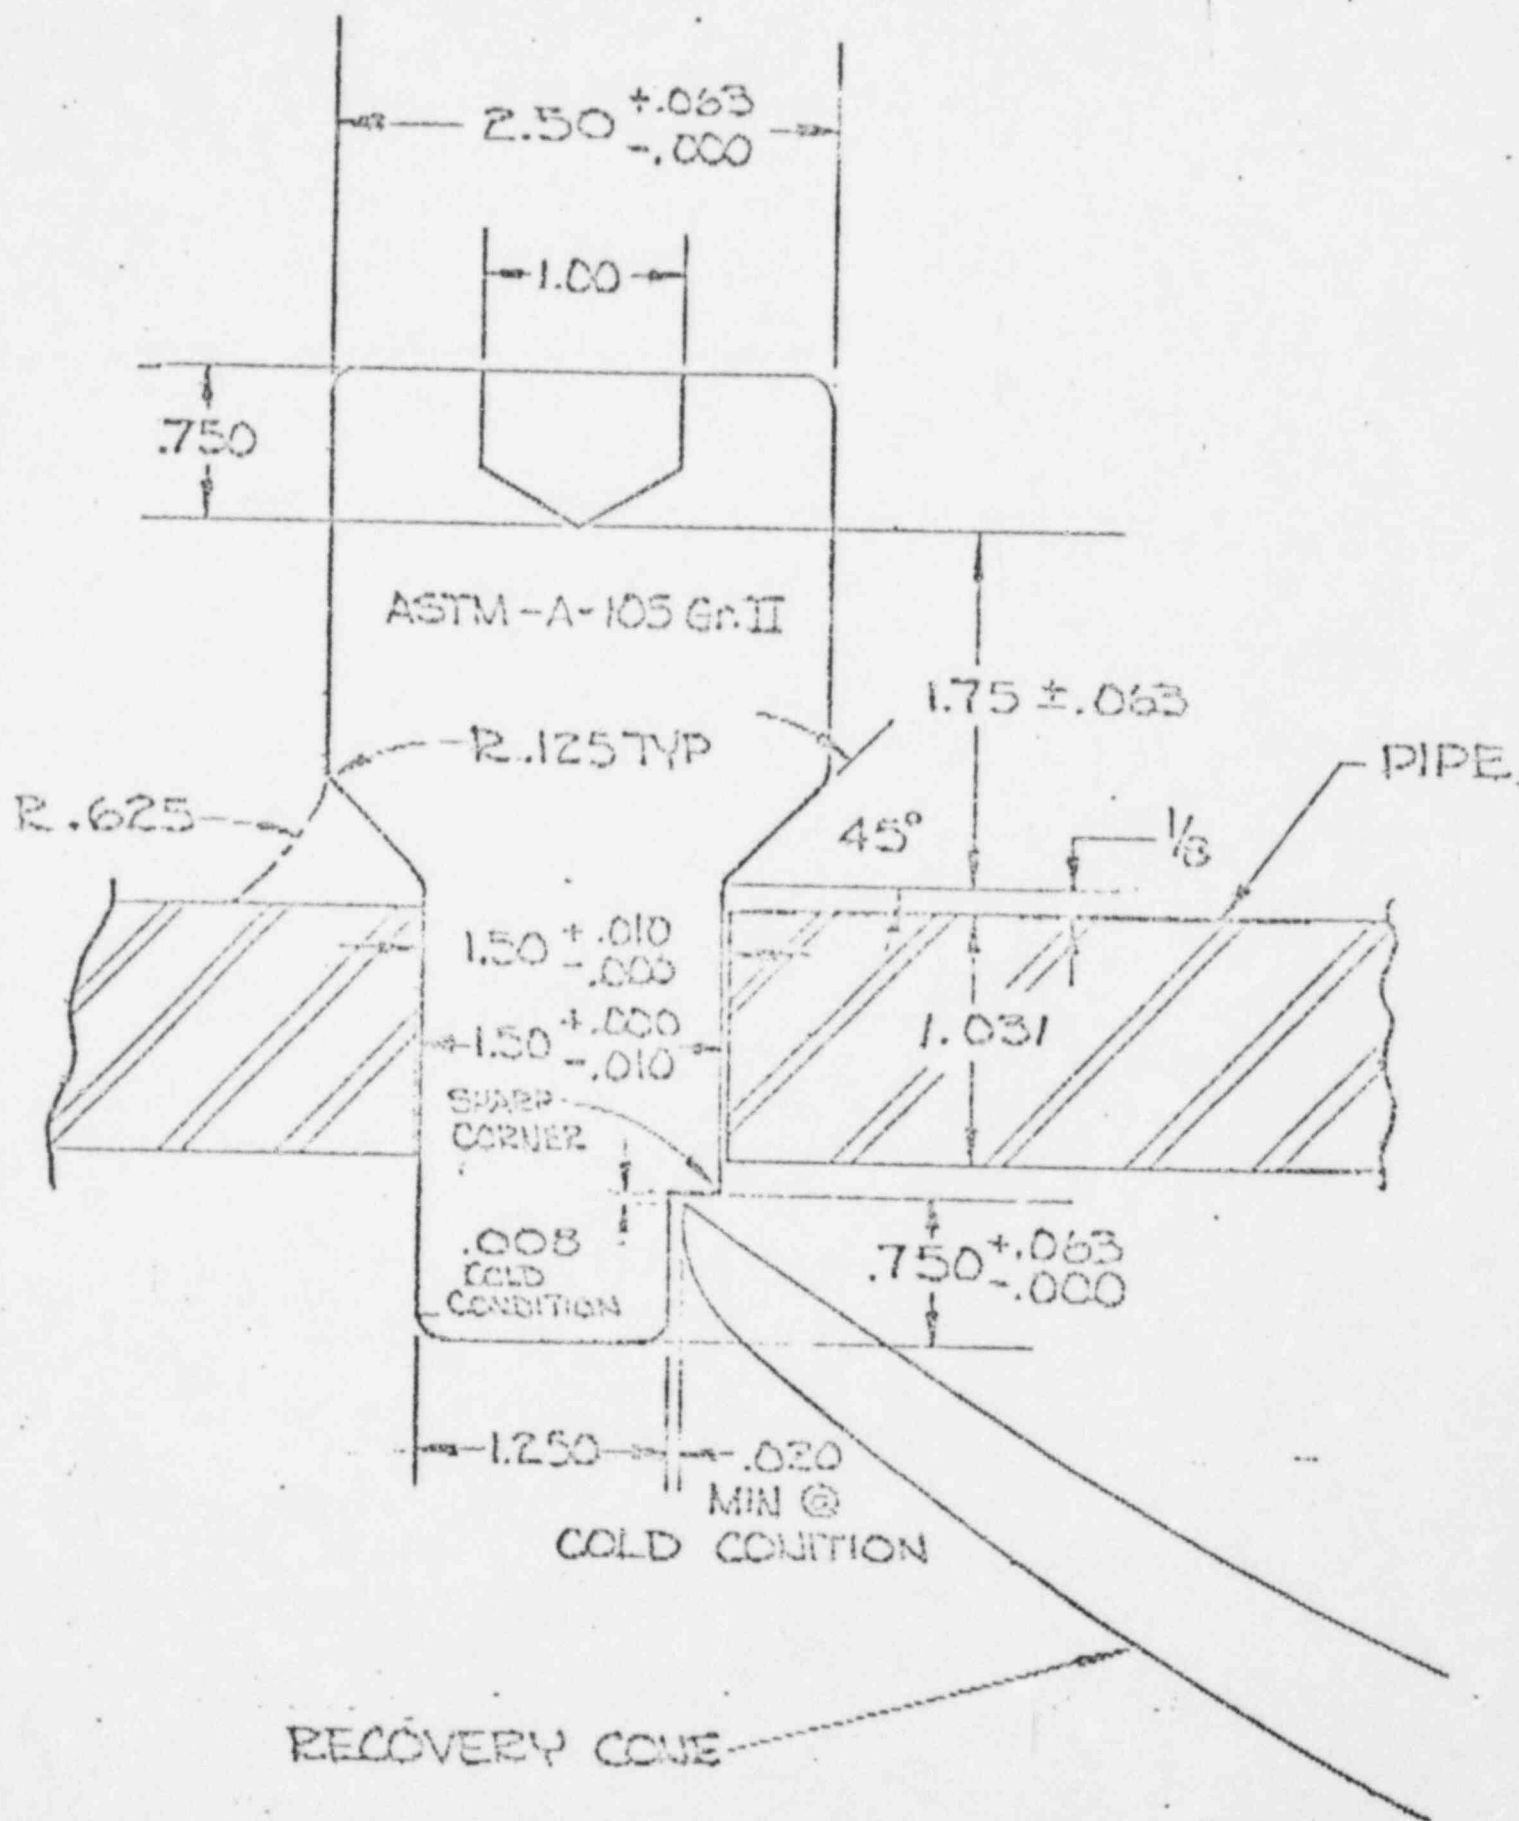
FIG. 1

Visual examination, through the use of a boroscope, of the failed "B" steam line flow element revealed weld discontinuities (lack of penetration, slag, and porosity) in the weld joining the recovery cone to the throat section. The mode of failure was determined to be fatigue originating at the locations of lack of weld penetration.

1. The Dresden II main steam flow element is modified by installing three (3) pins at 120° apart downstream of the recovery cone, with a clearance of .020" minimum to take care of the differential thermal expansion between pipe (carbon steel) and flow element cone (stainless steel) as shown on Figure 1, attached. Based on the assumption that the throat-to-recovery-cone weld on the A, C & D lines fail these pins are designed to prevent the recovery cones from moving down stream into the MSIV. These pins will also prevent any vibration of the downstream recovery cone that may exist during operation. Stress analyses show that if the downstream cone should fail and be held by only one pin, the pin shear stress will be 13,866 psi if 100 psid exists across the restrictor. This assumption is very conservative because normal operating differential is approximately half of this. The allowable stress for this emergency condition is 90% of yield strength, or 27,800 psi (Note: $S_m = 18,600$). Since the maximum stress with only one pin carrying the load is 13,866 psi, the design of the pins is more than adequate.

Area replacement was also considered in designing these pins, based on ASME-Section III, 1971, Paragraph NE-3643.3 - Reinforcement for Openings.

$$\text{Area removed} = 1.389 \text{ in}^2 \quad / \quad \text{Area Available} = 1.688 \text{ in}^2$$

Combined stress in $1\frac{1}{2}$ " pin weld is 9,259 psi. Includes pressure and temperature stress plus the stress due the cone resting on one pin. Allowable stress is 18,600 psi.
