# Commonwealth Edison Company

Dresden Nuclear Power Station

SUBJECT: LICENSE DPR-19, DRESDEN NUCLEAR POWER STATION, UNIT #2,  
SECTION 6.6.C.1 OF THE TECHNICAL SPECIFICATIONS.

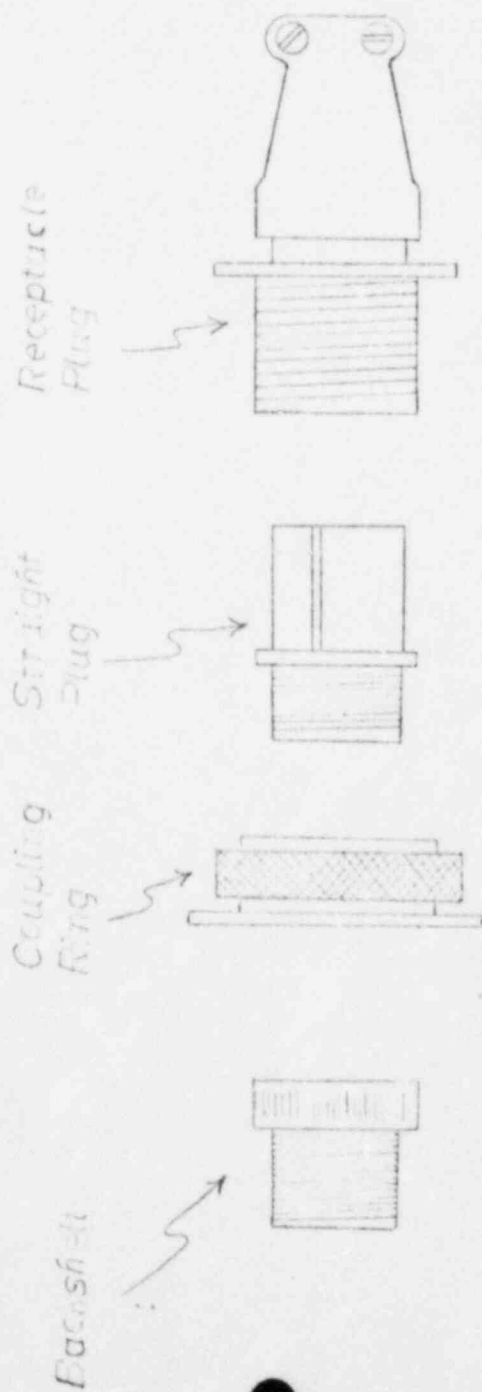
# AMPHENOL CONNECTOR

The cause of the malfunction was found to be a broken wire at the amphenol connector to the solenoid. The wire broke because of improper connector fastening to the solenoid body. The solid shell straight plug was attached directly to the body of the solenoid. The straight plug should have been attached to the solid threaded backshell; the backshell would then be attached to solenoid body. This arrangement permits the coupling ring to spin freely (see attached drawing for amphenol nomenclature).

However, since the straight plug was attached to the solenoid, the coupling ring could not be properly attached to the recepticle shell. In order to thread the coupling ring to the recepticle shell, it was necessary to loosen the straight plug.

Because of this, the straight plug vibrated itself free from the solenoid body. These vibrations caused the threads on the plug to become deformed. Once the straight plug worked itself free, the wires of the solenoid were hanging from the solenoid supporting the weight of the amphenol connector and cable. The weight of the connector and the cable caused one of the wires to snap. This snapped wire in turn prevented the solenoid from receiving the signal to fast close the control valve.

The amphenol connector was repaired and attached properly to the solenoid. The threaded backshell was attached. Loctite, a thread compound, was applied to all threaded fittings of the connector. The Loctite was applied to insure that the threaded fittings would not vibrate loose.
