FLORIDA POWER &amp; LIGHT COMPANY

ABNORMAL OCCURRENCE NO. 251-75-4  
OCCURRENCE DATE: MARCH 12, 1975  
TURKEY POINT UNIT NO. 4  
LATERAL RESTRAINTS FOR SPENT  
FUEL RACKS BROKEN

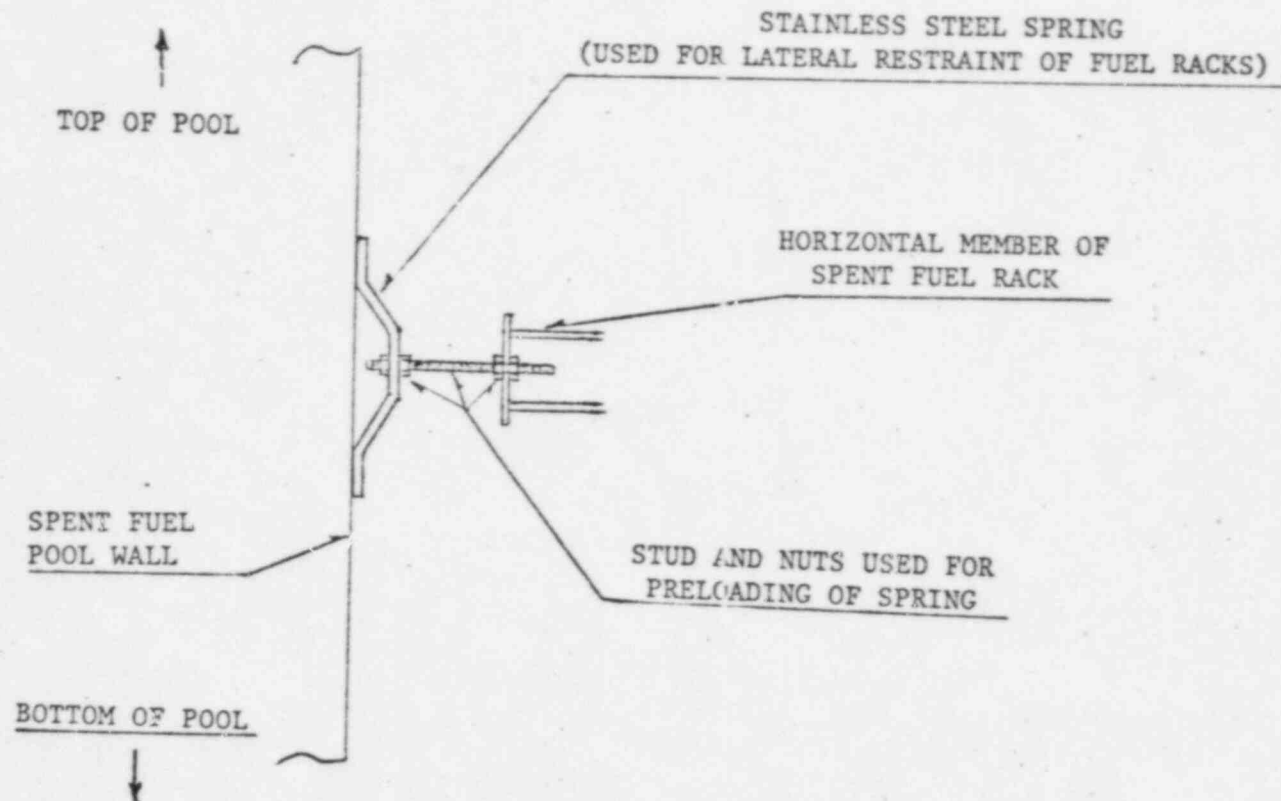
SKETCH NO. 1

During the spent fuel pool cleaning on March 6, 1975, it was found that one of the 116 stainless steel seismic restraint springs (see Sketches No. 1 and 2) on the spent fuel racks had broken into two pieces and was lying on the pool floor. The remaining springs were all noted to be in place. However, a more careful examination of each of the remaining 115 springs was completed on March 12, 1975 and revealed that 5 additional springs were similarly broken, but were held in place by the nuts used to fasten the spring to the stud used for preloading the spring (see Sketch No. 1).

The investigation to date has not conclusively determined the cause of the broken springs. One of the broken springs has been sent to a laboratory for metallurgical analysis, but the results are not yet available.

SPRING INSTALLATION  
IN TURKEY POINT SPENT FUEL POOL

The broken springs will be replaced with new springs of the same functional design. A supplement to this report will be issued in the event that additional corrective action is required as a result of the continuing investigation.

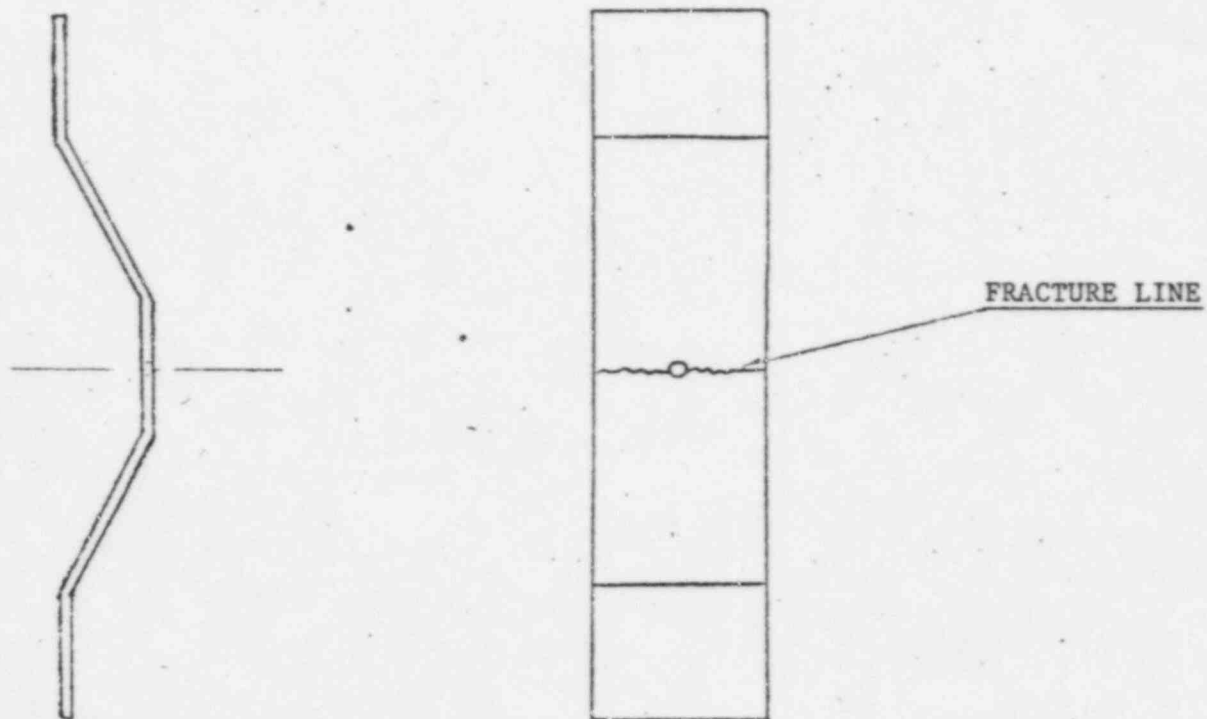
SKETCH NO. 2

There has been one other instance of a broken spring at the Turkey Point Plant. On March 10, 1975, one of the 116 springs installed in Unit No. 3 spent fuel pool was found to have broken. The springs are manufactured by Unistrut Corporation, Wayne, Michigan, and are designated as part number 115792.

STAINLESS STEEL SPRING USED FOR  
LATERAL RESTRAINT OF SPENT FUEL RACKS AT  
TURKEY POINT PLANT
