Jersey Central Power & Light Company

Re: Report of Abnormal Occurrence
Oyster Creek Nuclear Generating
Station, Unit No. 1
October 2, 1969

The inability to meet a limiting condition for operation at the Oyster Creek Nuclear Generating Station of the Jersey Central Power and Light Company on October 2, 1969. Reference AEC Operating License DPR-16, Technical Specifications, thereof, Section 3.2 "Reactivity Control," Specification B, Sub-Specification No. 3 - "The average of the scram insertion times of all operable control rods shall be no greater than:"

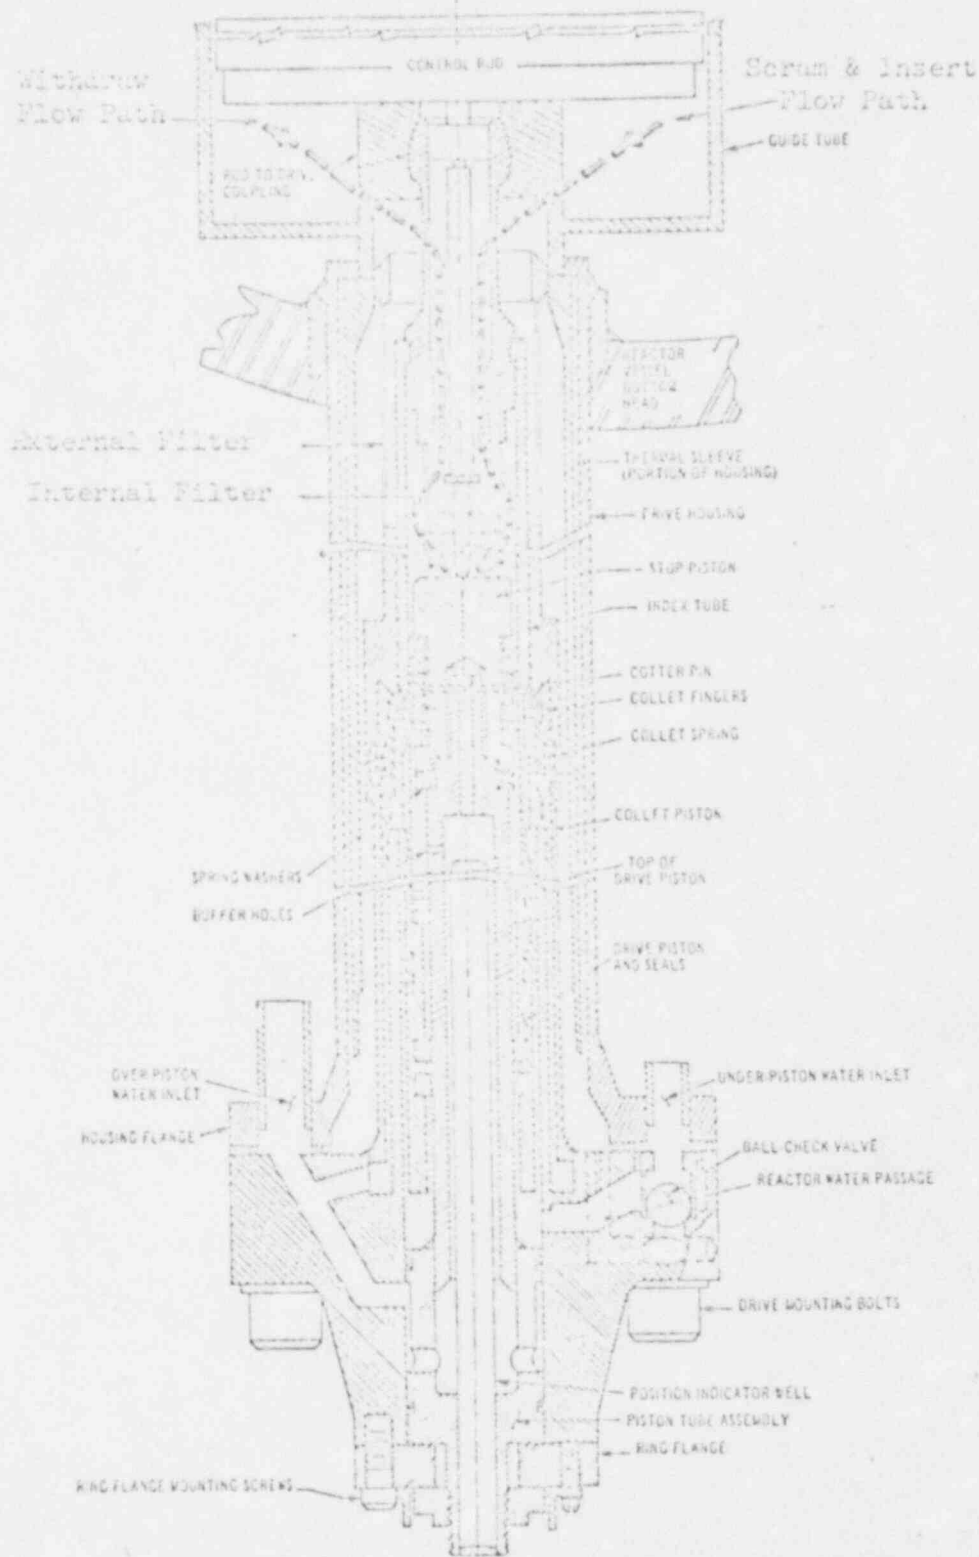
EXHIBIT A
Schematic Diagram -- Model TR-DB-144-A1 Control Rod Drive Mechanism

Examination of the drives disclosed the fact that the internal and external filters within the drive were partially plugged with a very fine red iron oxide. The internal filters, composed of a fine wire mesh of approximately three micron filtering capacity, were plugged to the extent that the flow of reactor water into the volume between the stop piston and the top of the index tube during a scram operation was excessively restricted. When this occurred, the pressure unbalance across the top of the index tube caused an increase in the scram insertion time for the drive. This fact was confirmed by retesting selected drives without the fine internal filter in place, at which time the drives tested in this manner more than met the scram insertion time specified. (See attached Exhibit A for a cross section of the drive showing the internal and external filters and the flow path of water when withdrawing and inserting the drives).

Based upon the control rod drive manufacturer's recommendation, the fine wire mesh on the internal filter will be removed on all of the 137 drives. (Consideration is being given to reinstall a small number of fine filters in order to obtain additional data). In addition, the external filters will be exchanged for clean filters on all of the 137 drives.

With the removal of the fine wire mesh from the internal filter, the reactor water will now pass through the filter support basket which is a cylinder perforated with 5/32 inch holes. The fine oxide cannot plug
