# Commonwealth Edison Company

Dresden Nuclear Power Station  
R. R. #1  
Morris, Illinois 60450

SUBJECT: LICENSE DPR-19, DRESDEN NUCLEAR POWER STATION, UNIT #2, SECTION 6.6.C.1 OF THE TECHNICAL SPECIFICATIONS, FOLLOW UP LETTER.

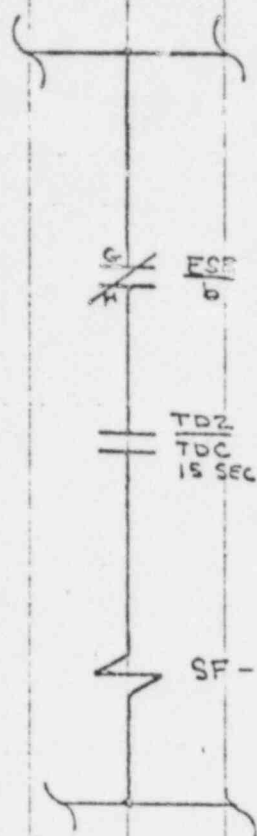
FIGURE 1

- b. ESR (G-H) opens when diesel reaches 200 rpm (Fig. 1)
- c. 15 sec. after auto start signal is initiated, TD2  
closes (Fig. 1) TDC
- d. When the control switch is placed in the stop position, ESR (G-H) closes immediately (Fig. 1)

- f. ECR relay is de-energized-starting the time out sequence. ECR (3-5) closes. TD2 (N-P) opened when the TD2 relay was de-energized.
- g. When the control switch is returned to the AUTO position, the start signal is again initiated, but due to the SF (C-D) contacts being open, the TD2 relay can not be re-energized and consequently the ECR relay shutdown sequence takes precedence.

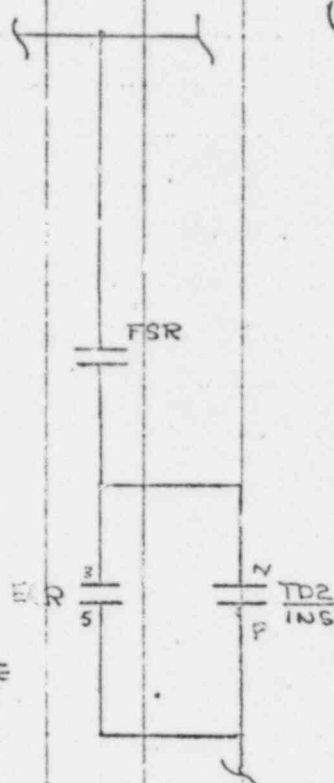
FIGURE 3

- a. on auto start signal, TD2 relay is energized closing TD2 and FBR (Fig. 3)

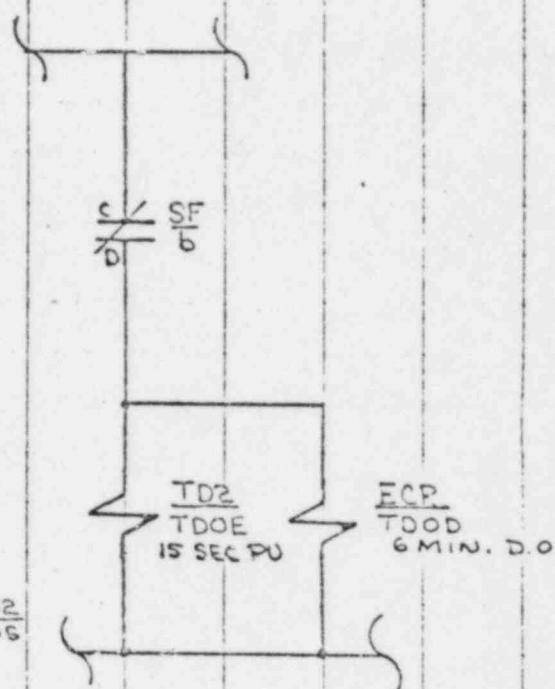
FIGURE 2

- e. Due to the finite amount of time required for the slow TD2 relay to open before the TD2/TDC contacts can open the SF relay is energized and the SF (C-D) contacts (Fig. 2) open and must be manually reset at the engine panel.
