Jersey Central Power & Light Company  
New Jersey Power & Light Company

Re: Report of Abnormal Occurrence  
Oyster Creek Nuclear Generating Station - Unit No. 1  
September 9, 1969

Turbine Initial Pressure Regulator (operating or electric pressure regulator) malfunction caused an unplanned reactor trip at the Oyster Creek Nuclear Generating Station of the Jersey Central Power & Light Company on September 9, 1969. Reference AEC Operating License DPR-16, Technical Specification, thereof, Section I - Definitions, Sub-Paragraph 1.15C, and Section 6.3 "Actions to be Taken in the Event of an Abnormal Occurrence in Plant Operation."

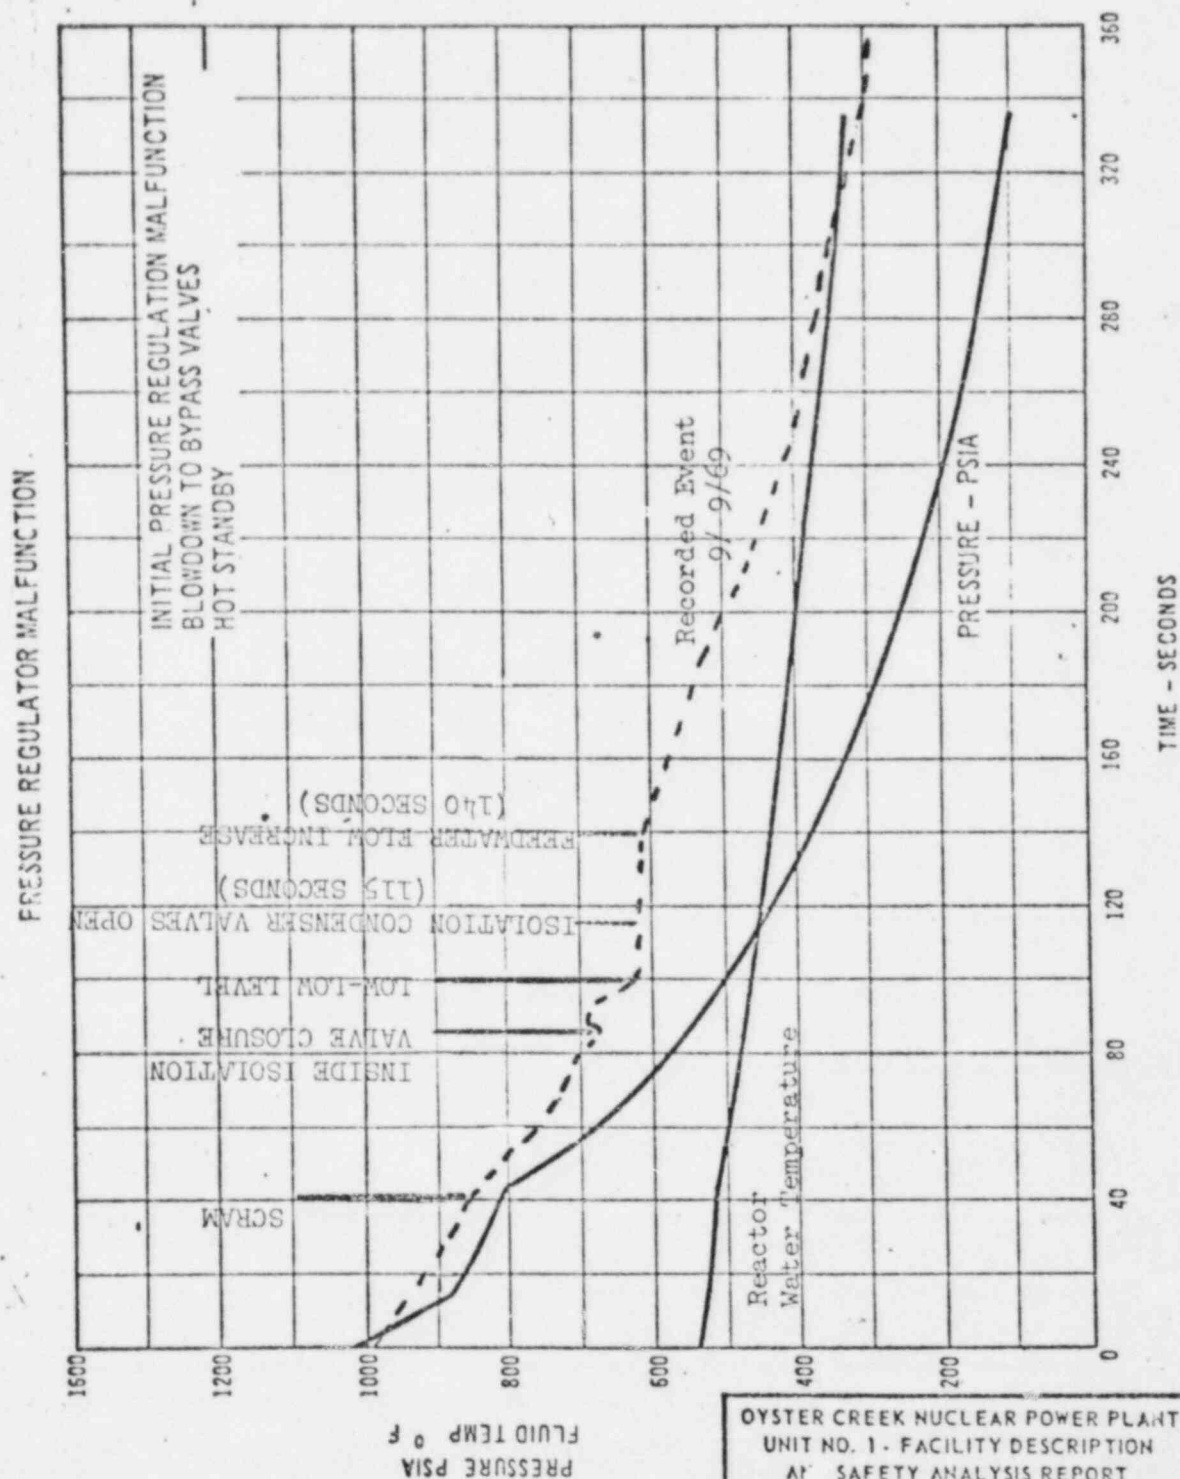
FIGURE VII-8-1a

Pressure regulator malfunctions have been analyzed and discussion of the effect of opening the bypass valves is presented in the FDSAR, Section VII-8-1 as revised 11/1/67 and Figure VII-8-1a as revised 12/19/67. As stated therein, blowdown from the hot standby condition leads to the most rapid depressurization rate. In the actual event, the depressurization rate was less than the previously analyzed case. (actual data superimposed on attached Figure VII-8-1a) There was a decrease in reactor water temperature of approximately 125° F in 5½ minutes for an average rate of 23° F per minute. All measured vessel metal temperatures

Added Event of 9/9/69  
Revised 12/19/67

Pressure Regulator Malfunction -  
1600 MWt - Sheet 1
