REPORT ON MAIN STEAM LINE ISOLATION VALVE TESTING

In accordance with the letter from G. H. Ritter to P. A. Morris dated December 24, 1969, Oyster Creek Unit No. 1 started their scheduled shutdown on January 31, 1970, for the purpose of testing all four main steam isolation valves and to establish conformance with applicable provisions of the Technical Specifications.

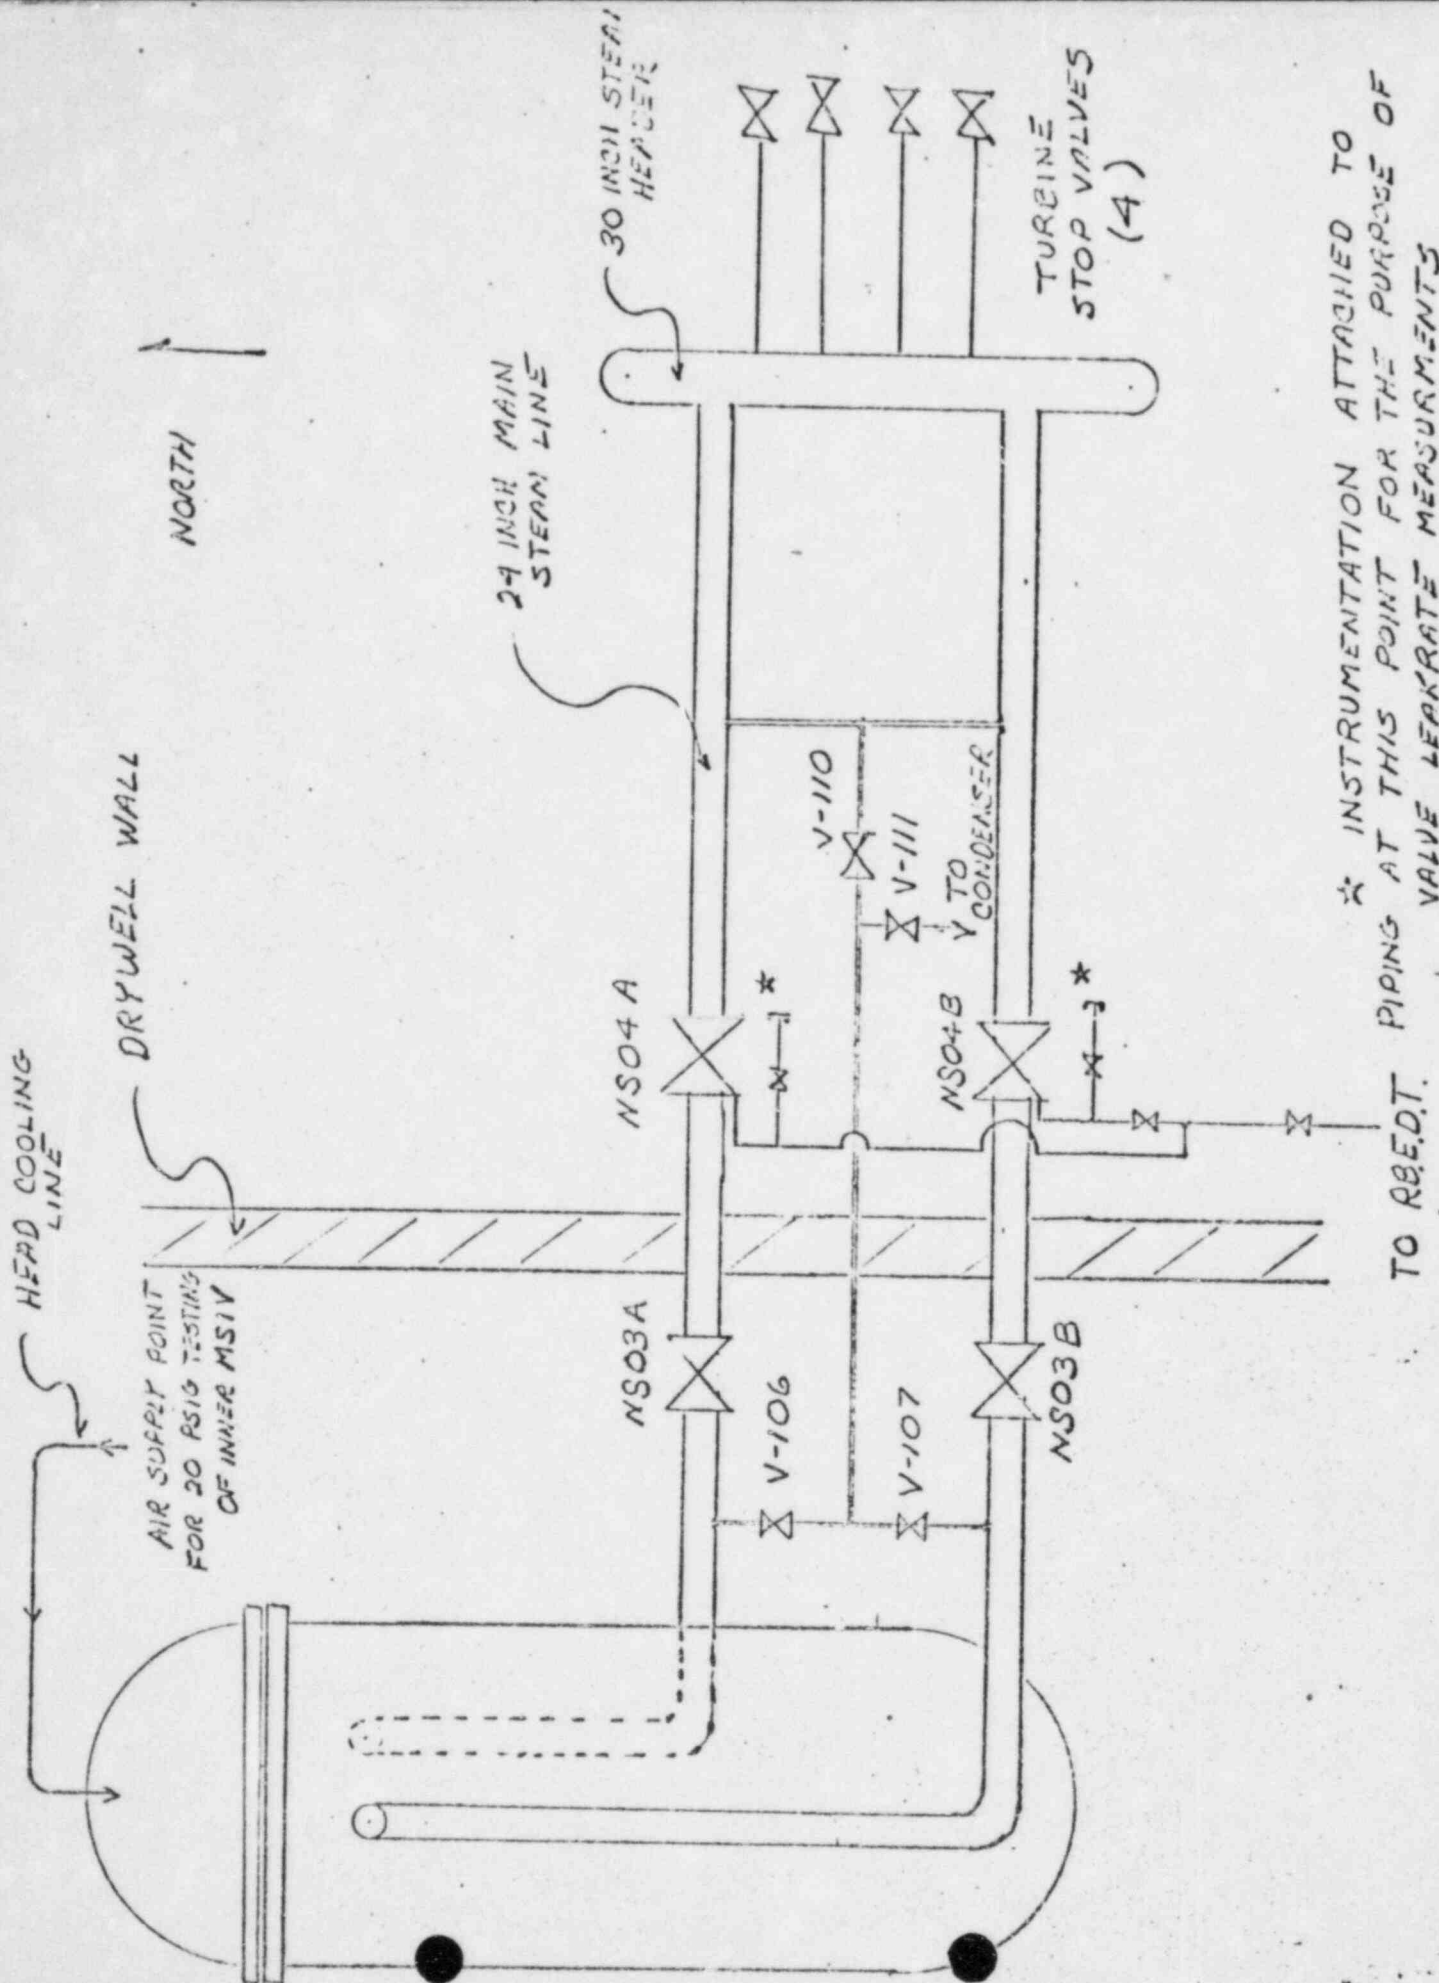
This report contains a summary of the test results as well as pertinent observations and recommendations relating to these valves. A testing chronology associated with the main steam isolation valves is also attached to this report as Appendix 1. In addition, Figure 1 shows the main steam line piping schematic.

In accordance with instructions from the regional compliance office, Mr. Capton was called and notified that the main steam isolation valves were going to be tested for record. Mr. Capton indicated he was not coming down to witness the test as originally planned. Final testing commenced in the afternoon. The reactor was pressurized to 20 psig with air, all four isolation valves closed. A manometer and bubbler were set up and tied into the system at the location shown on Figure 1. No change in manometer readings
