## LICENSEE EVENT REPORT (LER)

FACILITY NAME (1) Fort St. Vrain, Unit No. 1										DOCKET NUMBER (2) 0 5 0 0 0 2 6 7				PAGE (3) 1 OF 017											
TITLE (4) Corrosion of PCRV Tendon Wires (Voluntary LER)																									
EVENT DATE (5)			LER NUMBER (6)				REPORT DATE (7)			OTHER FACILITIES INVOLVED (8)															
MONTH	DAY	YEAR	YEAR	SEQUENTIAL NUMBER	REVISION NUMBER	MONTH	DAY	YEAR	FACILITY NAMES N/A			DOCKET NUMBER(S)													
0	3	2	7	8	4	8	4	0	0	5	0	0	0	4	2	6	8	4	0	5	0	0	0	1	1
OPERATING MODE (9) N		THIS REPORT IS SUBMITTED PURSUANT TO THE REQUIREMENTS OF 10 CFR 5: (Check one or more of the following) (11)																							
POWER LEVEL (10) 0 1 0 0		20.402(a)				20.405(a)				60.73(a)(2)(iv)				73.71(a)

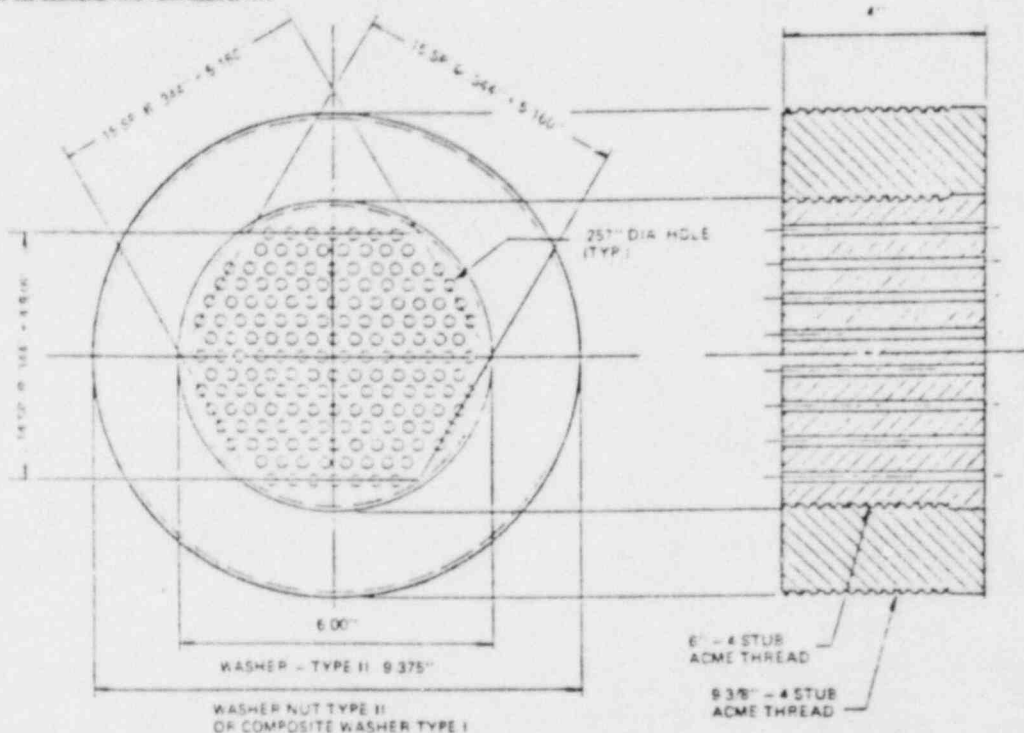
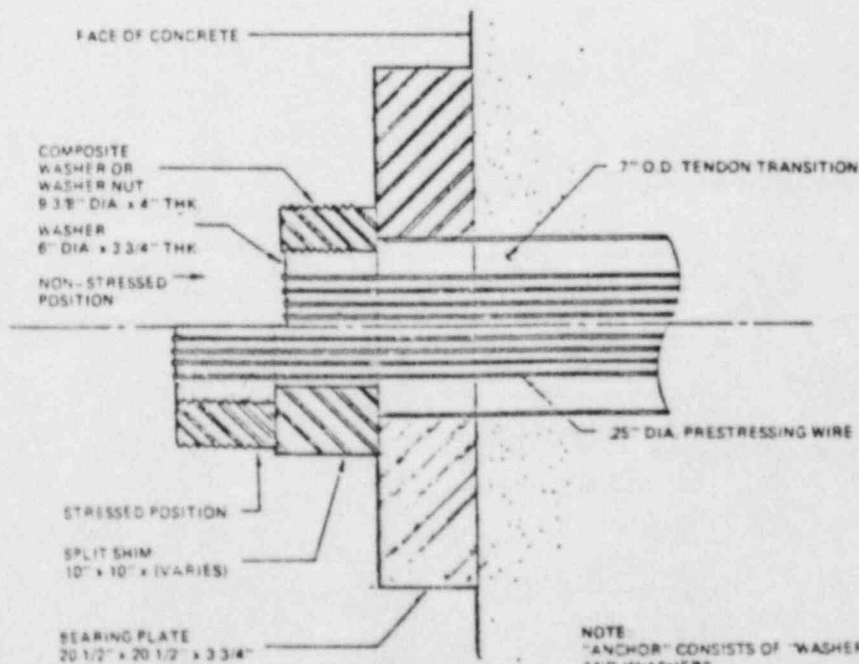
FIGURE 1

The Prestressed Concrete Reactor Vessel (PCRV) utilizes a system consisting of 448 prestressing tendons in two basic configurations consisting of 152 or 169 1/4 inch diameter wires. Each wire terminates at a buttonhead supported by an anchor (buttonhead) washer which seats through a split shim onto a bearing plate on the PCRV surface (see Figure 1). The tendons may be delineated into four different types according to the following table (also see Figure 2).

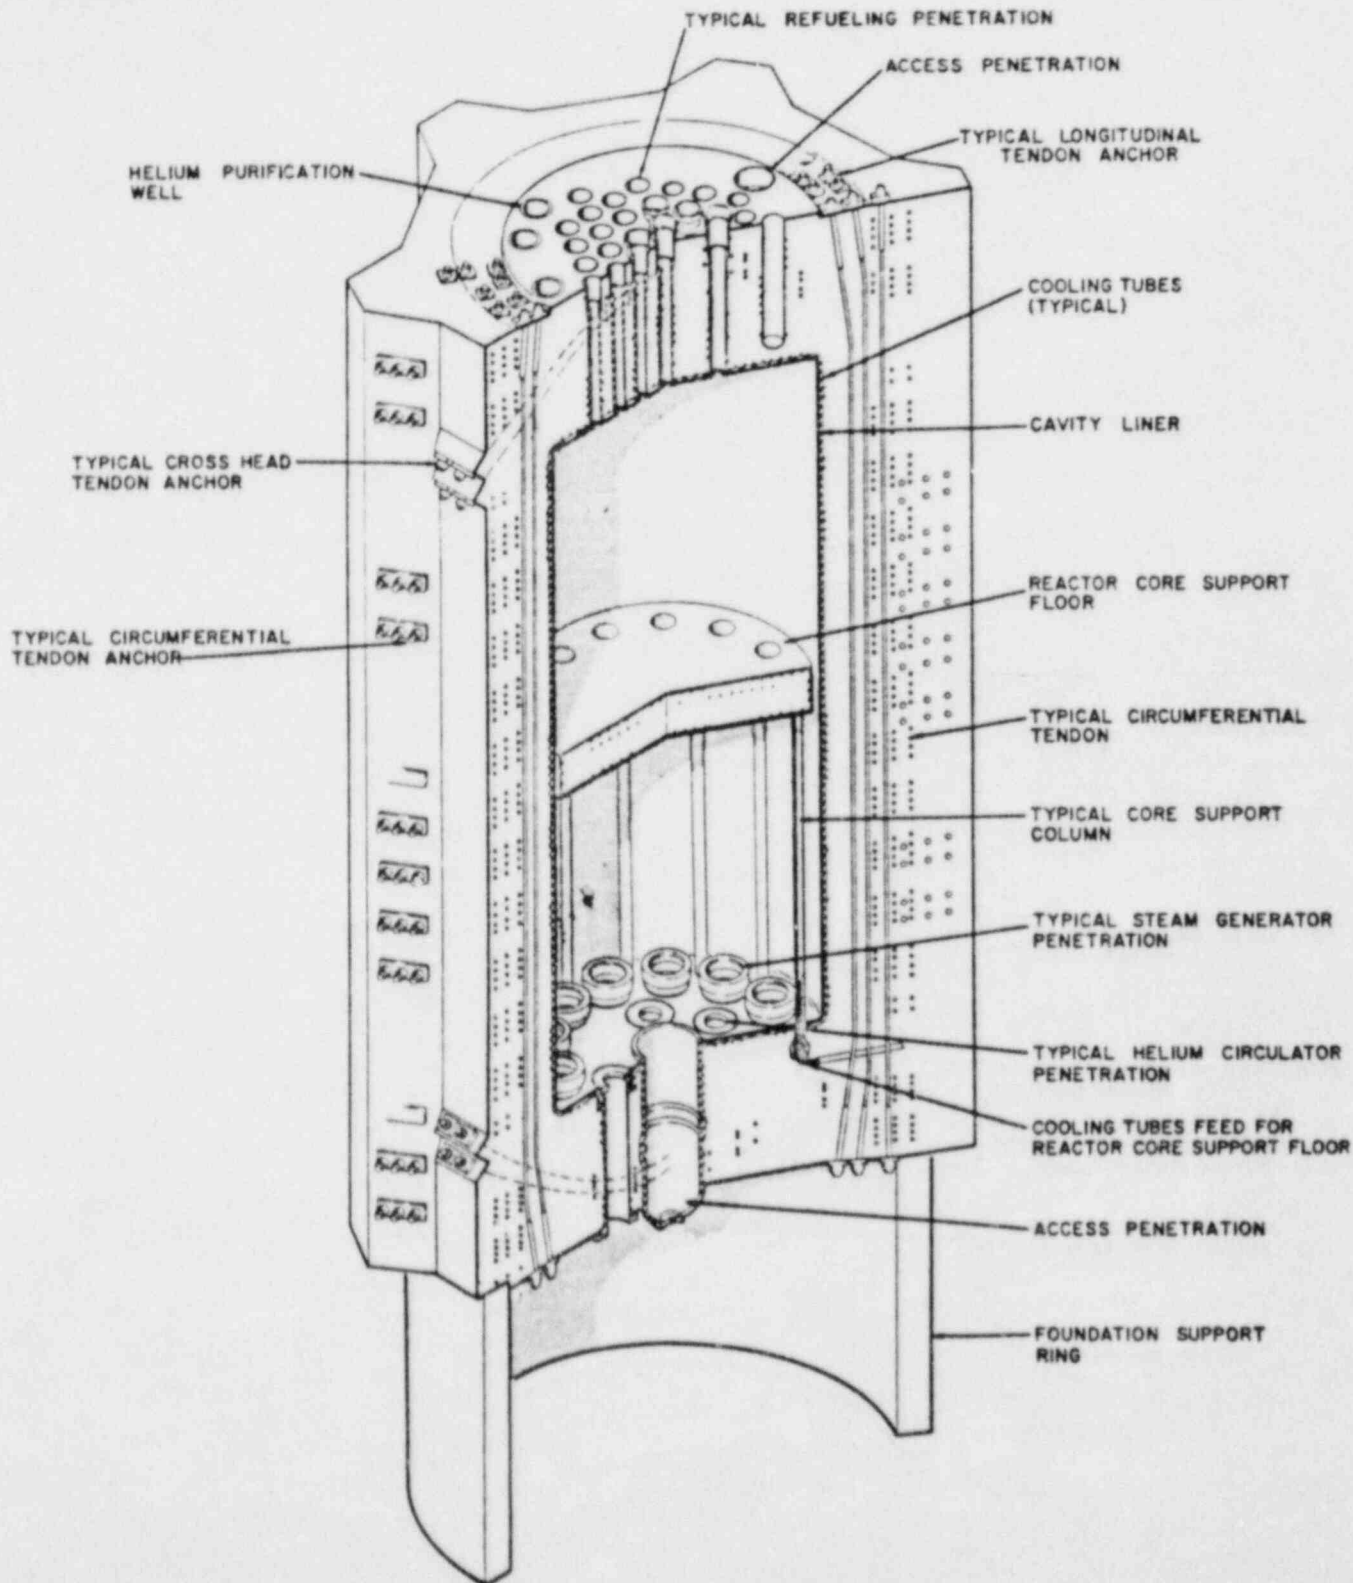
FIGURE 2

448 Tendons Total	27 Load Cells
310 Circumferential	17 Load Cells
90 Vertical	6 Load Cells
24 Top Cross Head	2 Load Cells
24 Bottom Cross Head	2 Load Cells
