TENNESSEE VALLEY AUTHORITY
CHATTANOOGA, TENNESSEE
37401

BROWNS FERRY NUCLEAR PLANT UNIT 2 - LOSS OF SUCTION TO CORE SPRAY
PUMPS DURING PREOPERATIONAL TESTING

BROWNS FERRY NUCLEAR PLANT UNIT 2
LACK OF SUCTION TO CORE SPRAY PUMPS CAUSED BY
PARTIALLY CLOSED VALVE HCV-75-1
FINAL REPORT

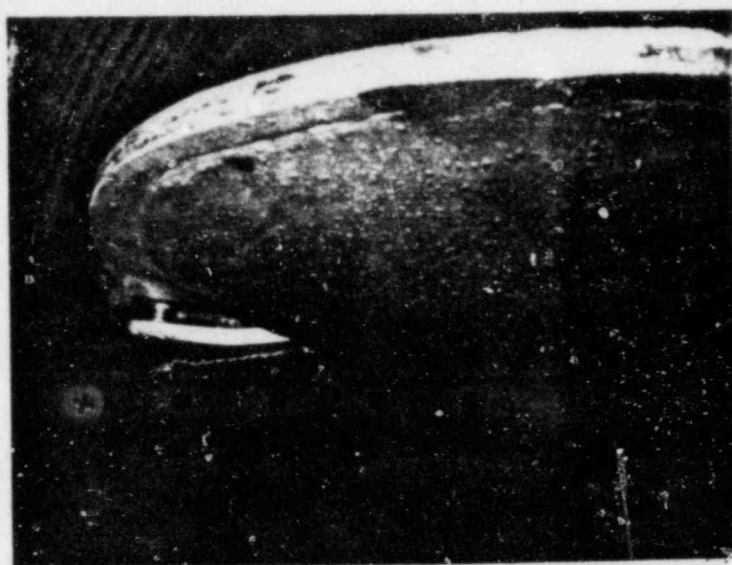
FIG. 1-DISC-TO-SHAFT INSTALLATION

Inspection of valve HCV-75-1 revealed the problem to be a function of the disc-to-shaft installation. Figure 1 shows the actual condition of the disc-to-shaft installation. After the keeper plate was removed, the disc keyway damage can be seen in Figure 2. Apparently the valve's failure to open and close properly was the result of vibration of the disc on the shaft. The disc keyway as shown in Figure 3 was deformed on one side. In addition, the bull gear shown in Figure 4 was worn approximately 1/16-in. as a result of contact with the adjustable stop screw. As the disc vibrated on the shaft, the vibration was suppressed in one direction by the disc keyway and in the other direction by the gear stop. This condition prevailed until excessive deformation of the disc keyway and failure of the keeper plate and bolts allowed the key to dislodge from the keyway on the shaft.

1. HCV-75-1: This valve was cut out of the system and replaced with a valve that had been rebuilt earlier to the manufacturer's original specifications.
2. HCV-75-29: This valve was cut out of the system and replaced with a new valve from Unit 3.

1. Using a larger key.
2. Machining a deeper and wider keyway in the shaft.
3. Building up the disc thickness at the keyway.
4. Assembling the disc-to-shaft joint using a larger keeper plate over the key-keyway assembly and six 3/8-in. bolts instead of four 1/4-in. bolts to secure the keeper plate.
5. Installing a safety wire through the heads of all six bolts.

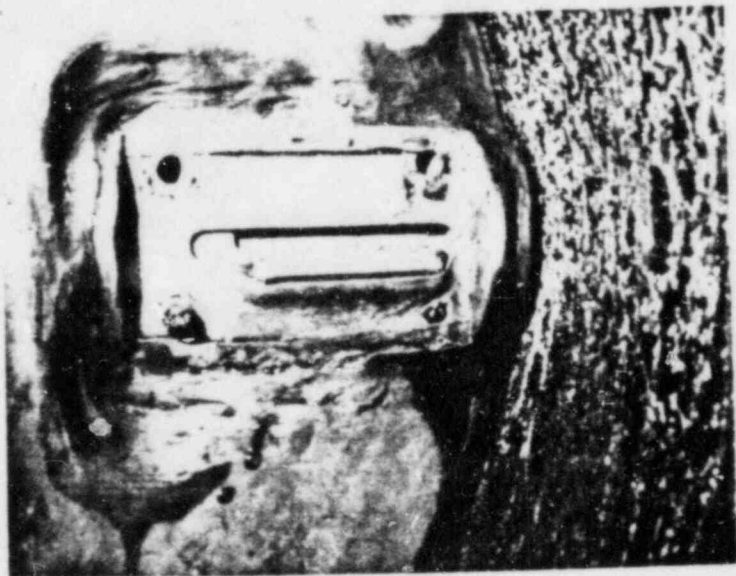
FIG. 5—DISC-TO-SHAFT INSTALLATION

An inspection revealed that a similar failure occurred on valve HCV-75-29, the respective valve in the suction line to core spray pumps 2B and 2D, but in this case the valve remained in its fully open position. Figure 5 shows the deformed condition of the keyway on the shaft of HCV-75-29 very clearly. However, the pumps associated with HCV-75-29 did not experience a loss of suction.
