TENNESSEE VALLEY AUTHORITY - BROWNS FERRY NUCLEAR PLANT UNIT 1 -  
DOCKET NO. 50-259 - FACILITY OPERATING LICENSE DPR-33 - ABNORMAL  
OCCURRENCE REPORT BFAO-7432W

## ABNORMAL OCCURRENCE REPORT

Report No.: BFAO-7432W  
Report Date: May 24, 1974  
Occurrence Date: May 14, 1974  
Facility: Browns Ferry Nuclear Plant unit 1

Failure to monitor gaseous effluent from unit 2 turbine roof exhausts.

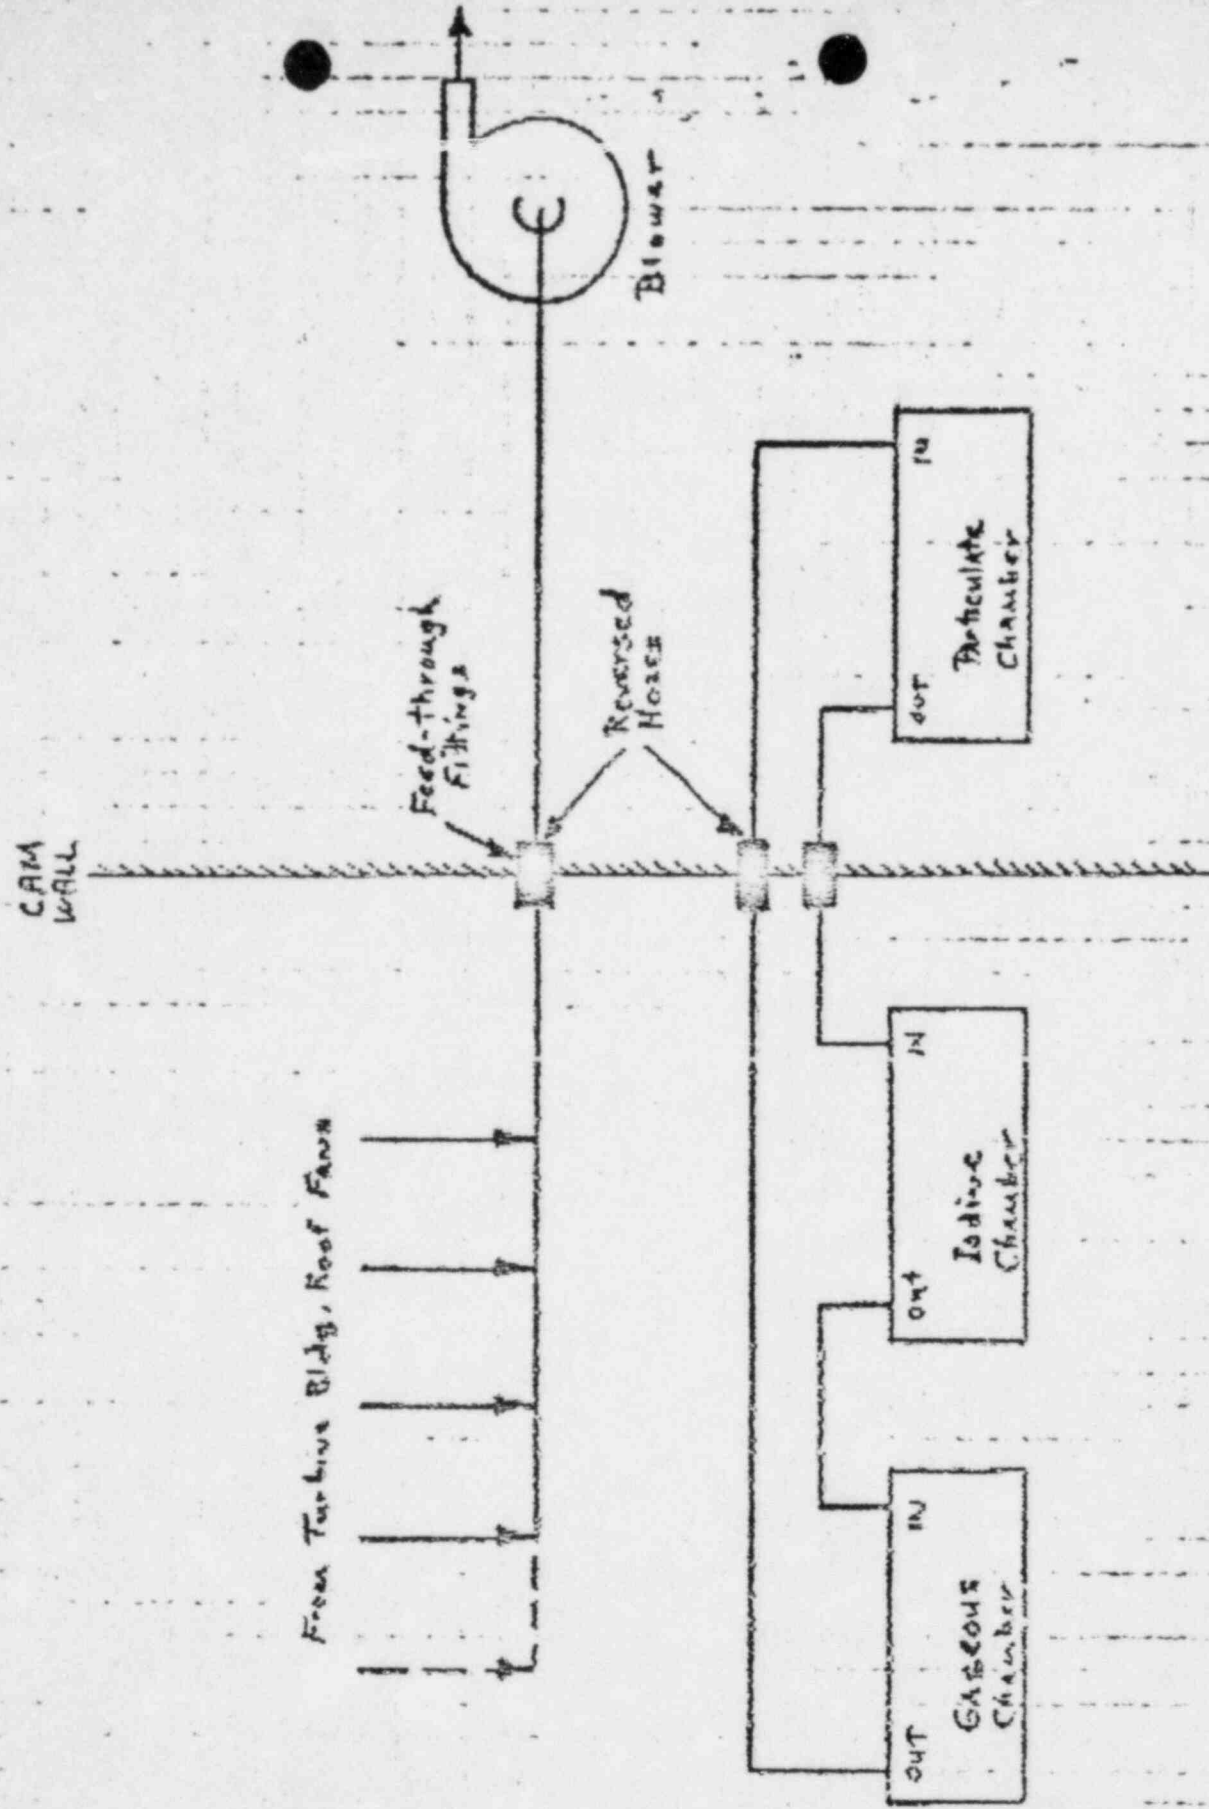
Nuclear Measurements Corp. - As Found Internal Hose Connections

The turbine roof exhaust on unit 2 is required to be monitored for gaseous release activity when exhaust fans are operated. This monitoring was not done between April 8th and May 14th for an accumulated operating period of 16-1/2 days. The two continuous air monitors (CAM) in use on unit 2 were found incorrectly assembled, allowing the sample to bypass the radiation monitors (see sketch).

CAM's: 2-RM-90-249 and 2-RM-90-251  
Manufacturer: Nuclear Measurements Corporation  
Model: AM-33IF(BF)

All other CAM's of this type were inspected and found correctly assembled. The CAM manufacturer was notified of the problem. Instructions will be revised to verify correct assembly before initial installation and after any CAM modification or repair that may affect the hose assembly.
