TENNESSEE VALLEY AUTHORITY
CHATTANOOGA, TENNESSEE
37401

TENNESSEE VALLEY AUTHORITY - BROWNS FERRY NUCLEAR PLANT UNIT 1 -
DOCKET NO. 50-259 - FACILITY OPERATING LICENSE DPR-33 - ABNORMAL
OCCURRENCE REPORT BFEAO-7419W

ABNORMAL OCCURRENCE REPORT

Report No.: BFEAO-7419W
Report Date: May 9, 1974
Occurrence Date: April 29, 1974
Facility: Browns Ferry Nuclear Plant Unit 1

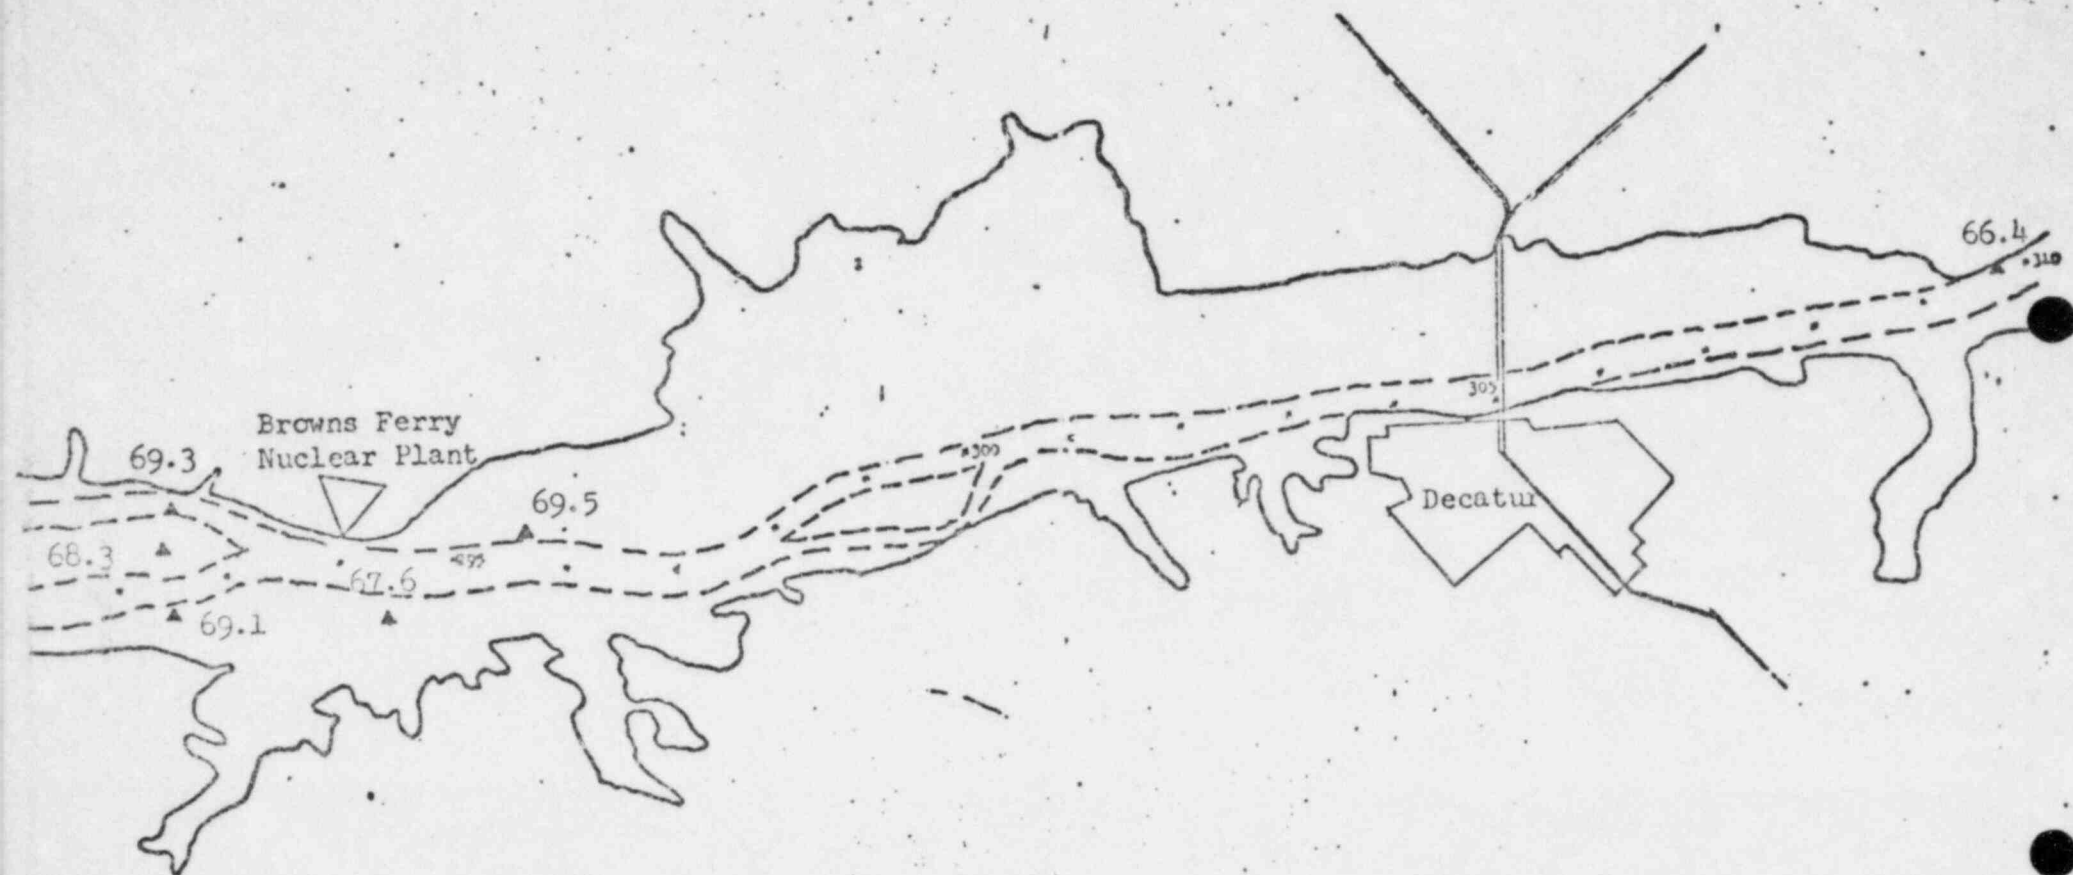
Time: 1400

The attached sketches show the variation of temperatures at the surface and at the 5-foot depth throughout the monitored reach of the river during the abnormal occurrence period. These sketches show a higher temperature rise between the two upstream thermistors than between any of the five thermistors in the immediate upstream and downstream vicinity of the plant.

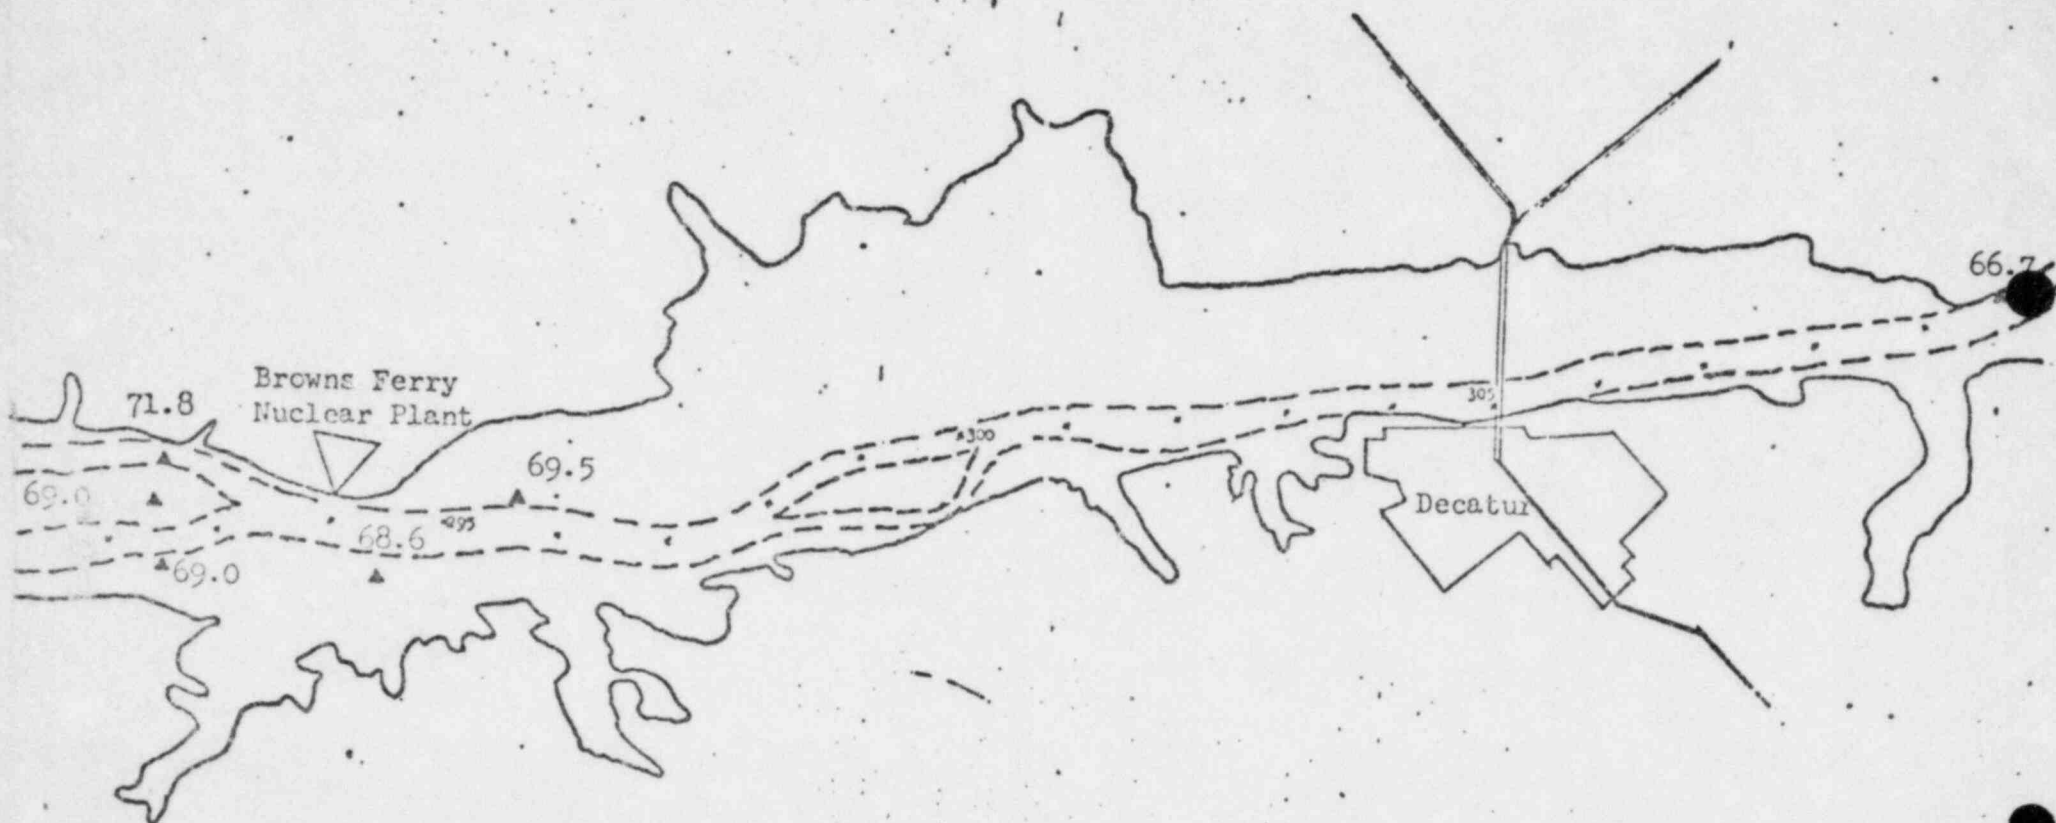
Time: 1600

The temperature difference between the upstream control thermistor at TRM 309.7 and the downstream thermistor at TRM 292.5, as displayed in the power plant control room, reached 5.3° F. at 4 p.m. The data printout from the monitoring stations at approximately the same time showed this difference to be 5.1° F.
