Jersey Central Power & Light Company

Subject: Oyster Creek Station
Docket No. 50-219
Reactor Coolant System Leakage

Subject: Abnormal Occurrence Report 73-14

Report No. 73-14

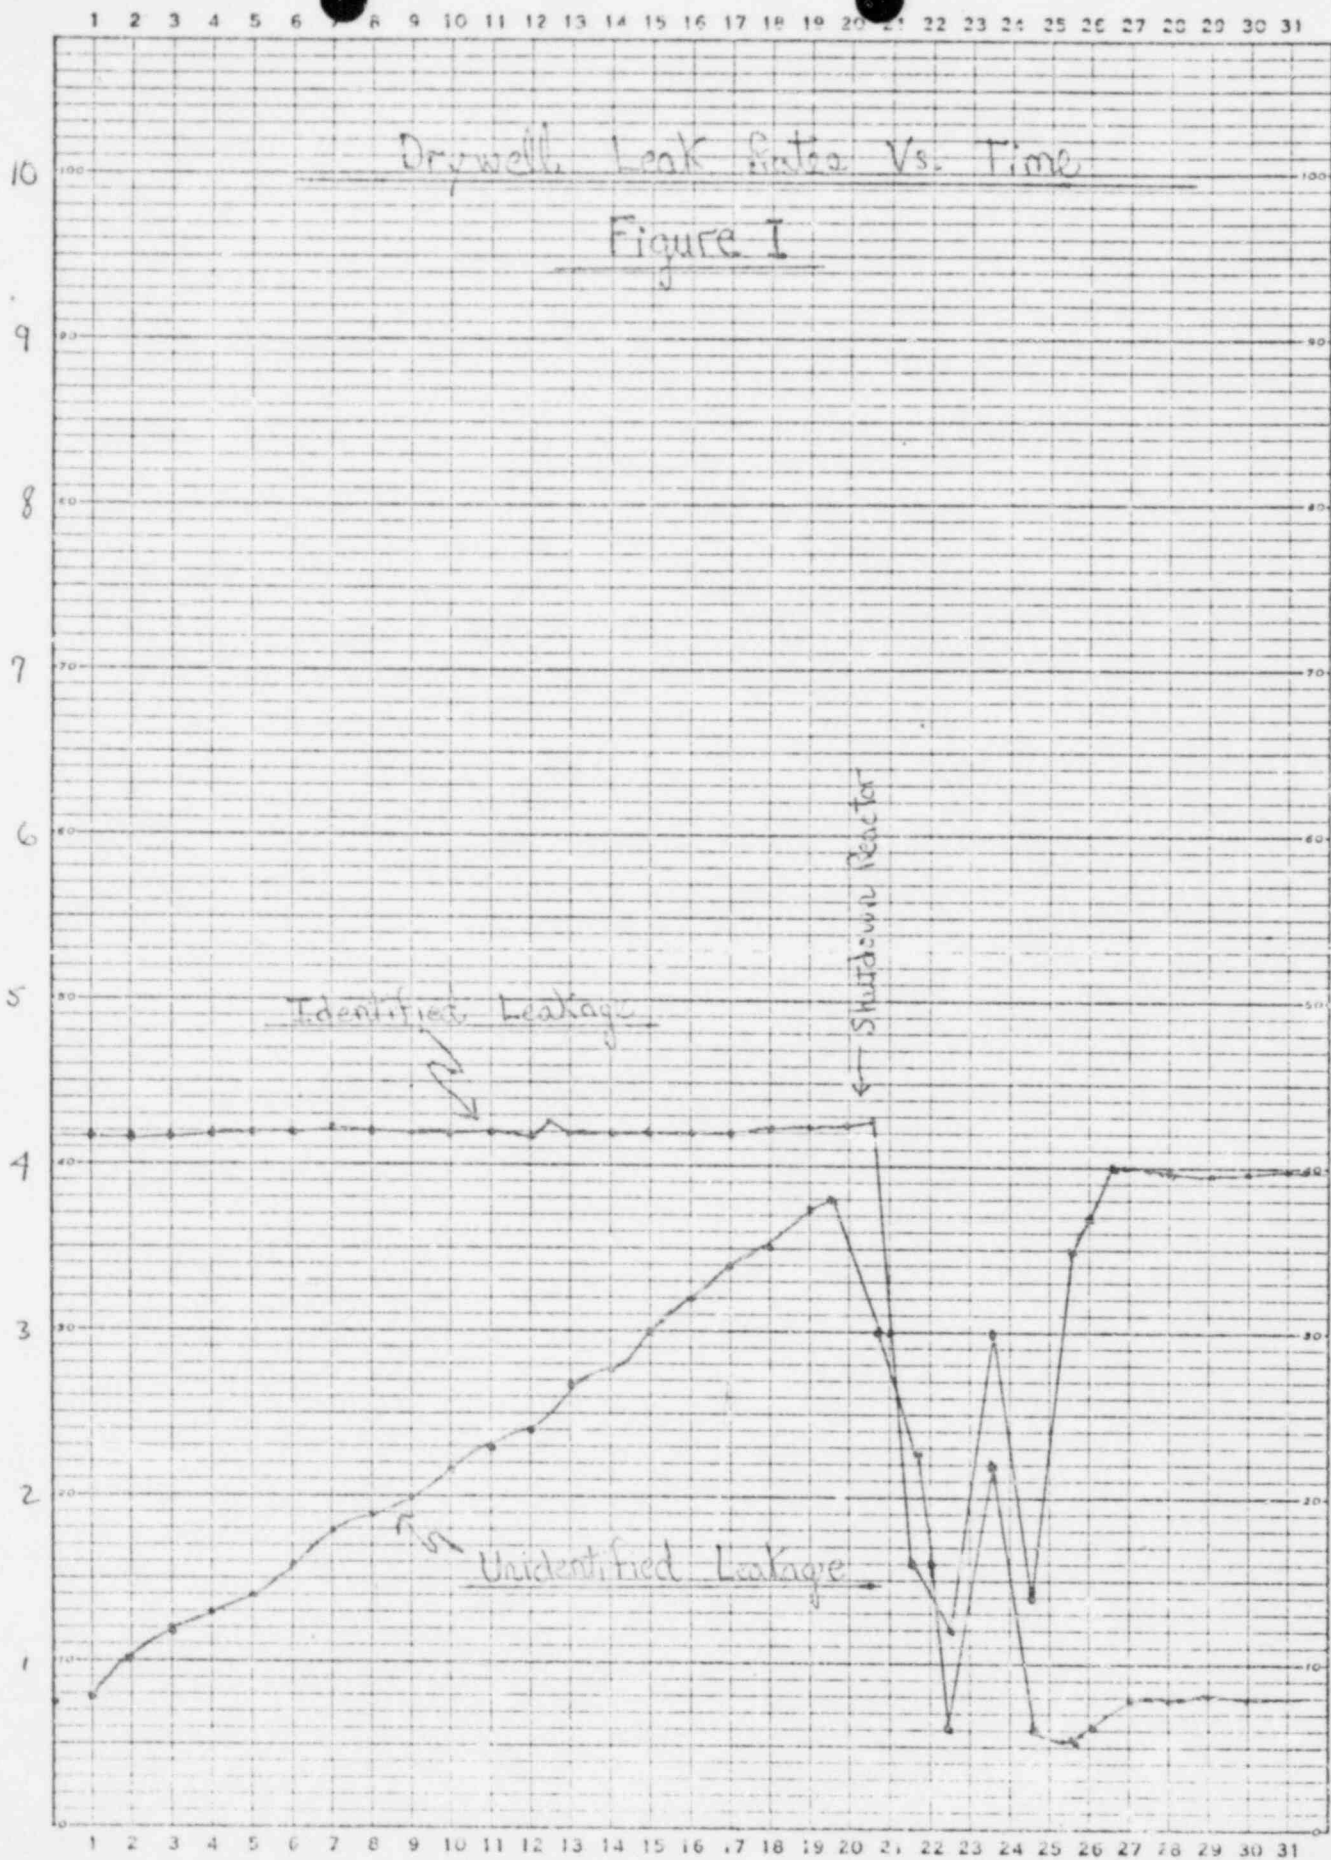
Figure III

As indicated in Figure 1, attached, an increasing rate of leakage into the drywell sump began to occur on July 1, 1973 and continued through July 19, 1973, reaching a peak of approximately 3.92 gpm when averaged over 24 hours. As shown in Figure 2, attached, a plot of absorption pool (torus) water level developed on July 23, 1973 over the same period indicated the level to be increasing starting about July 11, 1973. It is now estimated that the unexplained leak rate increased to >5.0 gpm at some time during July 17, 1973 and continued to be above the 5.0 gpm limit until the plant was shut down and depressurized on July 21, 1973.

Torus Level Vs. Time

- ① Removed ~400 gal. from torus.
- ② Removed additional ~400 gal. from torus.
- ③ Recalibrated torus level indicator indicating ~7 in. too high.
- ④ Removed ~3500 gal. from torus.

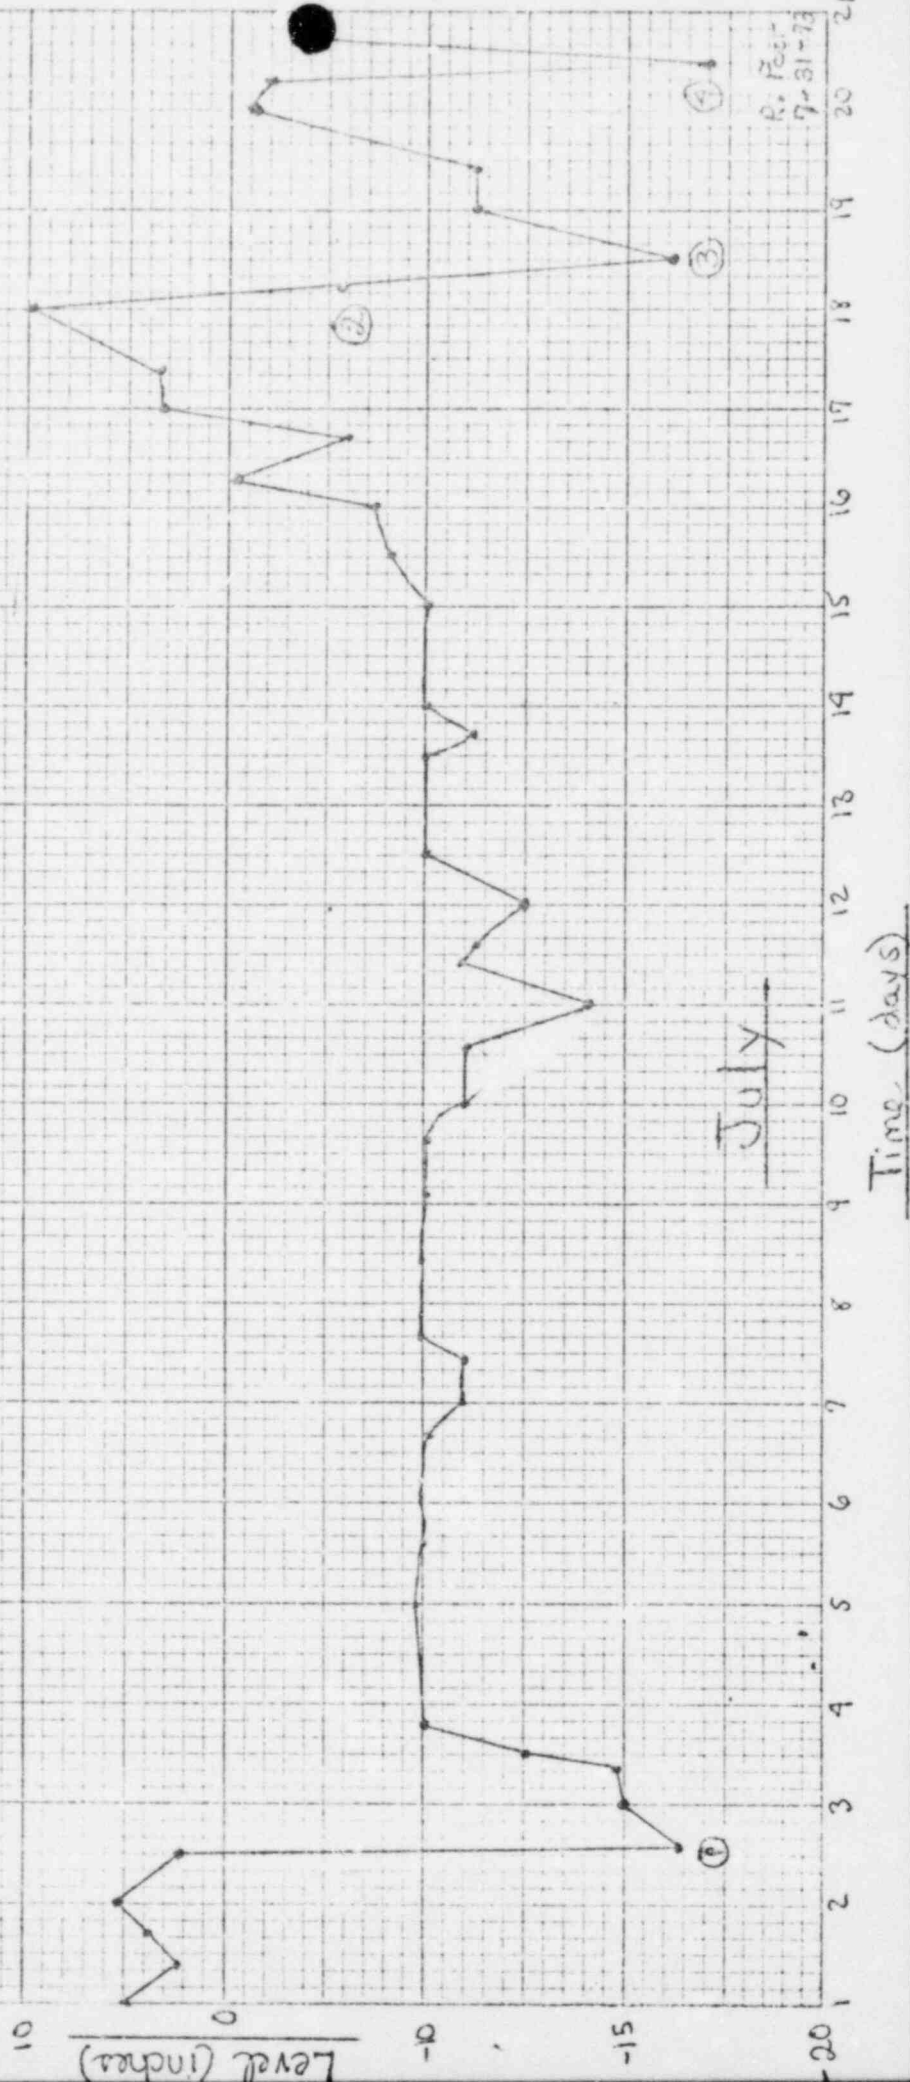
D.W. LEAK RATES IN GPM

As indicated in Figure 1, attached, an increasing rate of leakage into the Drywell Sump began to occur on July 1, 1973 and continued through July 19, 1973, reaching a peak of approximately 3.92 gpm when averaged over 24 hours. As shown in Figure 2, attached, a plot of Absorption Pool (Torus) water level developed on July 23, 1973 over the same period indicated the level to be increasing starting about July 11, 1973. It is now estimated that the unexplained leak rate increased to >5.0 gpm at some time during July 17, 1973 and continued to be above the 5.0 gpm limit until the plant was shutdown and depressurized on July 21, 1973.
