Commonwealth Edison Company
LaSalle Generating Station
2601 North 21st Road
Marseilles, IL 61341-9757
Tel 815-357-6761

Licensee Event Report #95-009-00, Docket #050-374 is being submitted to your office in accordance with 10CFR50.73(a)(2)(iv).

NRC FORM 366 (5-92)		U.S. NUCLEAR REGULATORY COMMISSION			APPROVED BY OMB NO. 3150-0104 EXPIRES 5/31/95			
LICENSEE EVENT REPORT (LER)								
FACILITY NAME (1) LaSalle County Station Unit 2					DOCKET NUMBER (2) 05000374		PAGE (3) 1 OF 6	
TITLE (4) High Pressure Core Spray (HPCS) Diesel Generator and HPCS Pump Initiation Due to Procedural Deficiency								
EVENT DATE (5)			LER NUMBER (6)			REPORT DATE (7)		
MONTH	DAY	YEAR	YEAR	SEQUENTIAL NUMBER	REVISION NUMBER	MONTH	DAY	YEAR
05	03	95	95	-- 009 --	00	06	02	95
						OTHER FACILITIES INVOLVED (8)		
						FACILITY NAME None		
						DOCKET NUMBER		
						FACILITY NAME		
						DOCKET NUMBER		
OPERATING MODE (9)		THIS REPORT IS SUBMITTED PURSUANT TO THE REQUIREMENTS OF 10 CFR §: (Check one or more) (11)						
N		20.2201(b)			20.2203(a)(3)(i)			50.73(a)(2)(iii)

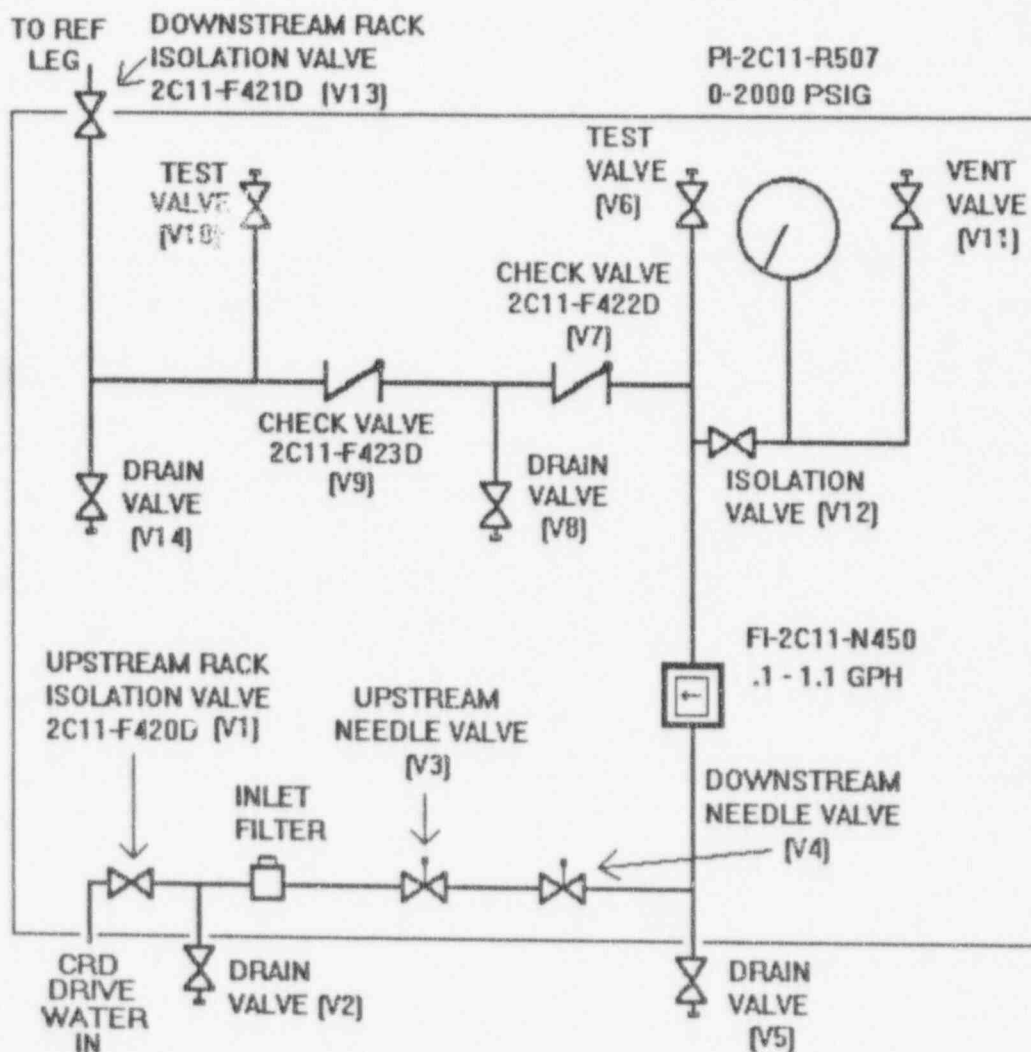
ATTACHMENT A
CONTINUOUS BACKFILL PANEL LAYOUT

LaSalle Station had experienced recurring problems with physical damage to needle valves when they were used to isolate the backfill panels. In response to these problems, the associated procedures were revised in February 1995, to specify a valving sequence to isolate and return to service the backfill panel without having to manually torque the needle valves (V3) and (V4) in the closed direction. (Refer to attached diagram for simplified piping diagram and valve numbers). The procedure revision prescribed steps to carefully establish backfill system pressure slightly above reactor pressure by positioning the downstream needle valve (V4) one turn in the open direction from the fully closed position and manipulating the upstream rack isolation valve (V1), the test valve (V10), and the downstream rack isolation valve (V13).

The procedure erroneously excluded the steps to establish backfill pressure slightly above reactor pressure when returning the backfill panel to service from conditions with reactor pressure at zero psig. The valving sequence specified for the zero reactor pressure condition, opened the downstream rack isolation valve (V13) and the upstream rack isolation valve (V1) with both needle valves (V3 and V4) full open. This resulted in a pressure transient in the instrument reference leg because the Control Rod Drive (CRD) system pressure which supplies the backfill panel is approximately 250 psi greater than reactor pressure.

For extended reactor shutdown periods, the continuous backfill panels are shutdown and depressurized. At the time of this event, reactor vessel pressure was at zero psig. The downstream rack isolation valve of the continuous backfill panel was opened in accordance with the procedure. The valving manipulation resulted in a flow surge in the instrument reference leg due to the differential pressure between the backfill supply and the instrument reference leg. This rapidly changing pressure condition was sensed by the differential pressure transmitters as rapidly decreasing reactor water level. By design, the trip logic cards associated with these differential pressure transmitters responded and initiated their protective functions. The IM Technician recognized the transient and quickly reclosed the downstream rack isolation valve.

There are six continuous backfill panels per unit with an individual procedure for each. To date, the six procedures associated with Unit 2 have been revised to reflect the correct valve sequencing. Each has been successfully performed subsequent to the procedure revision.
