Commonwealth Edison
Quad-Cities Generating Station
Post Office Box 216
Cordova, Illinois 61242
Telephone 309/654-2241

Reference: Quad-Cities Nuclear Power Station, Unit 1
Docket No. 50-254, DPR-29, Appendix A
Sections 1.0.A.4, 6.6.B.1.a

The purpose of this letter is to inform you of the details of the findings from jet pump inspections performed on Quad-Cities Unit 1. Initial inspections were completed on April 15, 1974. The initial findings were discussed with Region III Regulatory Operations personnel on April 16, 1974 and were reported to you and to the Region III Directorate of Regulatory Operations by telegram that same day. On April 24, 1974 the findings and plans to date were discussed with Commission personnel at the station.

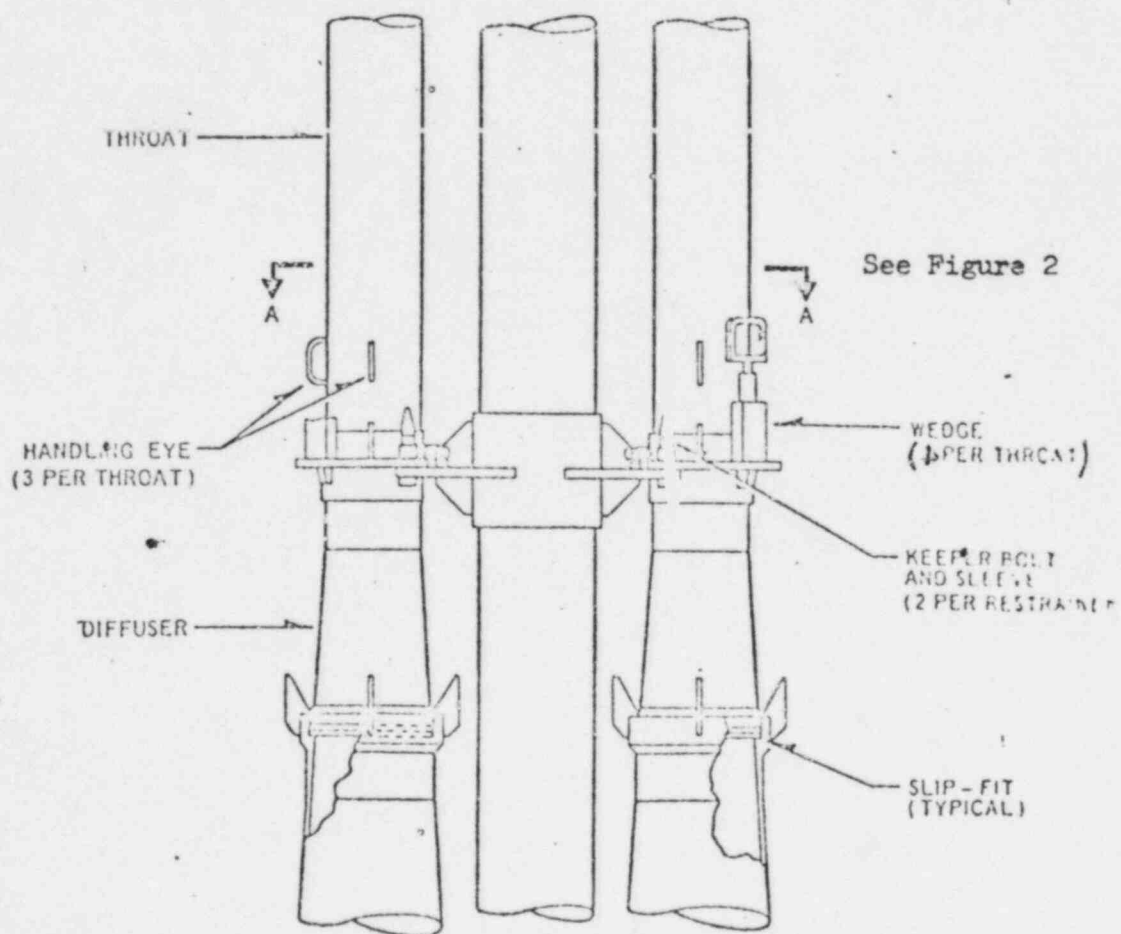
Jet Pump Figure 1

- 1) While applying up to 200 ft-lbs. of torque to the beam bolts, movement was detected on three bolt assemblies, namely numbers 10, 13, and 16. They thus failed the test.
- 2) Three restrainer gate bolts and keepers were found to be completely sheared and missing. Two of these were from jet pump 5; one was from jet pump 6.
- 3) Thirty of thirty-seven remaining restrainer bolt keeper welds were found to be either missing or cracked.
- 4) The restrainer gate wedge on jet pump 5 was missing.
- 5) The restrainer gate on jet pump 18 showed signs of wear in the vicinity of the wedge indicating possible vertical movement of the wedge prior to the inspection.

The cause of the failed restrainer gate bolt keeper tack welds and the apparent lack of preload on the beam bolts is presently being attributed to construction and installation deficiencies. The apparent cause of the failed restrainer bolts and the missing and possibly moved restrainer gate wedge is probably excessive vibration as a result of the deficient installation.

All beam bolts (20) for the twenty jet pumps will be completely detensioned and then retensioned. The procedure to be used will be one previously used at Quad-Cities Station for jet pump repairs but modified from the tensioning procedure used for the original installation. The modified procedure includes observing the beam bolt for rotation while being tensioned. The retensioned beam bolts will then be rewelded with two tacks per bolt.
