BRUNSWICK STEAM ELECTRIC PLANT, UNIT NO. 1
DOCKET NO. 50-325/LICENSE NO. DPR-71
RESPONSE TO NRC BULLETIN 80-13
EXAMINATION OF CORE SPRAY SYSTEM SPARGERS

BRUNSWICK STEAM ELECTRIC PLANT, UNIT NO. 1
DOCKET NO. 50-325
LICENSE NO. DPR-71
RESPONSE TO NRC BULLETIN 80-13
EXAMINATION OF CORE SPRAY SYSTEM SPARGERS

UNIT 1 CORE SPRAY PIPING EVALUATION
BASED ON B110R1 IVVI EXAMINATION RESULTS

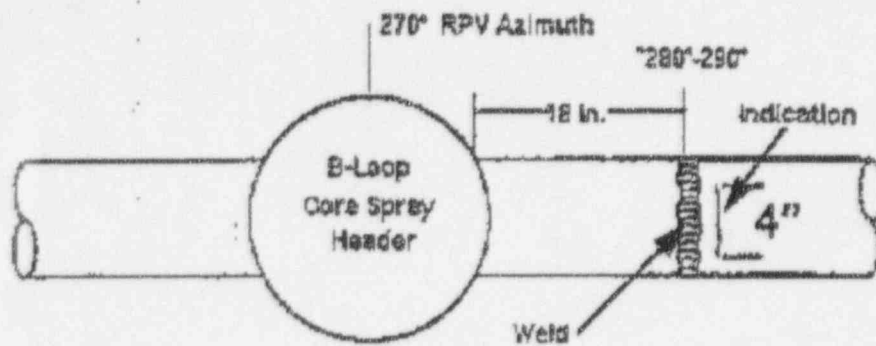
Figure 1: Location of B-Loop Core Spray Piping Indication

BFO B109R1: During BNP-1 Refueling Outage #8 IVVI inspections, two cracks were discovered in the Core Spray B-loop piping. One crack (*Crack A* for the purposes of this report) was in the heat affected zone (HAZ) of a circumferential weld located approximately 18 inches downstream of the B-loop tee-box on the 5" (NPS) invessel piping. This crack was judged to be approximately 4 inches in length. Another crack (*Crack B* for the purposes of this report) was discovered in the HAZ of a tee-to-sparger arm circumferential

ATTRIBUTE	CRACK A	CRACK B
Crack Length from RFO B109R1 IVVI	Approx 4"	Approx 3"
Estimated End Of Cycle Crack Length from Reference 3.3 (RFO B110R1)	$\leq 5.2"$	$\leq 4.1"$
Crack Length from RFO B110R1 IVVI	Approx 4.2"	Approx 3.2"
Estimated Crack Growth per Operating Cycle (from IVVI Data)	Approx 0.2"	Approx 0.2"

ATTRIBUTE	CRACK A	CRACK B
Maximum Evaluated Crack Length From Leakage Analysis ¹	Approx 8.3"	Approx 5.9"
Maximum Permitted Crack Length Based on Structural Analysis (Net Section Collapse Evaluation)	Approx 11.1" (240°)	Approx 7.2" (220°)
Length Data from RFO B110R1 IVVI	Approx 4.2"	Approx 3.2"
Estimated Crack Growth Rate per Operating Cycle from IVVI Data	Approx 0.2"	Approx 0.2"
Postulated Crack Length at End of Operating Cycle #10	Approx 4.4"	Approx 3.4"

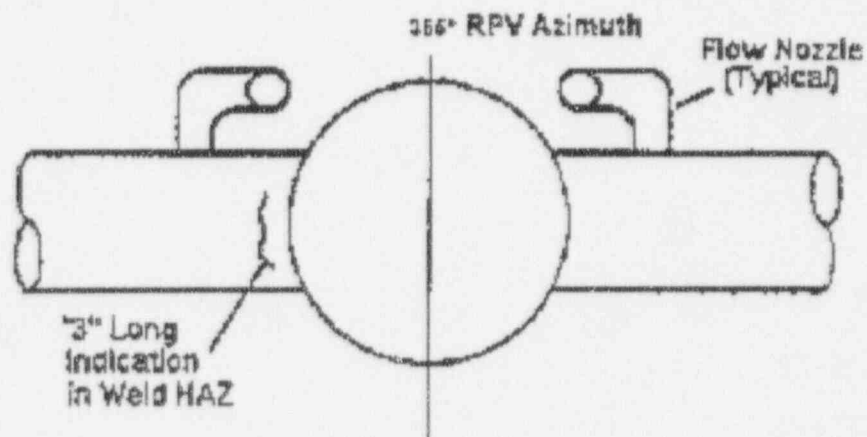
Figure 2: Location of B-Loop Core Spray Sparger Indication

weld on one of the lower B-loop spargers (3½" NPS) and was judged to be approximately 3 inches in length. This condition was evaluated by General Electric (GE) in report GE-NE-523-97-0793 (Reference 3.3), in terms of four relevant issues. The issues and conclusions are summarized in Table 1.
