**EXAMINATION OF
CRYSTAL RIVER-3 PULLED
STEAM GENERATOR TUBES
FINAL REPORT**

**Submitted by:
Florida Power Corporation**

May 31, 1995

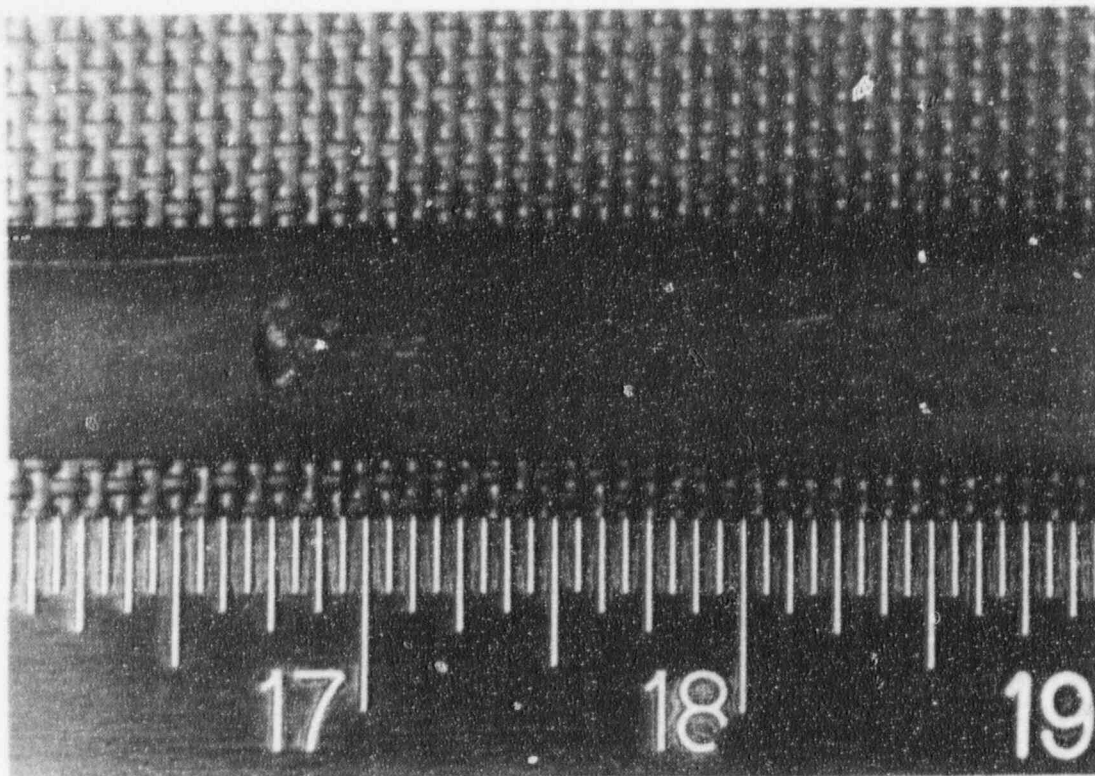
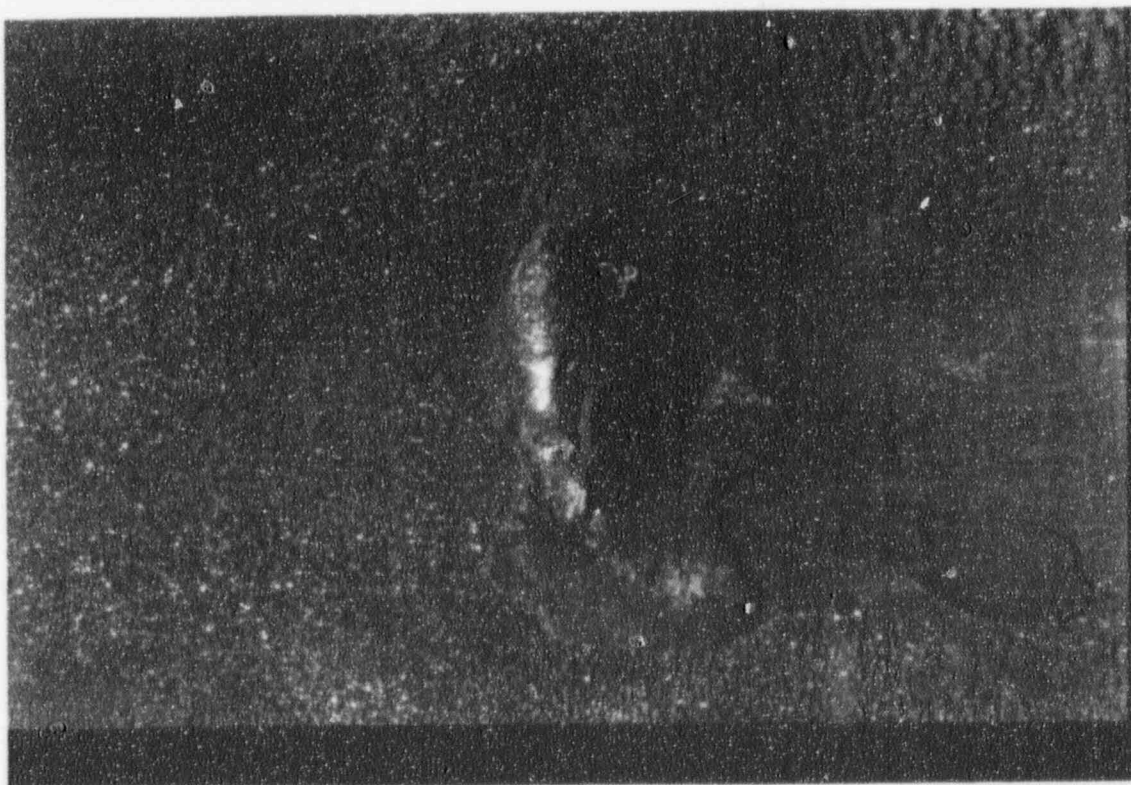
- At the 7th TSP, circular or "D"-shaped wear marks were observed at the bottom edge of the lands on all four pulled tubes. Figure 2-1 is an example of this type of defect.

The wear marks observed at the tube support plate edges appear to be simple mechanical wear. No conclusive evidence of corrosion was found associated with these defects.

Tube Section 136-26-15
Wear Mark at 7th TSP

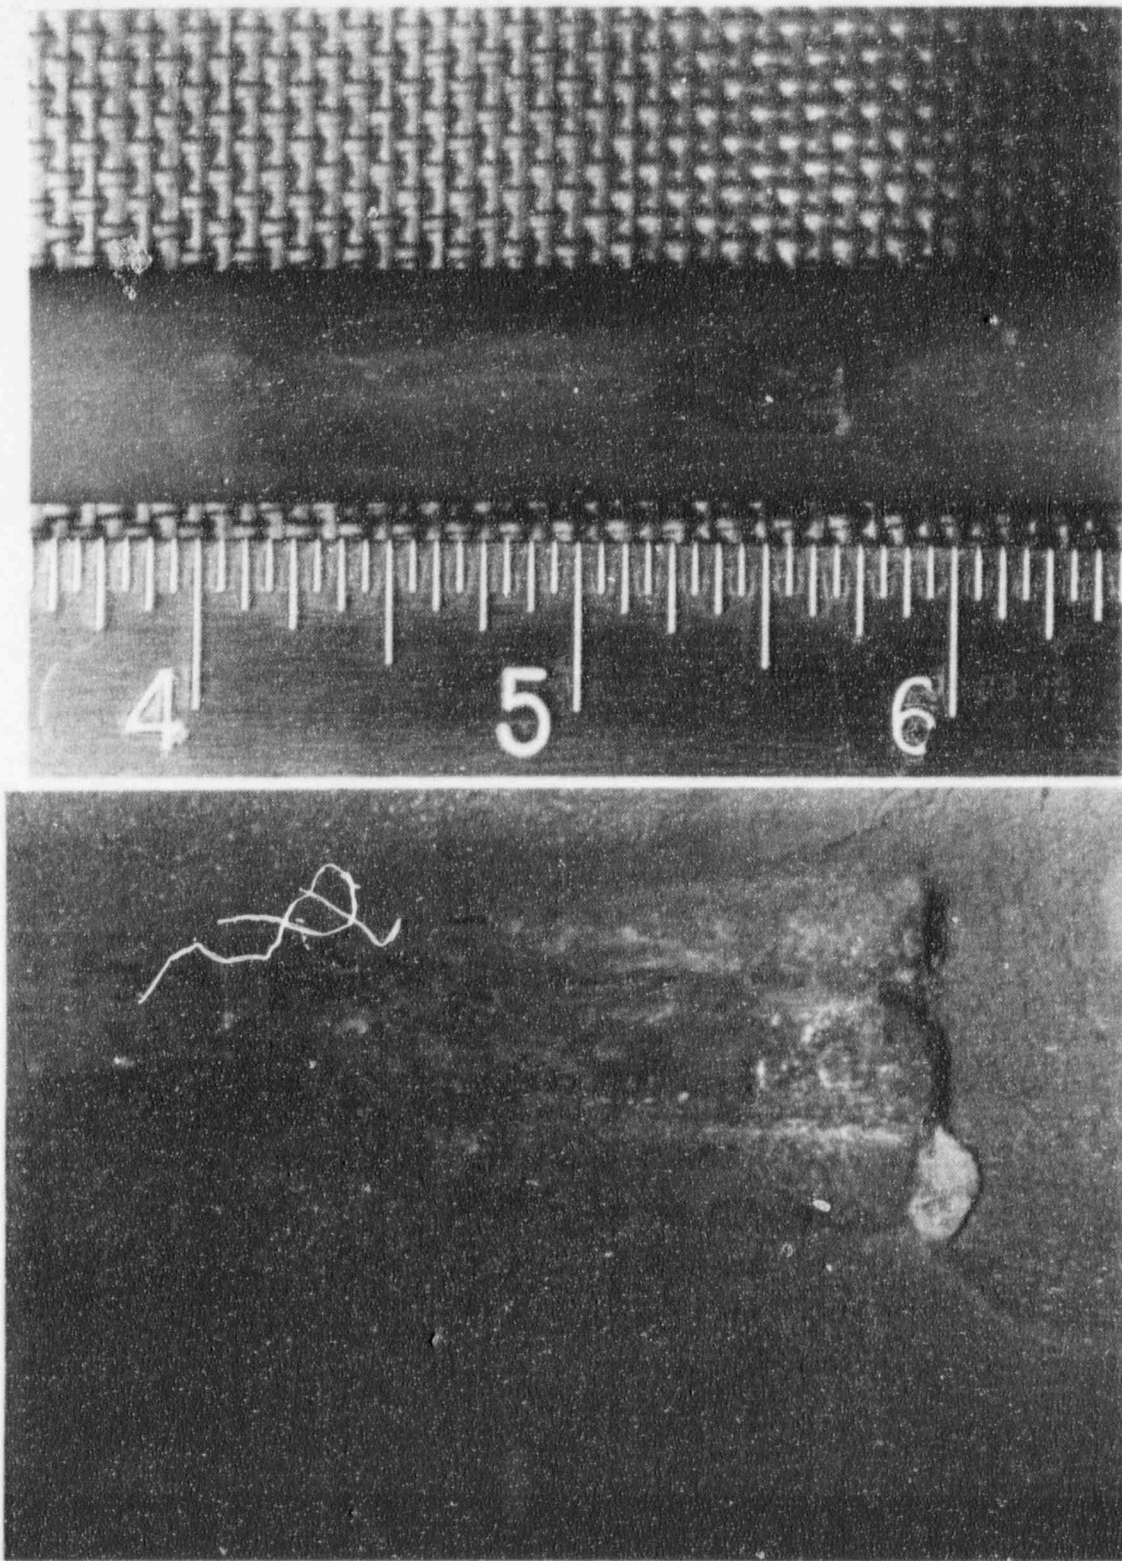
Figure 2-2

- At the 9th TSP, "tapered" wear marks (see Figure 2-2) were observed at the top edge of one TSP land and the bottom edge of a second, adjacent TSP land. These marks were axial in orientation and deepest at the edge of the support plates.

Four (4) tapered wear scars present on two tubes pulled in 1994 were examined in the laboratory. The maximum depth observed in any of the scars was less than 20% through wall. The lengths of the scars were up to 0.64 inch. All four tapered wear scars were detected by both bobbin coil and MRPC eddy current inspection.

Tube Section 68-46-18
Tapered Wear Mark at 9th TSP

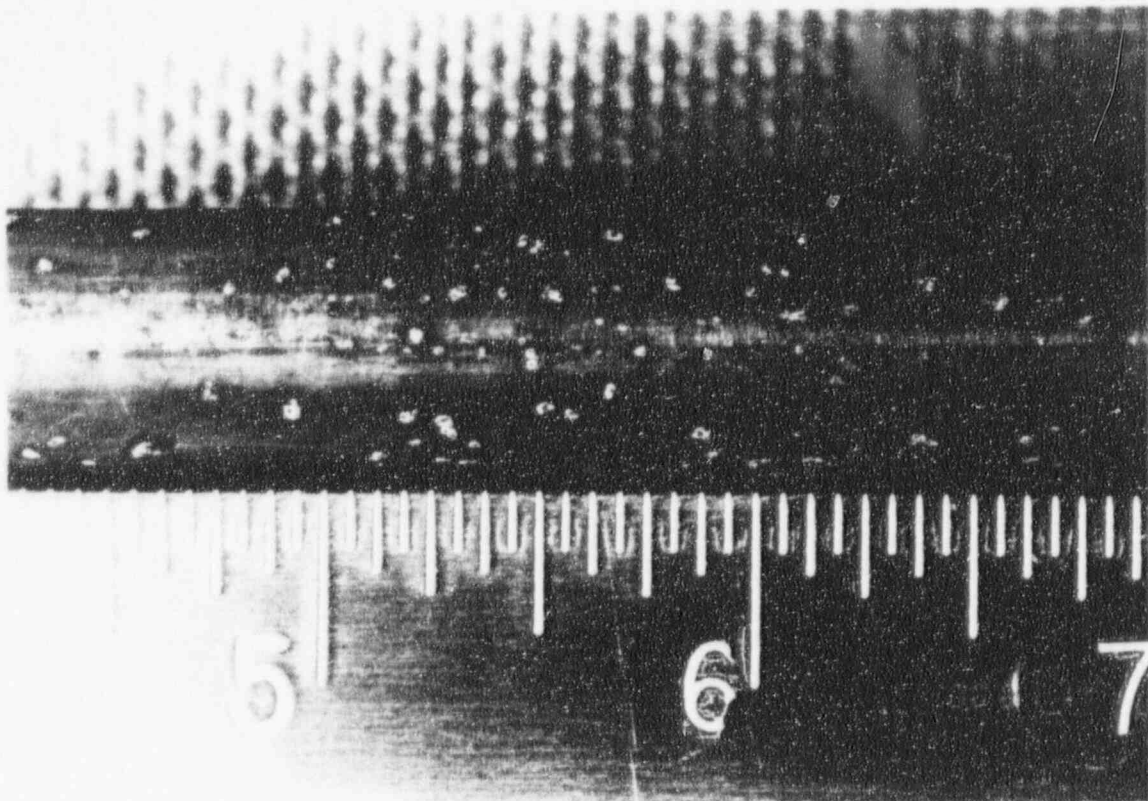
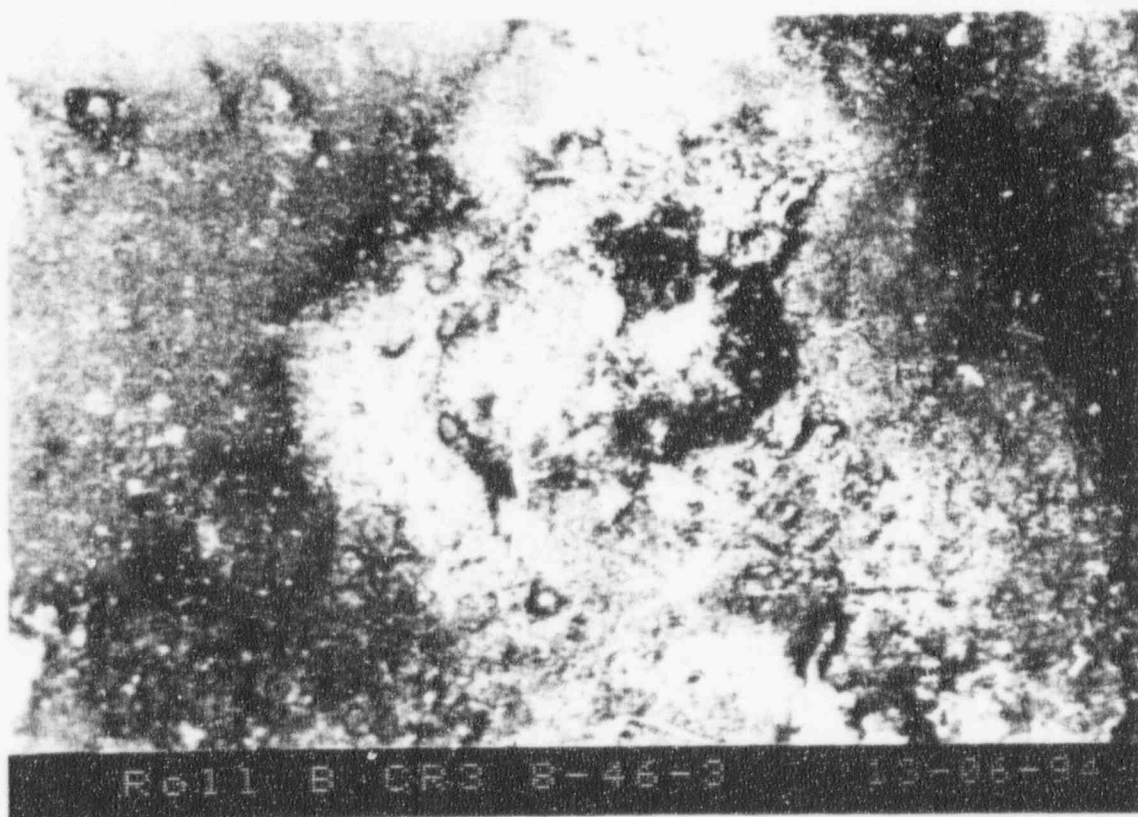
Figure 2-3
2-11

4. Spots of yellow deposit "nodules", as shown in Figure 2-3, were observed, most predominantly within the lower tubesheet crevice regions and first (lowermost) tube span of tubes 68-46 and 72-49. Streaks of white deposit were also observed in the upper elevations (Figure 2-4) on all four 1994 pulled tubes.

In the lower tubesheet crevice regions, which are relatively free of deposit, yellow deposit nodules (Figure 2-3) were observed. EDS/WDS analysis confirmed that this deposit is elemental sulfur.

YELLOW DEPOSIT IN LOWER TUBESHEET CREVICE

The elemental sulfur deposits observed in the first tube span and within the lower tubesheet crevices may or may not be associated with the intergranular defects. Elemental sulfur is not in the right oxidation state to initiate IGA; although changing environmental conditions during startup, shutdown, and layup could create conditions which could make the sulfur aggressive. Since there is not a direct correlation of the IGA patches with the spots of yellow deposit, it is concluded that the yellow sulfur deposits do not pose a significant corrosion risk.

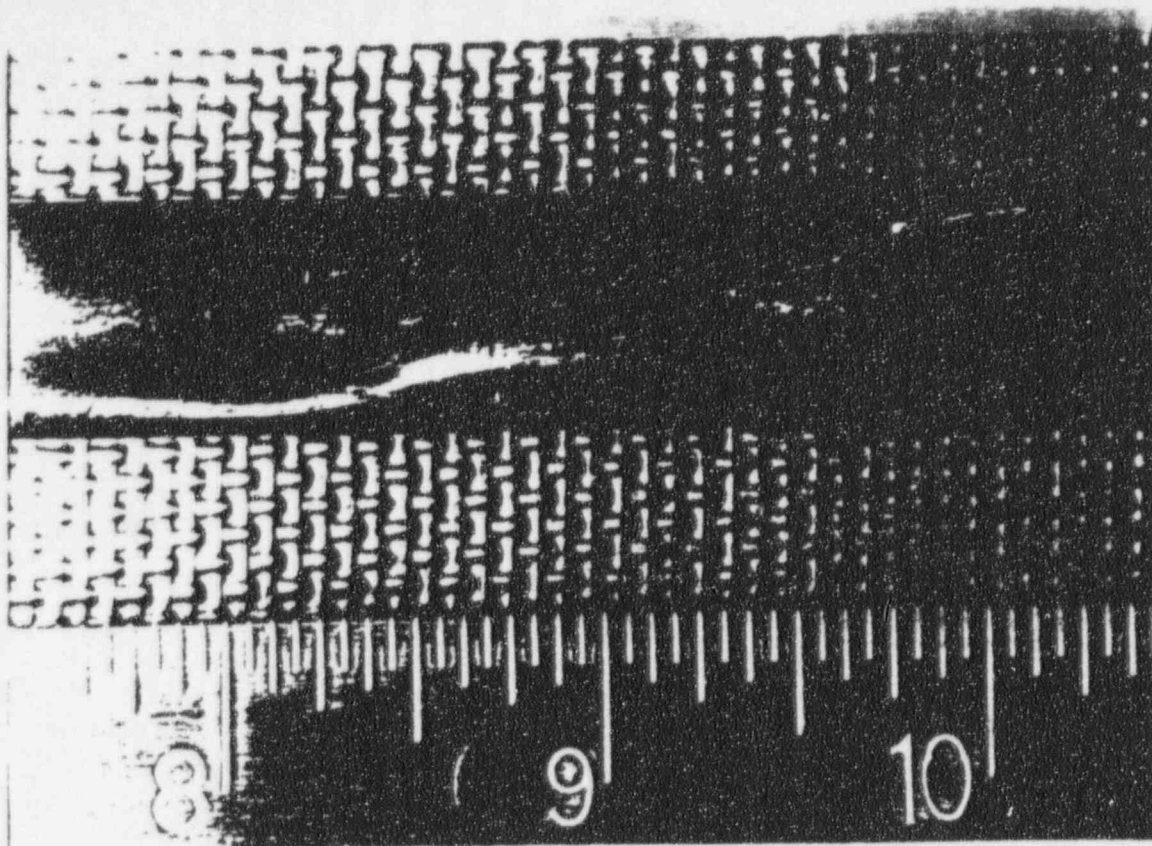
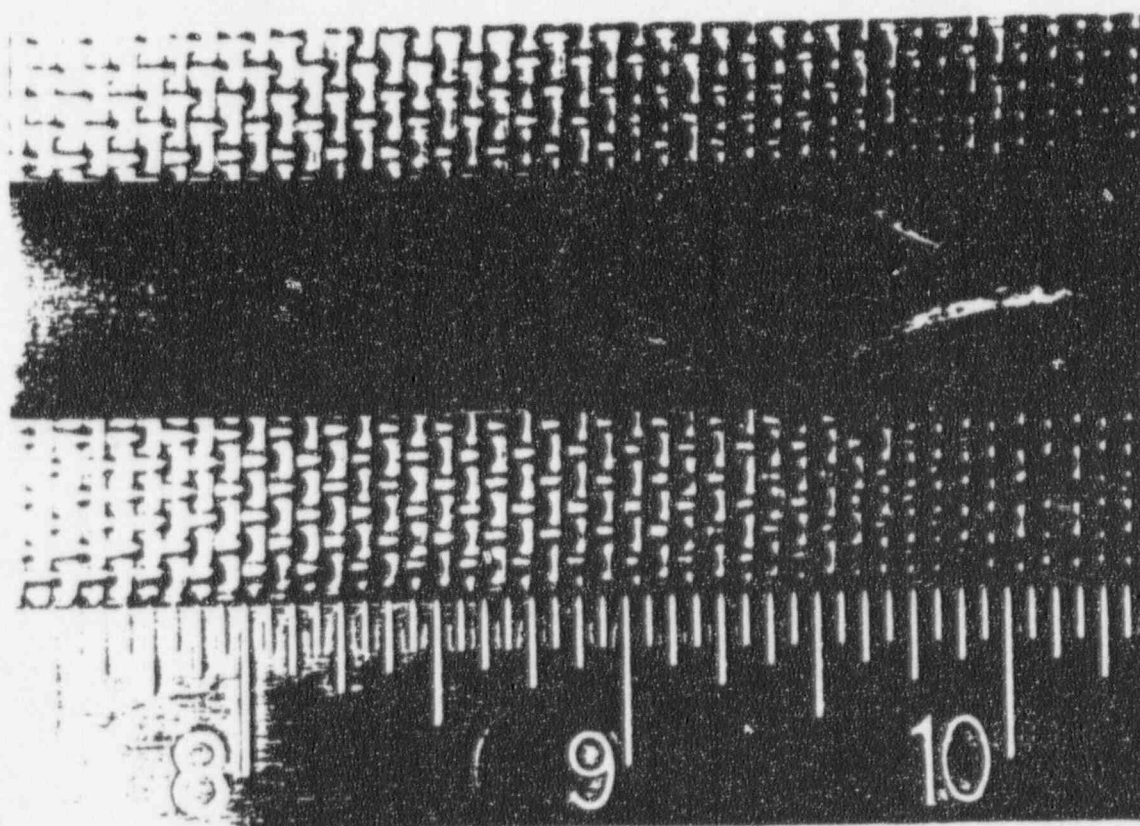
Figure 2-4

In the upper elevations, white streaks of deposit were observed. Scanning electron microscope (SEM)/EDS/WDS analysis suggests that this deposit is thin, relatively fine-grained and rich in manganese and other hardness contaminants. The thin streaks are deposited on top of the magnetite deposits on the tube.

TYPICAL STREAK OF WHITE DEPOSIT AT TSP (TUBE 68-46-20)

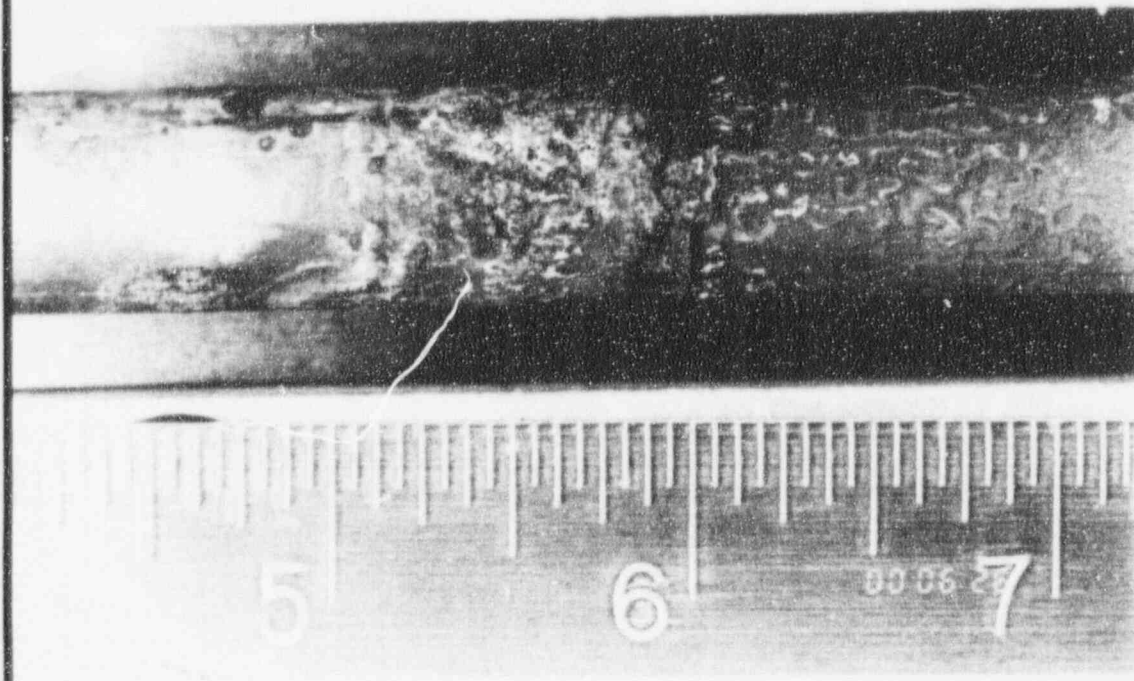
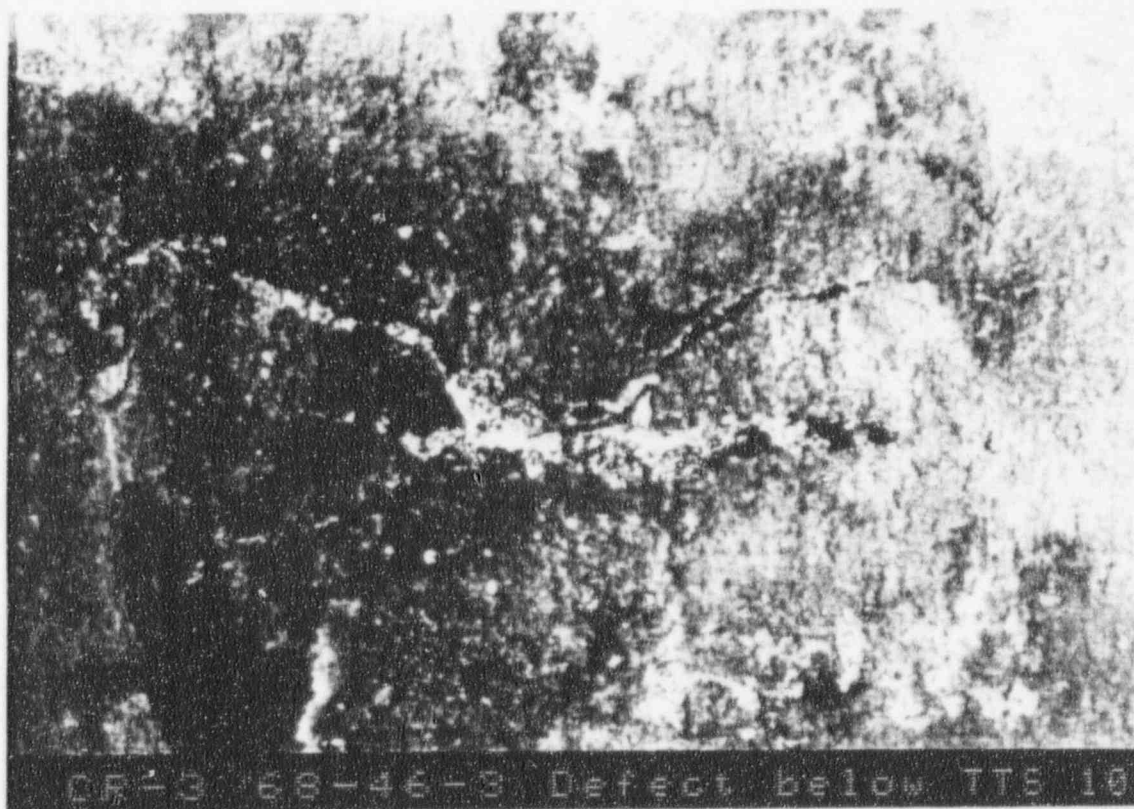
During expansion of a section of tube number 68-46 from the lower tubesheet region for collecting deposits, a leak developed at ~6914 psi at an elevation ~0.6 inch below the secondary face of the tubesheet. The tube was then shimmed and the actual burst pressure per EPRI guidelines was obtained, as shown in Table 2-2. The IGA patch at which rupture occurred (see Figure 2-5) was about 0.23" in length (axial) and ~70% through wall. Its location corresponded to large amplitude volumetric indications found during laboratory eddy current inspection by both bobbin and RPC. This large amplitude signal condition was not observed during field examinations where instead a small amplitude low signal-to-noise ratio was observed. The increase in voltage observed in the laboratory exam is due, presumably, to trauma experienced by the tube during removal operations (cutting, pulling, shipping, etc.). Metallography determined the degradation to be similar to the pit-like IGA that was present in the first span and lower tubesheet region of tubes pulled in 1992, although the axial

INTERGRANULAR DEFECT ~ 1/2-IN. BELOW TTS (TUBE 68-46-3)

Figure 2-5. Tube 68-46-3 After Swelling to Remove Deposits.

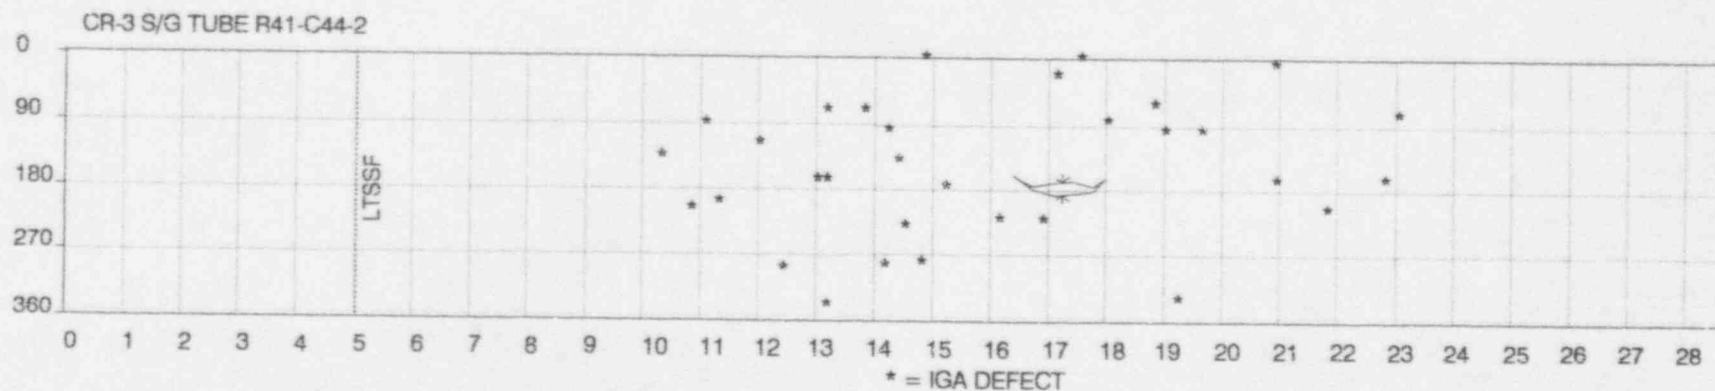
Figure 2-6
2-14

For archived tube number 41-44, a total of 33 patches of pit-like IGA were found in the first span section, in a band from 5 to 19 inches above the secondary face of the lower tubesheet (Figure 2-6). Typically, these patches were ~30% through wall and similar in size to those seen in the other tube sections removed in 1992. Burst occurred at a defect ~50% through wall. The location and morphology of these defects are identical to those found in other tubes removed from Crystal River-3 in 1992.

Tube Section 41-44-2
Map of discovered small IGA patches
