U. S. NUCLEAR REGULATORY COMMISSION
REGION I

Report No. 50-354/95-05

Facility: Hope Creek Nuclear Generating Station

Inspection Summary: This inspection was a special reactive safety inspection conducted to review the circumstances surrounding, and licensee actions and evaluations associated with an unplanned release of radioactive material from the Hope Creek Station south plant vent which occurred on the early morning hours of April 5, 1995.

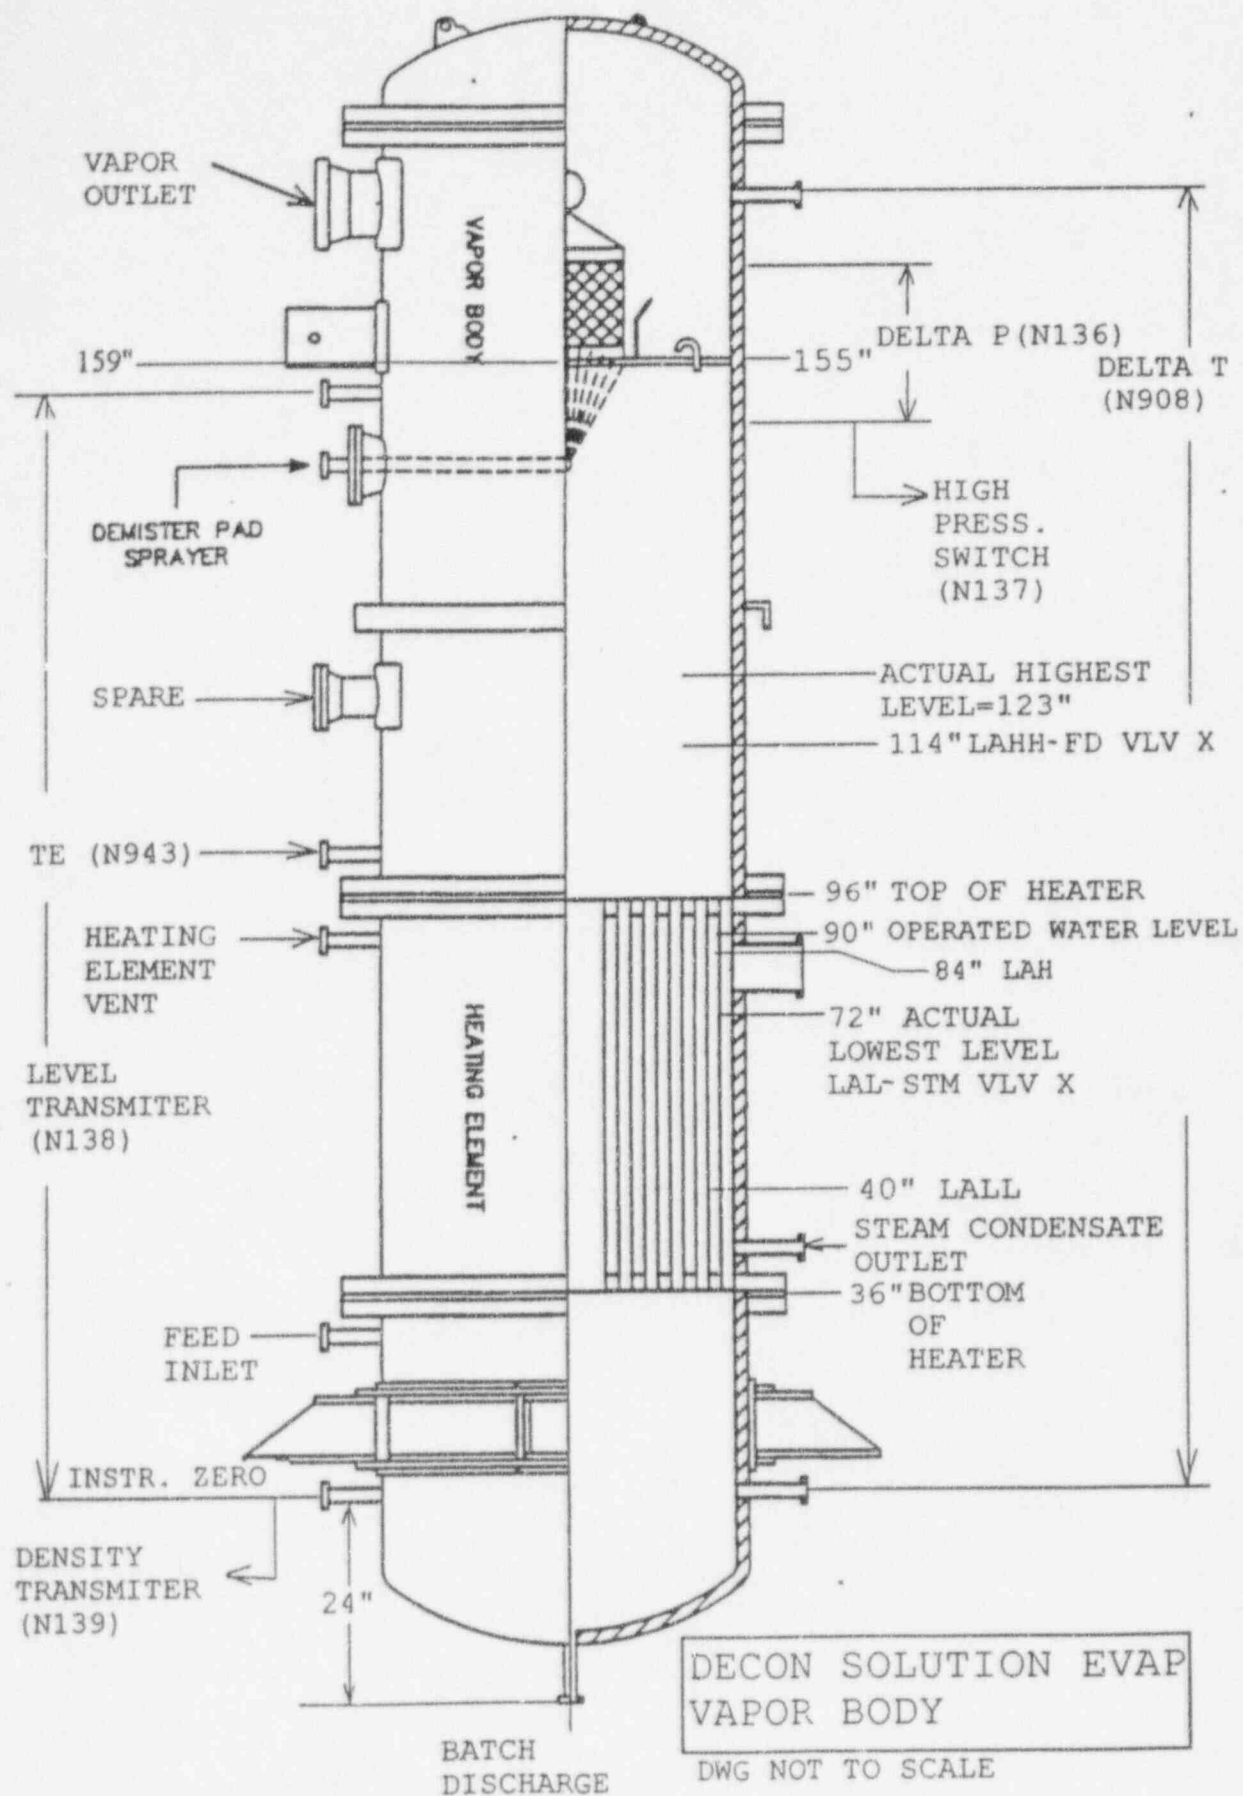
Attachment 4. Schematic of Decontamination Solution Evaporator

The prolonged spraying of the demister, combined with a continuous supply of heating steam to the evaporator, caused a buildup of steam in the vapor body of the DSE. This resulted in an increased evaporator pressure that was suddenly relieved when the spray flow was secured. Unknown to the operator, the depressurization caused a momentary high steam flow condition in the six-inch diameter DSE evaporator effluent exhaust pipe that ejected approximately 43 and 15 gallons on two occasions of a water and steam mixture to the south plant vent (SPV). Portions of the steam and water mixture (an estimated 25 gallons) was released to the environment from the SPV, while the remainder was deposited in the SPV duct work on the 155' elevation of the services radwaste (SRW) building.

Ultimately the RCA team attributed the cause of the event to a design problem. Specifically, steam vapor leaving the DSE discharged directly into the SPV without any condensing or filtering unit. This allowed two short duration releases of a steam/water mixture (approximately 58 gallons total) to exit undetected from the DSE effluent vent pipe to the SPV after a high differential pressure condition inside the DSE was relieved by prolonged spraying of an internal demister element.

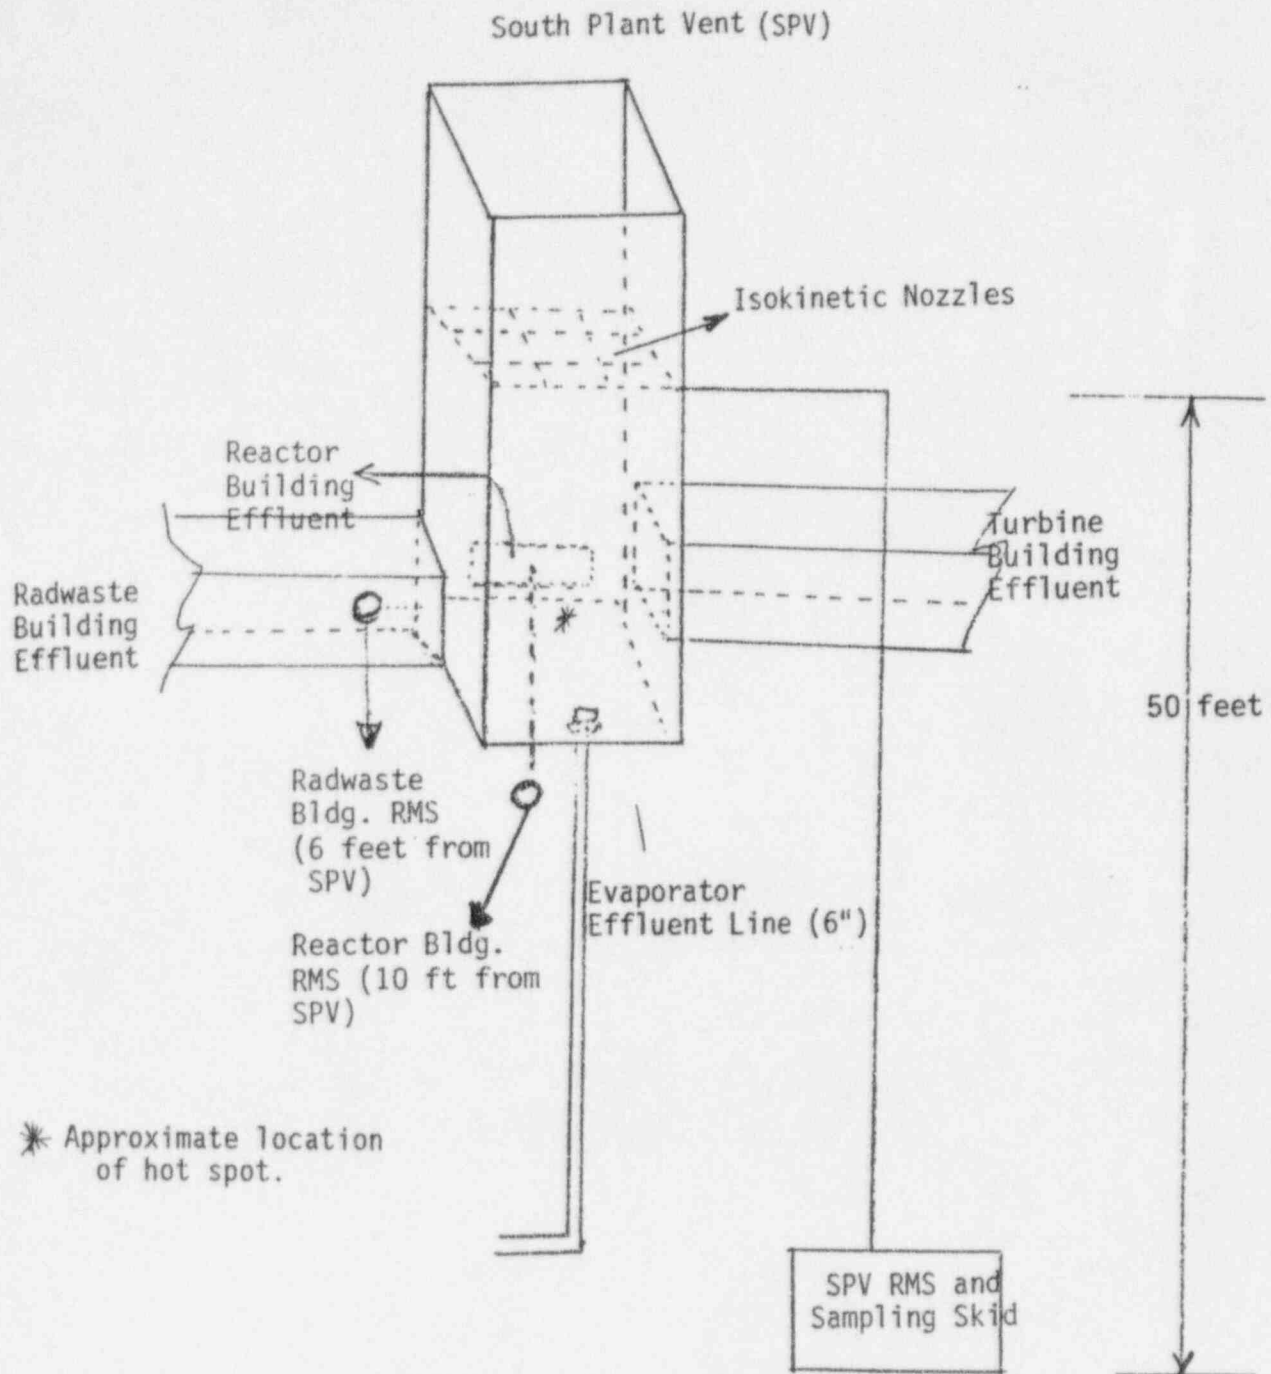
Attachment 5. General Arrangement of Duct Work Affected by Release

The radioactive liquid in the SPV duct work caused a limited increase in general area radiation levels, which were detected by three radiation monitors in the area. Two of the radiation monitors, on the reactor building ventilation system exhaust (RBVSE) and the radwaste area exhaust (RWE), alarmed at about 12:30 a.m. Both monitors indicated two distinct increases in radiation levels occurring approximately 7 minutes after each of the two prolonged sprays of the DSE demister. Increased radiation levels were also indicated on the filtered ventilation recirculation system (FRVS) area radiation monitor (ARM), but no alarm was received on this monitor due to the low radiation levels detected by this ARM. There were no increases in radiation levels detected by the SPV effluent monitor. Attachment 5 depicts the general arrangement of the duct work and radiation detectors affected by the release.

The senior nuclear shift supervisor (SNSS), the work control supervisor, an instrumentation and controls (I&C) technician, and two RP technicians (technicians A and B) went to the area of the alarms to investigate the cause of the alarms. They identified a hot spot in the SPV duct work that measured approximately 120 mR/hr on contact and 15 mR/hr at approximately one foot. (See Attachment 5 for location of hot spot.)

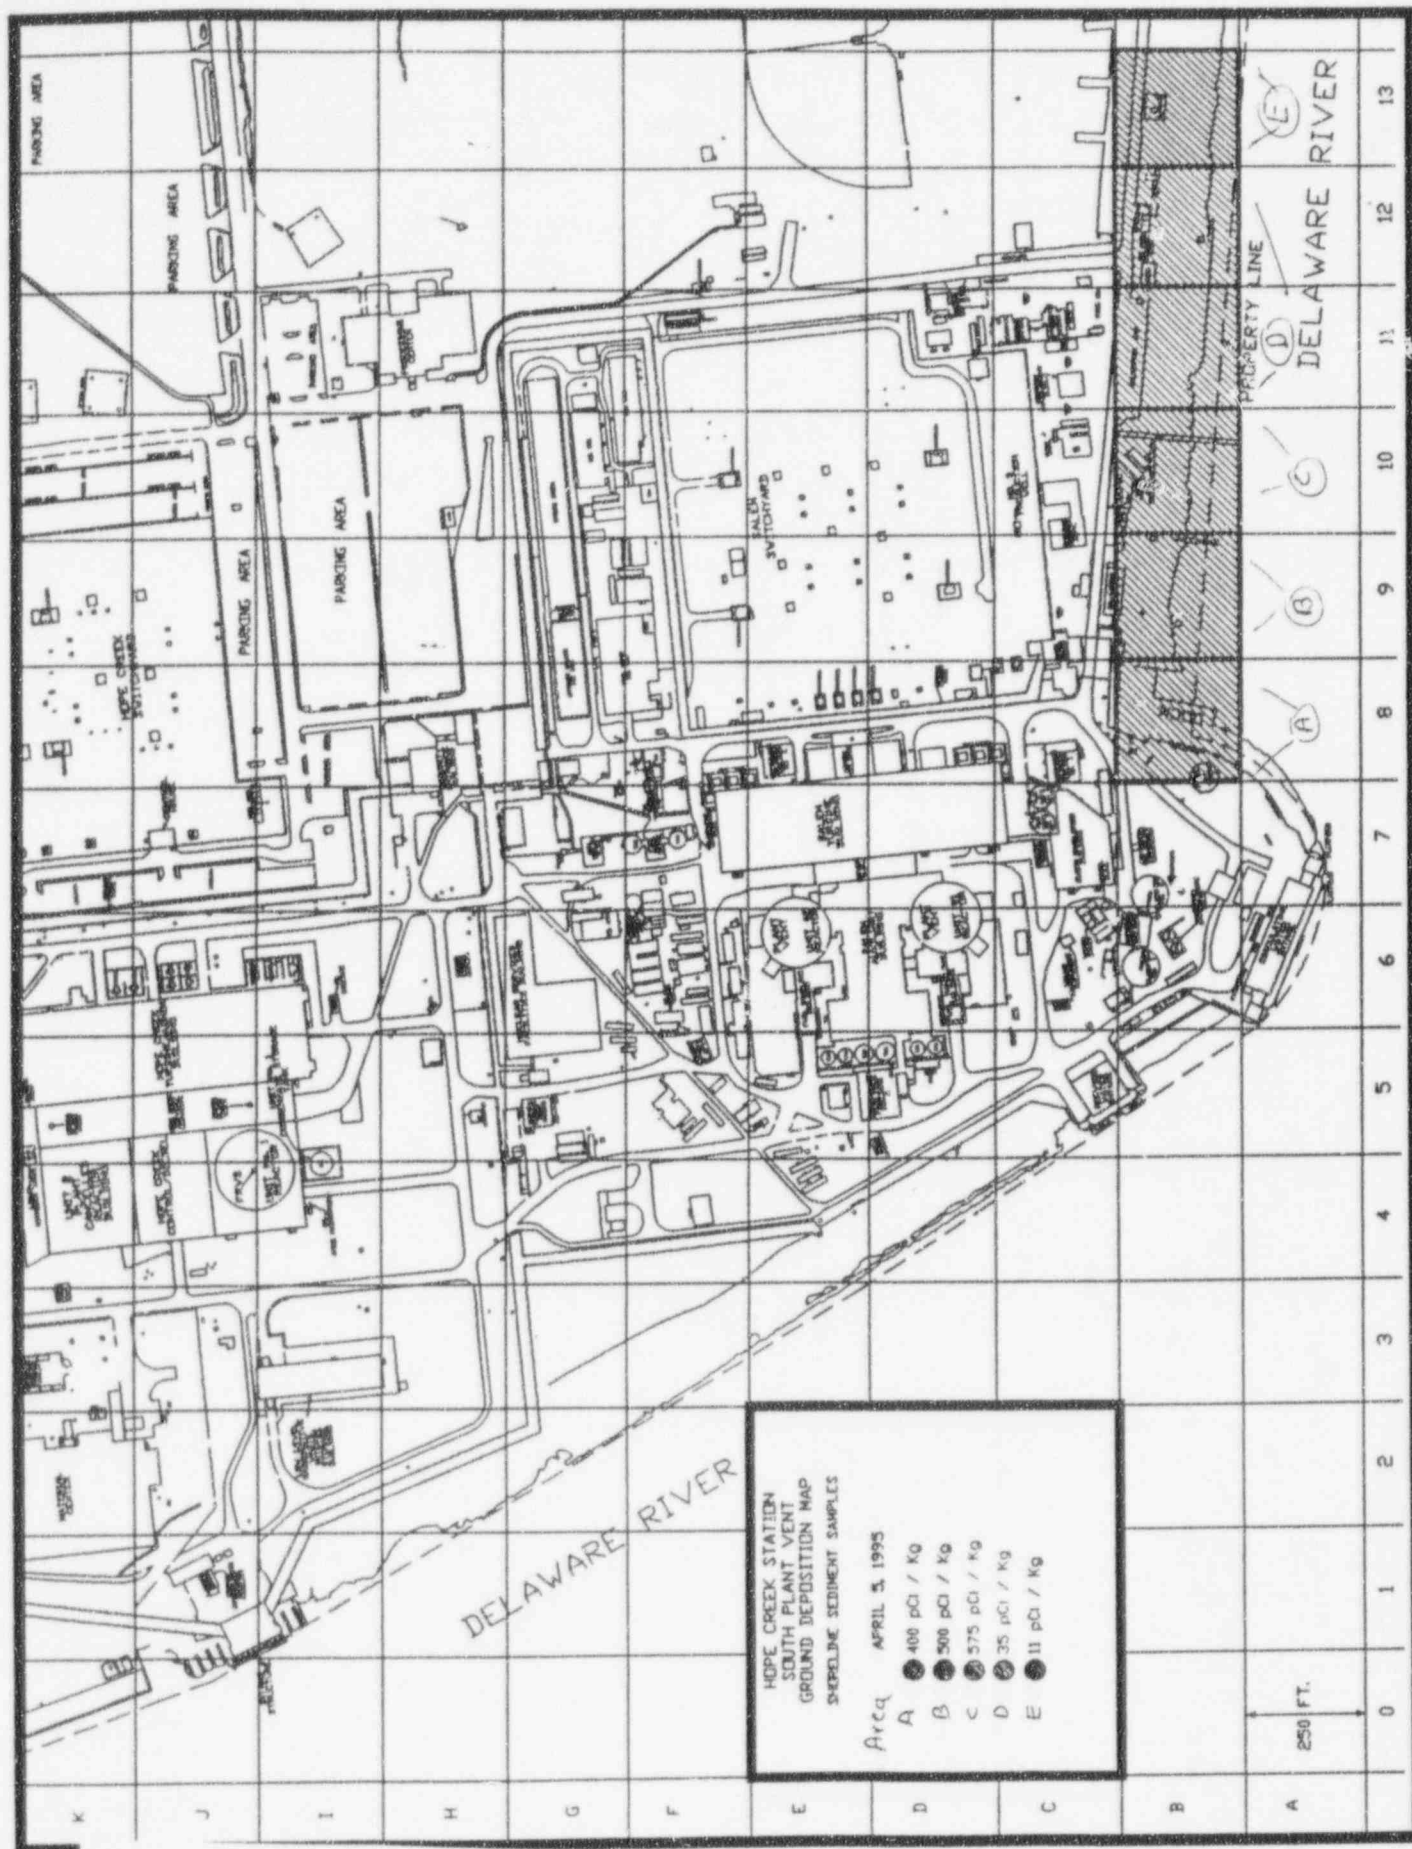
Attachment 8, Shoreline Sediment Sample Analysis Results Map

The levels detected in soil samples, as well as their location, are shown in Attachment 8. This maximum result indicated twice the concentration of normal activity seen in river sediment samples near the plant liquid effluent discharge point. The inspectors noted that the radioactive contamination detected would not result in any significant exposure of members of the public. The maximum offsite doses projected for the radioactive contamination released is discussed in Section 7.4 of this report.

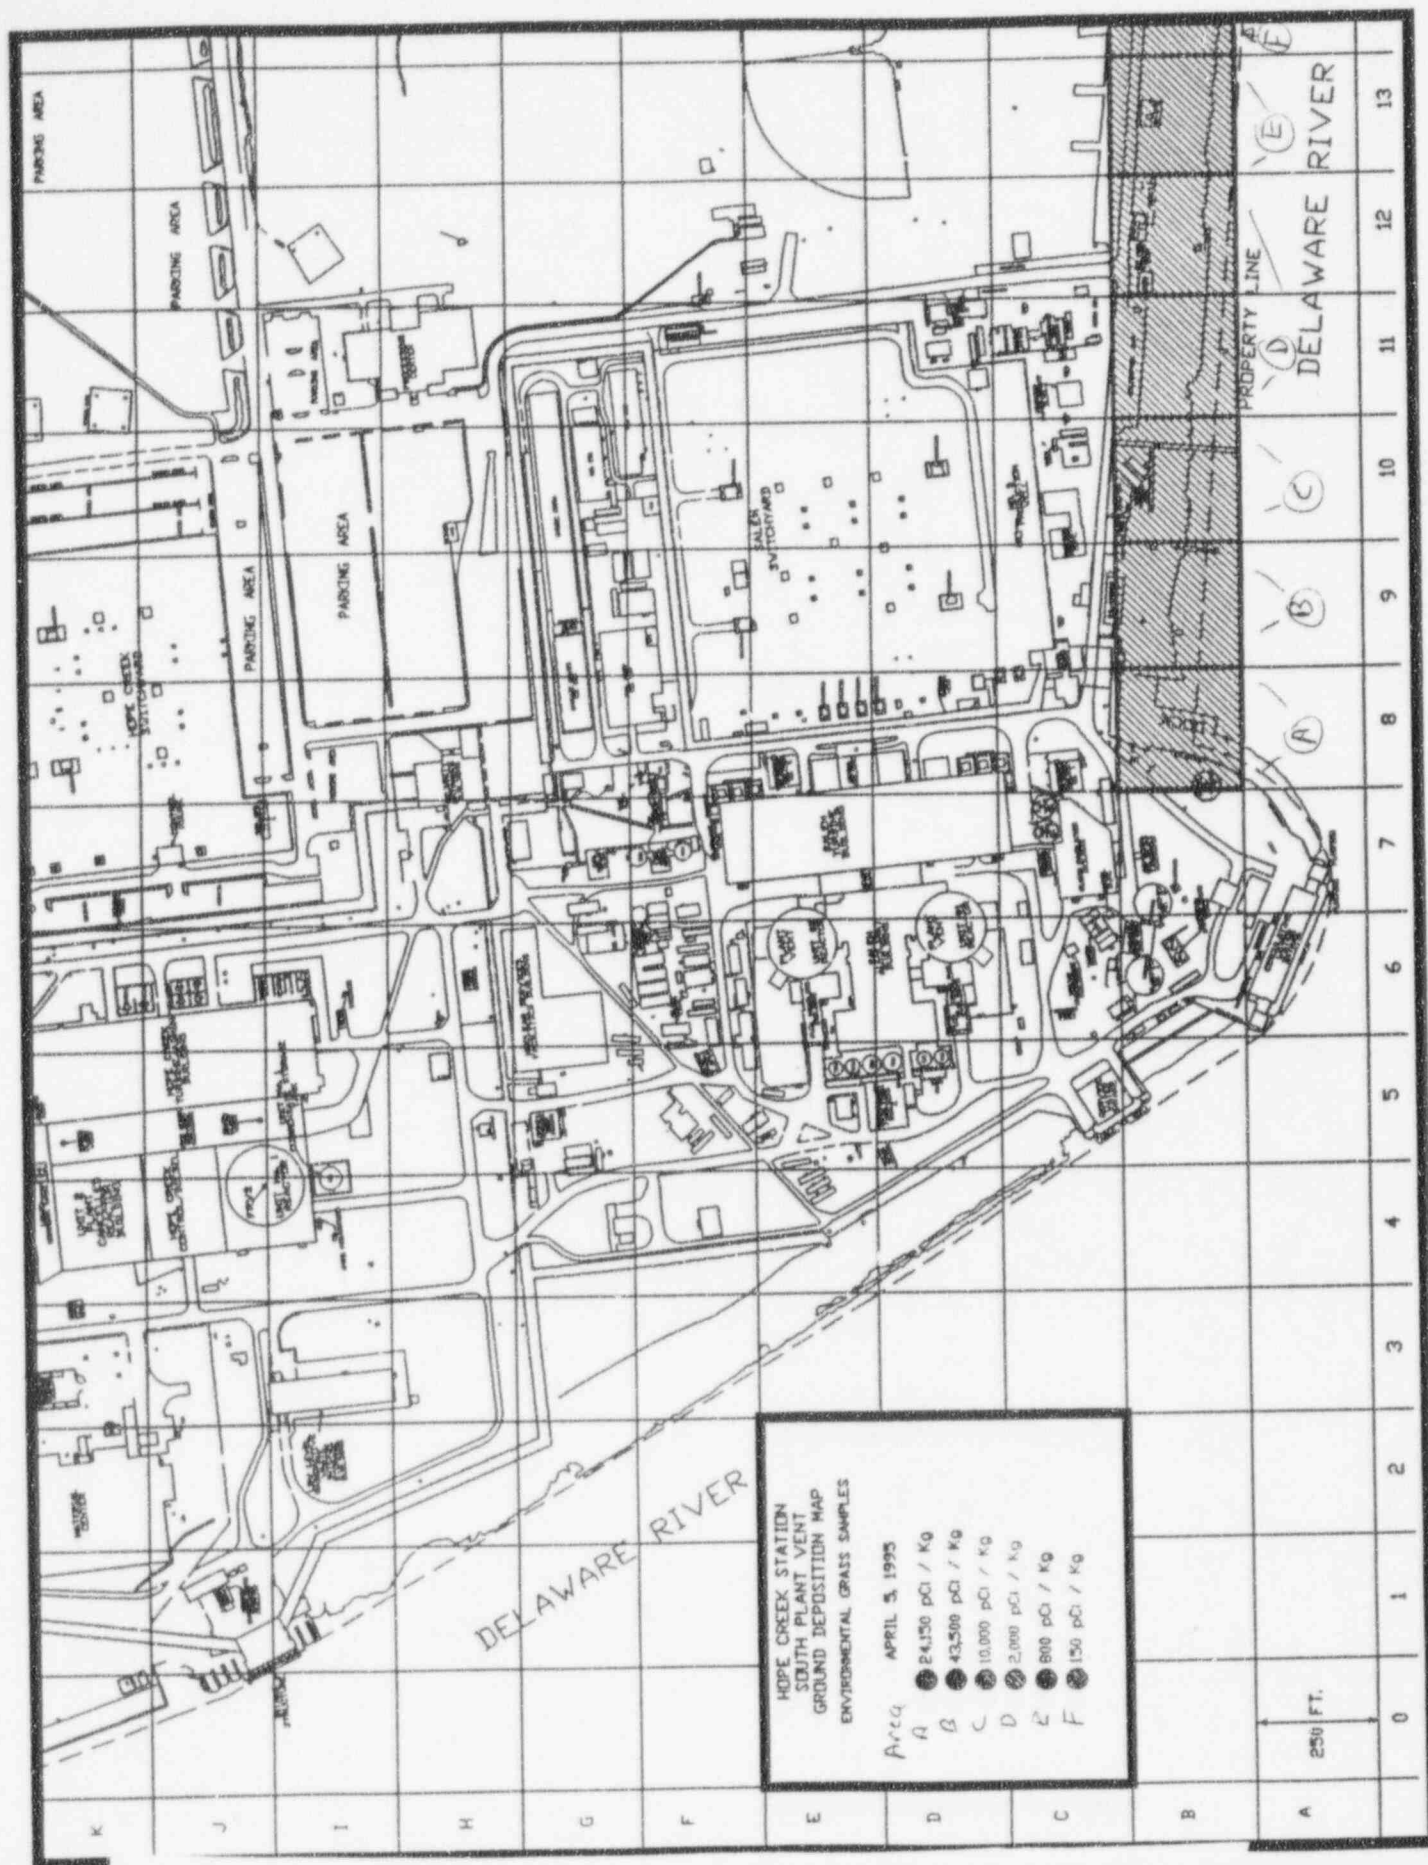
Attachment 9, Shoreline Grass Sample Analysis Results Map

The licensee also collected soil and grass samples from the shoreline directly downwind from the Hope Creek SPV. The samples were collected within the owner controlled area and were analyzed by high sensitivity gamma spectroscopy analysis to lower limits of detection recommended by the NRC. The samples were collected to evaluate the potential for contamination outside the protected area.
