LICENSEE EVENT REPORT

1 0 2 On June 13, 1983, personnel discovered a fire damper (FD-86) was missing.

REPORT NO.: 50-302/83-023/01X-3

FACILITY: Crystal River Unit 3

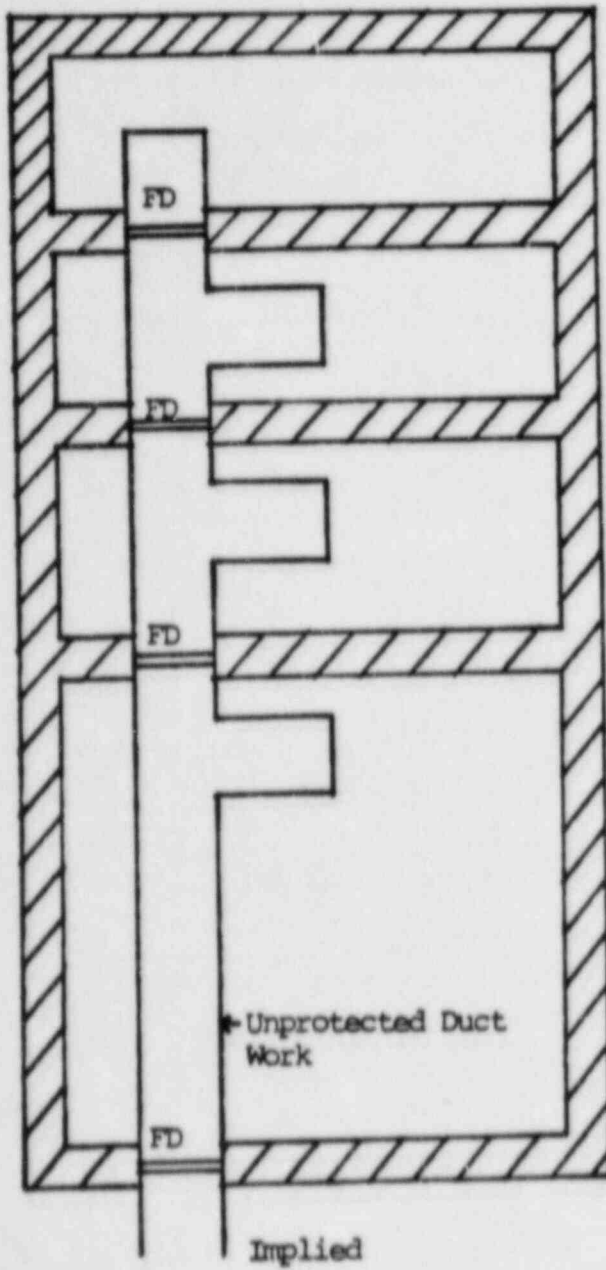
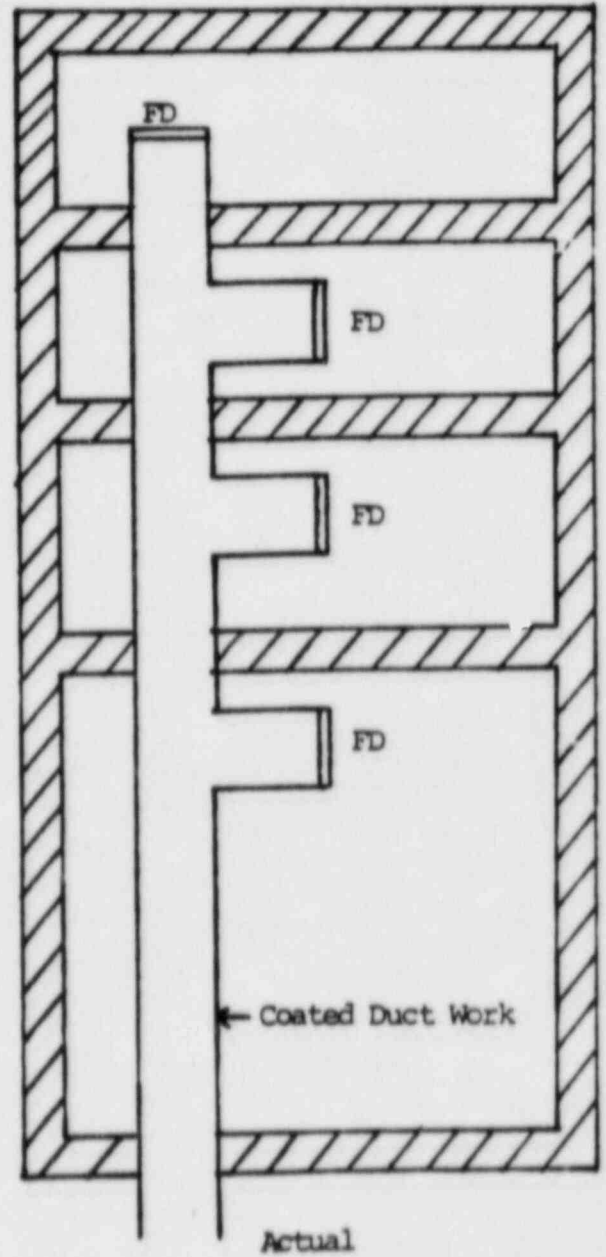
Figure 1 Fire Damper Location Schemes

Further investigation also revealed that 21 of the 55 fire dampers were installed in the duct work (see Figure 1, attached). The 1977 FPPR implied that the fire dampers were located in the fire barriers.

1. The specification of 1-1/2 hour rated fire dampers.
2. The placement of some fire dampers in or at the fire barrier.
3. The placement of some fire dampers in the duct work (not in or at fire barrier) with a fire resistant covering.

Of the 21 remaining fire dampers that are 1-1/2 hour rated and are not located in or at a fire barrier:

- a. All twenty-one (21) fire dampers will be deleted from the Fire Protection Program but wired open and allowed to remain in place.
- b. Newly located, 3 hour rated fire dampers will be installed in the fire barriers to protect the areas initially protected by the 21 above. An engineering evaluation was conducted to determine the location of the new 3 hour fire dampers based on the 1977 FPPR. This evaluation is being reviewed in conjunction with our Appendix R plans in order to finalize the number and location of the new dampers. These dampers will be installed during the Appendix R upgrade.
