LICENSEE EVENT REPORT

Subject: License Event Report Narrative Description

Reference:	Docket No. 50-277
Report Number:	2-83-11/IT-0
Report Date:	May 20, 1983
Event Date:	May 6, 1983
Facility:	Peach Bottom Atomic Power Station RD 1, Delta, PA 17314

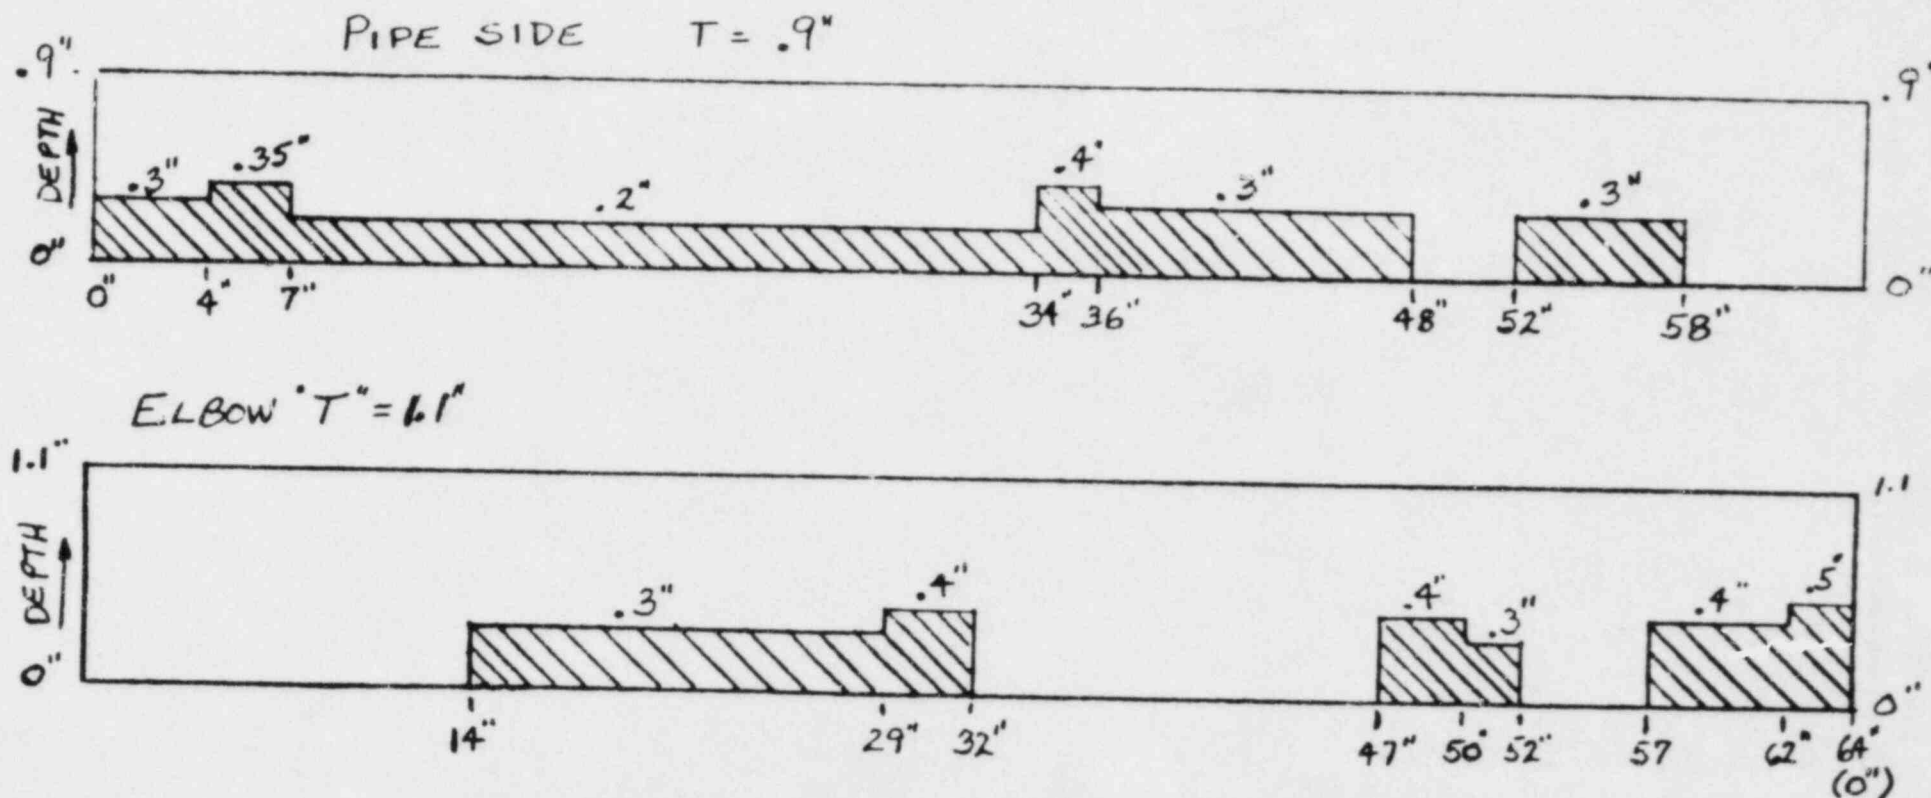
Peach Bottom Unit #2
RHR Suction; Pipe to Elbow Weld: 10-0-6
20" diameter Assume 64" circumference

Graphic Plot of the location and thru-wall depth of all ultrasonic indications, assumed to be cracks.

Analysis of ultrasonic testing data confirms the presence of cracks in the 20" RHR shutdown cooling suction line. These cracks are located in the heat affected zone of the pipe and elbow at weld 10-0-6. Attachment I of this letter shows the location of this weld in the RHR shutdown cooling suction line. Attachment II of this letter is a graphic plot of the location and depth of all ultrasonic indications in weld 10-0-6. The pipe side of the weld is 0.9" thick and the elbow side of the weld is 1.1" thick. The cracks are all circumferential in nature. In the pipe side the longest single crack length is approximately 48" long and the maximum thru-wall depth is 0.4". In the elbow side of the weld the longest single crack is 18" long and the maximum thru-wall depth is 0.5".

The analysis of the data shows a pattern typical of intergranular stress corrosion cracking.

On Unit 2, weld 10-0-6 was the only weld of the three welds inspected that was found with indications. These indications were confirmed as cracks. A fracture mechanics analysis was performed by the NSS vendor. The crack growth evaluation was performed using the initial average crack depths of 0.3" on the pipe side of the weld and 0.4" on the elbow side of the weld. For the analysis, conservatively, the crack was assumed to be a 360 degree circumferential crack. Analyses were performed with and without considering the beneficial effects of the weld residual stresses. The analyses also used a conservative applied stress value of 13KSi. The analyses showed that with the maximum crack growth rate for weld sensitized material, the stress in the pipe would not exceed code allowable if operation continued up to six months.

On May 8, 1993, EPRI approved "Water Sensitive Tape" was installed on 10 selected welds in Unit 2 to improve on early warning detection. Three riser to elbow welds in each recirculation loop, and four welds on the RHR shutdown cooling suction line were selected for tape installation. This tape is calibrated to alarm on a very low amount of water leakage
