DR 5579

ROE 71 12

RUPTURE OF MAIN STEAM SAFETY
VALVE PIPE NOZZLENOTE

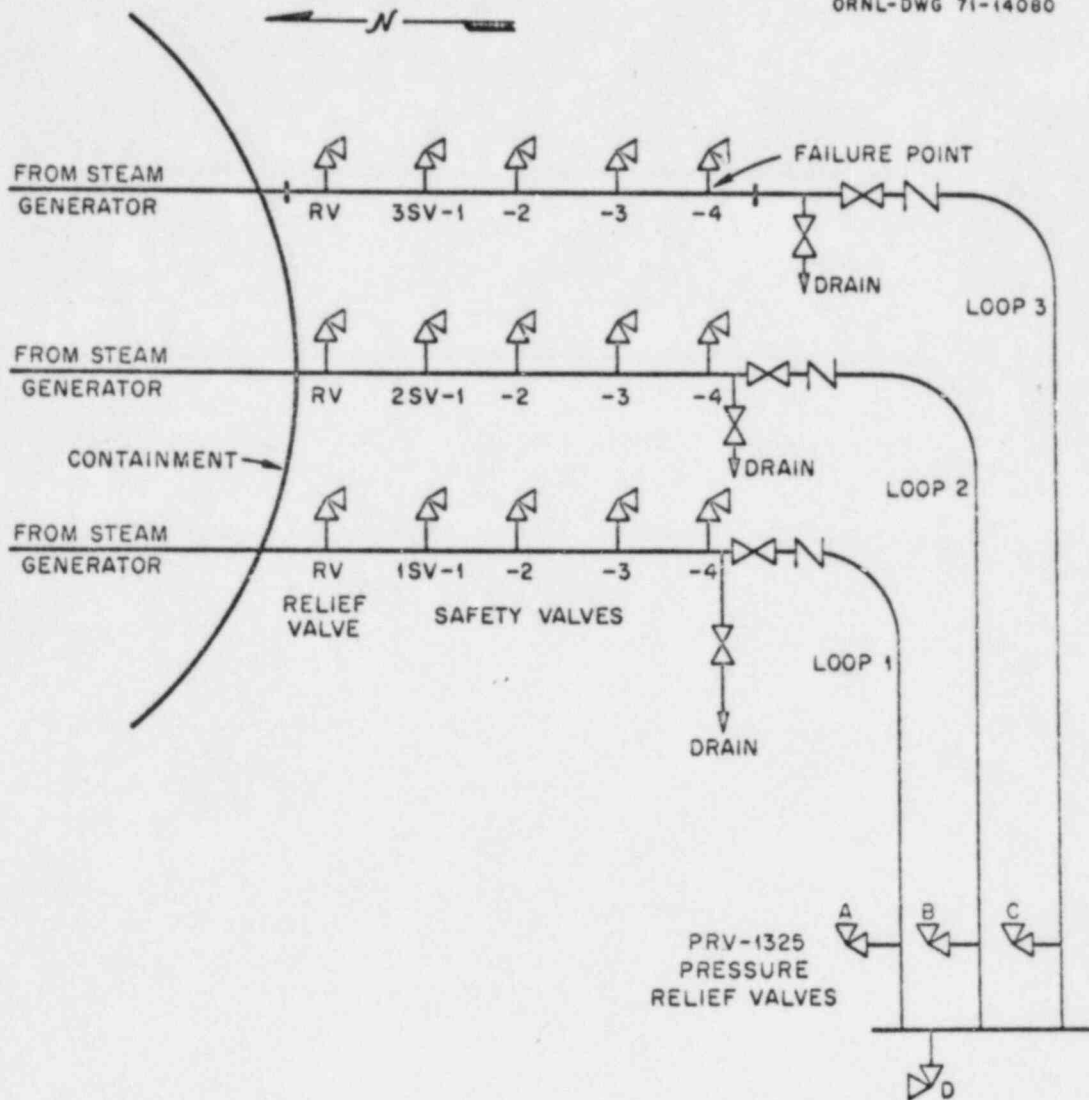
Figure 1. Main Steam Piping System

The secondary system is comprised of three steam generators each with one separate main steam line passing from each generator through the containment wall to a common main steam header. Four safety valves and two relief valves are installed on each of the three separate main steam lines (see Figure 1).

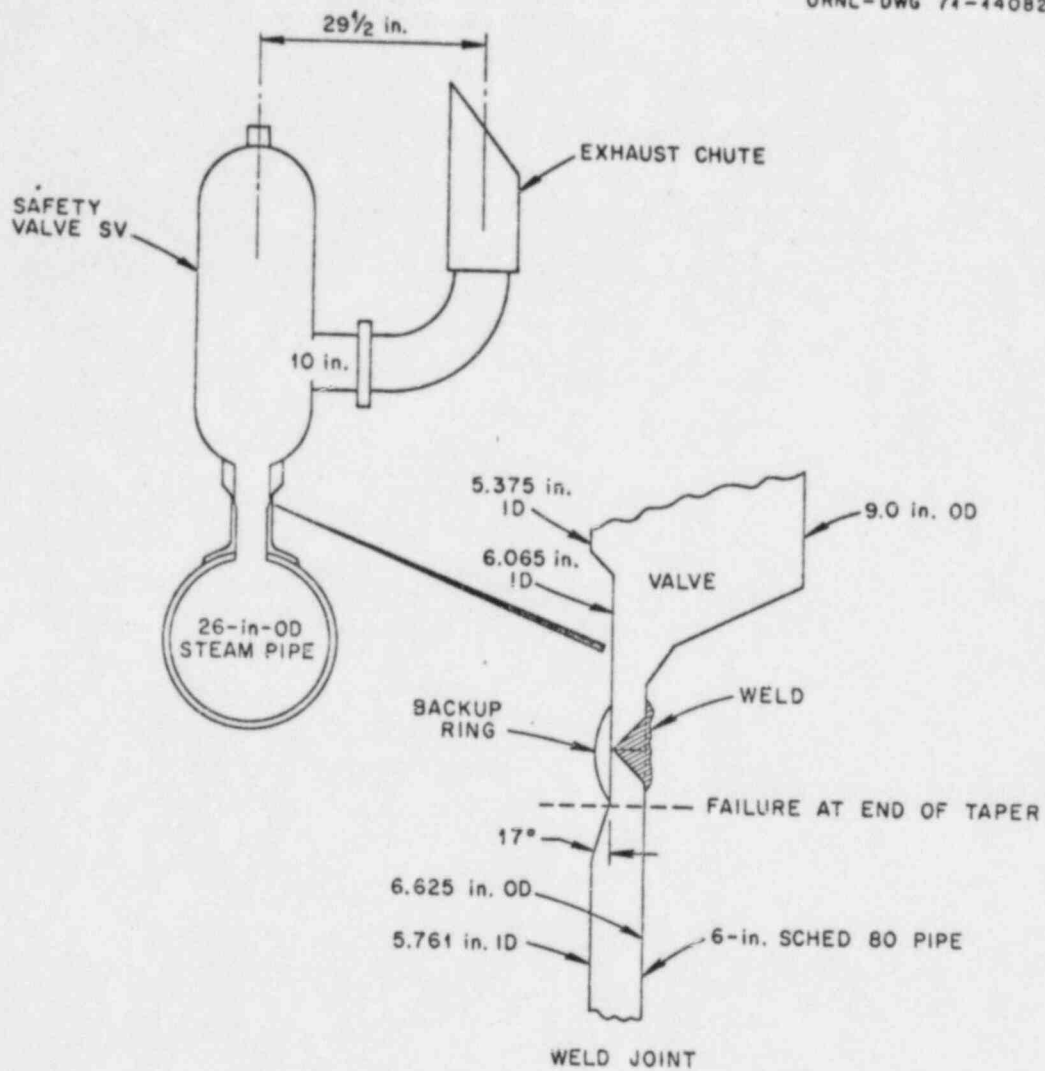
Figure 2. Safety Valve Connection

All safety valves were welded to a 6-inch schedule 80 pipe nozzle, with the nozzle weld preparation formed by counterboring and tapering the nozzle to schedule 40. The schedule 80/40 pipe nozzle was in turn welded to a 26-inch OD main steam pipe spool piece (see Figure 2).

The failure occurred in the reduced section of the six-inch pipe nozzle which connected the safety valve to a 26-inch steam line. The internal fracture path coincided exactly with the end of the machined internal diameter taper.

The results of the investigation (available at this writing) indicate that the fracture initiated at one location on the pipe nozzle and proceeded circumferentially around it in both the clockwise and counter-clockwise directions terminating about 180° opposite the fracture starting point. All areas of the fracture showed evidence of extensive plastic deformation and the internal diameter fracture path coincided exactly with the end of the machined inner diameter taper (see Figure 2). The fracture path was not associated with the heat-affected zone of the weld although it did penetrate the heat affected zone in several locations. No significant material deficiencies were found with respect to chemical analysis, microstructure, pre-existing defects, or mechanical properties. No evidence of fatigue damage was observed in any area of the fracture.

The lack of any material deficiency and the extreme plastic strain viewed on the fracture surface, indicate that failure was caused by overloading. The peak stress must reach the ultimate stress to initiate a

The twelve main steam line safety valve inlet nozzles were redesigned to provide for a conservative design and to negate the effects of possible stress intensification factors. The extent of the revision included increasing inlet pipe nozzle size to 8-inch schedule 160 thereby enlarging the nozzle diameter and decreasing the thickness differences between the nozzle wall and the valve body wall. The seven relief valve pipe nozzles have also been modified using the same approach taken for the modification of the safety valve pipe nozzles.
