Subject: Quad Cities Nuclear Station Unit 2  
Core Shroud Examination Final Results  
NRC Docket No. 50-265

Q2R13 EXAMINATIONS  
OF CORE SHROUD  
QUAD CITIES UNIT 2

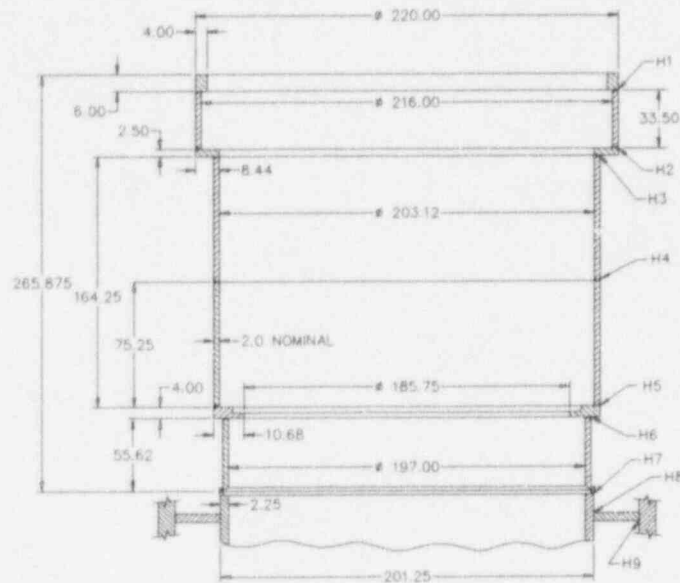
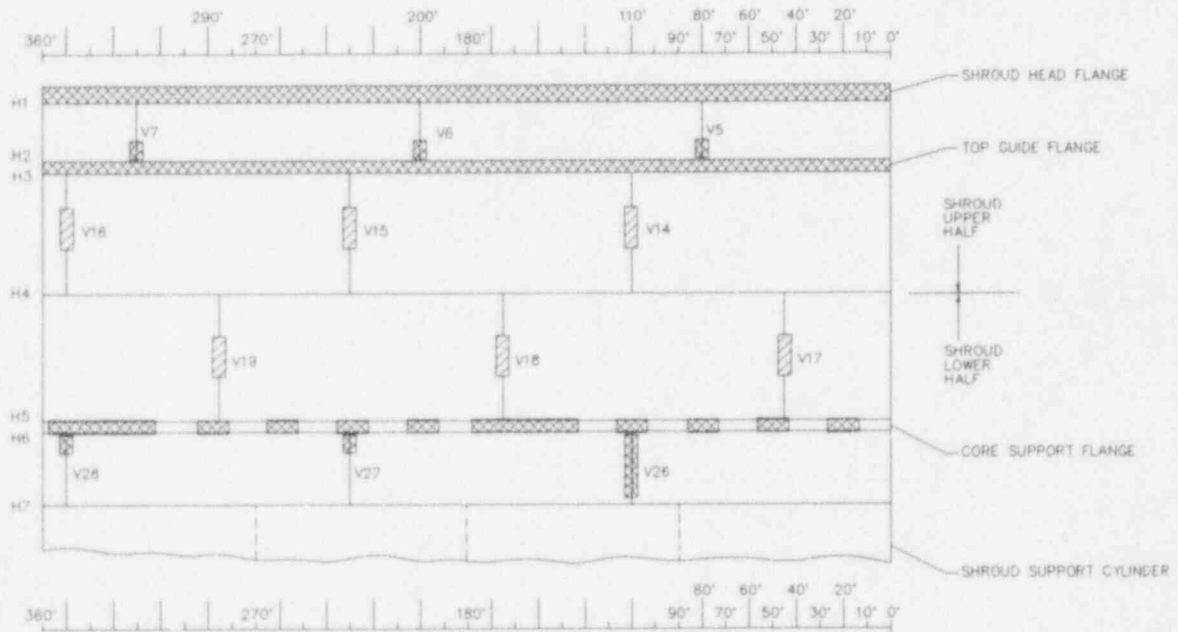
# FIGURE

- o Ultrasonic examination of the shroud vertical welds (V14 through V19) located between horizontal welds H3/H4 and H4/H5 (i.e. beltline region). The examinations resulted in no reportable indications.
- o Enhanced visual examination of the shroud head flange ring, top guide support ring, core plate support ring, shroud vertical welds (V5-V7 and V26-V28, inclusive) and the shroud repair hardware attachment sites at the jet pump support plate. The examinations resulted in a total combined crack length of 51" with the longest observed crack 24" in length.

In conclusion, the indications observed on the core plate support ring vertical (OD) surface result in a total combined crack length of 51" or approximately 15% of the area examined. The observed SCC is considerably less than that observed at other units of this vintage. As expected, the indications are associated with the heat affected zone (HAZ) of horizontal weld H5. The installed shroud repair has been designed to structurally replace the shroud horizontal welds.

Component	Area Inspected	Inspection Results
Shroud Head Flange Ring H1	Visually examined 100% of accessible surfaces or 72% (499") of OD, 100% (665") of ID and 100% (690") of Top of ring.	3/4" long indication at 290° in steam dam to ring fillet weld.
Top Guide Support Ring H2-H3	Visually examined 100% of accessible surfaces or 100% (690") of OD and 100% (690") of Bottom of ring.	No Reportable Indications
Core Plate Support Ring H5-H6	Visually examined 100% of accessible surfaces or 55% (356") of OD and 55% (356") of Bottom of ring.  Approximately 15% (51") of area examined has indications in the HAZ associated with the H5 horizontal weld.	2" long circ. indication at 20° 24" long circ. indication at 45° 10" long circ. indication at 80° 6" long circ. indication at 143° 1" long circ. indication at 200° 8" long circ. indication at 350° 3 axial indications at 163°, 1/4" to 1/2" in length at toe of H5

Vertical Welds V5, V6 and V7	Visually examined at least 12" or 36% of each weld, inspected OD surface, ID not accessible.	No Reportable Indications
Vertical Welds V14, V15, V16, V17, V18 and V19	Ultrasonically examined 27" or greater than 30% of each weld.	No Reportable Indications
Vertical Welds V26, V27 and V28	Visually examined at least 12" or 22% of each weld, inspected OD surface, ID not accessible.	No Reportable Indications
Shroud Ledge to Shroud H8 Weld	10" of weld in area of repair attachments at 4 locations; 20°,110°, 200°,290° azimuths.	No Reportable Indications
Shroud Ledge to RPV H9 Weld	12" of weld in area of repair attachments at 4 locations; 20°,110°, 200°,290° azimuths.	No Reportable Indications
Shroud Ledge in Area of Repair Attachments	Examined face of plate in area of repair attachments; approximately 150 square inches at 4 locations; 20°,110°, 200°,290° azimuths.	No Reportable Indications
