# SNUPPS

SLNRC 83- 028 FILE: 0491.10.2  
SUBJ: Final Report: DS-416 Reactor  
Trip Switchgear Undervoltage  
Attachment (SDR 83-07)

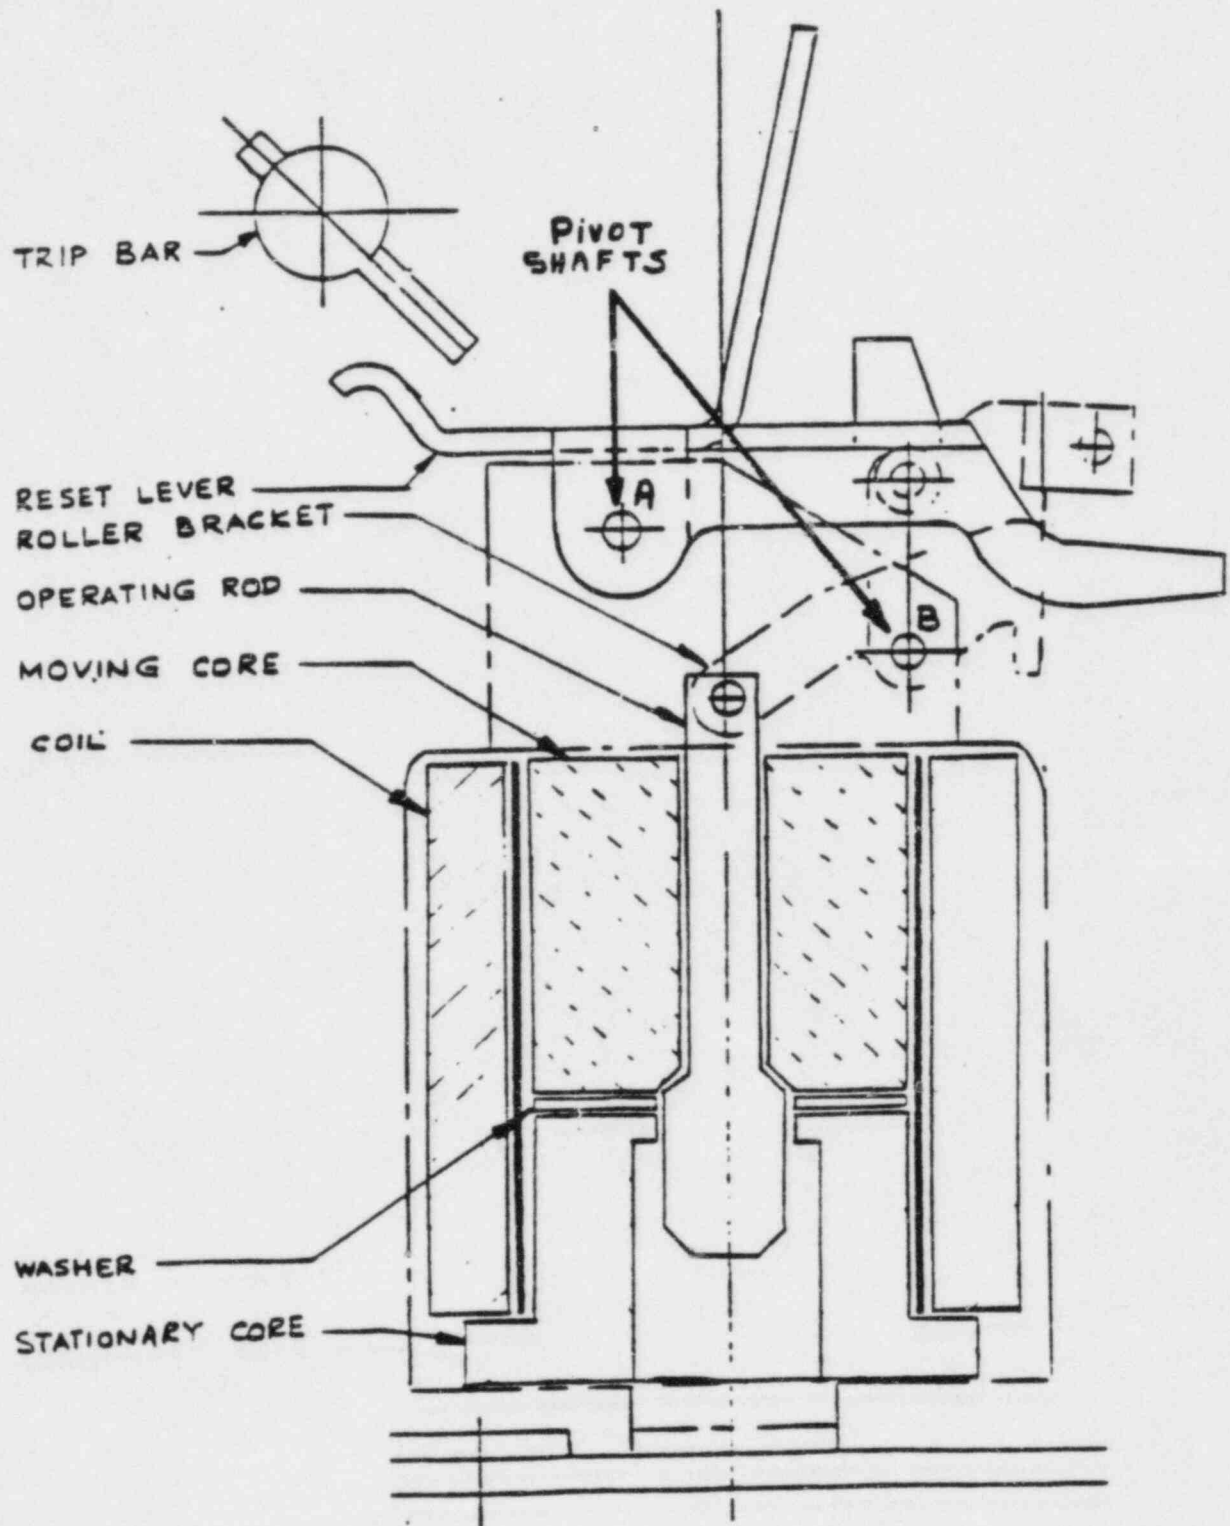
# DS-416 Undervoltage Attachment

The cause of the problem has been reported by Westinghouse as follows: the design width of the retaining ring was increased in 1972, but the width of the mating groove in the pivot shaft was not similarly widened to be consistent with the retaining ring modification; consequently the wider retaining rings do not seat properly in the existing pivot shaft grooves.

To correct the problem, all DS-416 reactor trip breaker undervoltage attachments at Callaway and Wolf Creek will be replaced. The replacement DS-416 attachments will have modified (widened) grooves to accommodate the new retaining rings. The DS-416 undervoltage attachments will

be replaced at each site prior to fuel loading. Westinghouse also reports that, in addition to revising manufacturing drawings, quality control procedures have been modified to assure that critical design dimensions are maintained during manufacture of the replacement DS-416 undervoltage attachments. It will be verified by inspection that the replacement undervoltage attachments meet part number and critical dimensional requirements.
