Dresden Nuclear Power Station  
R. R. #1  
Morris, Illinois 60450  
June 20, 1975

SUBJECT: FOLLOW-UP REPORT TO ABNORMAL OCCURRENCE ENTITLED "CORRELATION OF FUEL  
FAILURES AT DRESDEN-3 IDENTIFIED BY WET SIPPING TESTS TO CALCULATED  
VIOLATIONS OF GE POLICIES"

Fuel Failures Identified at D3-ECC3 by Wet Sipping Tests and Comments Regarding the PCICMR.

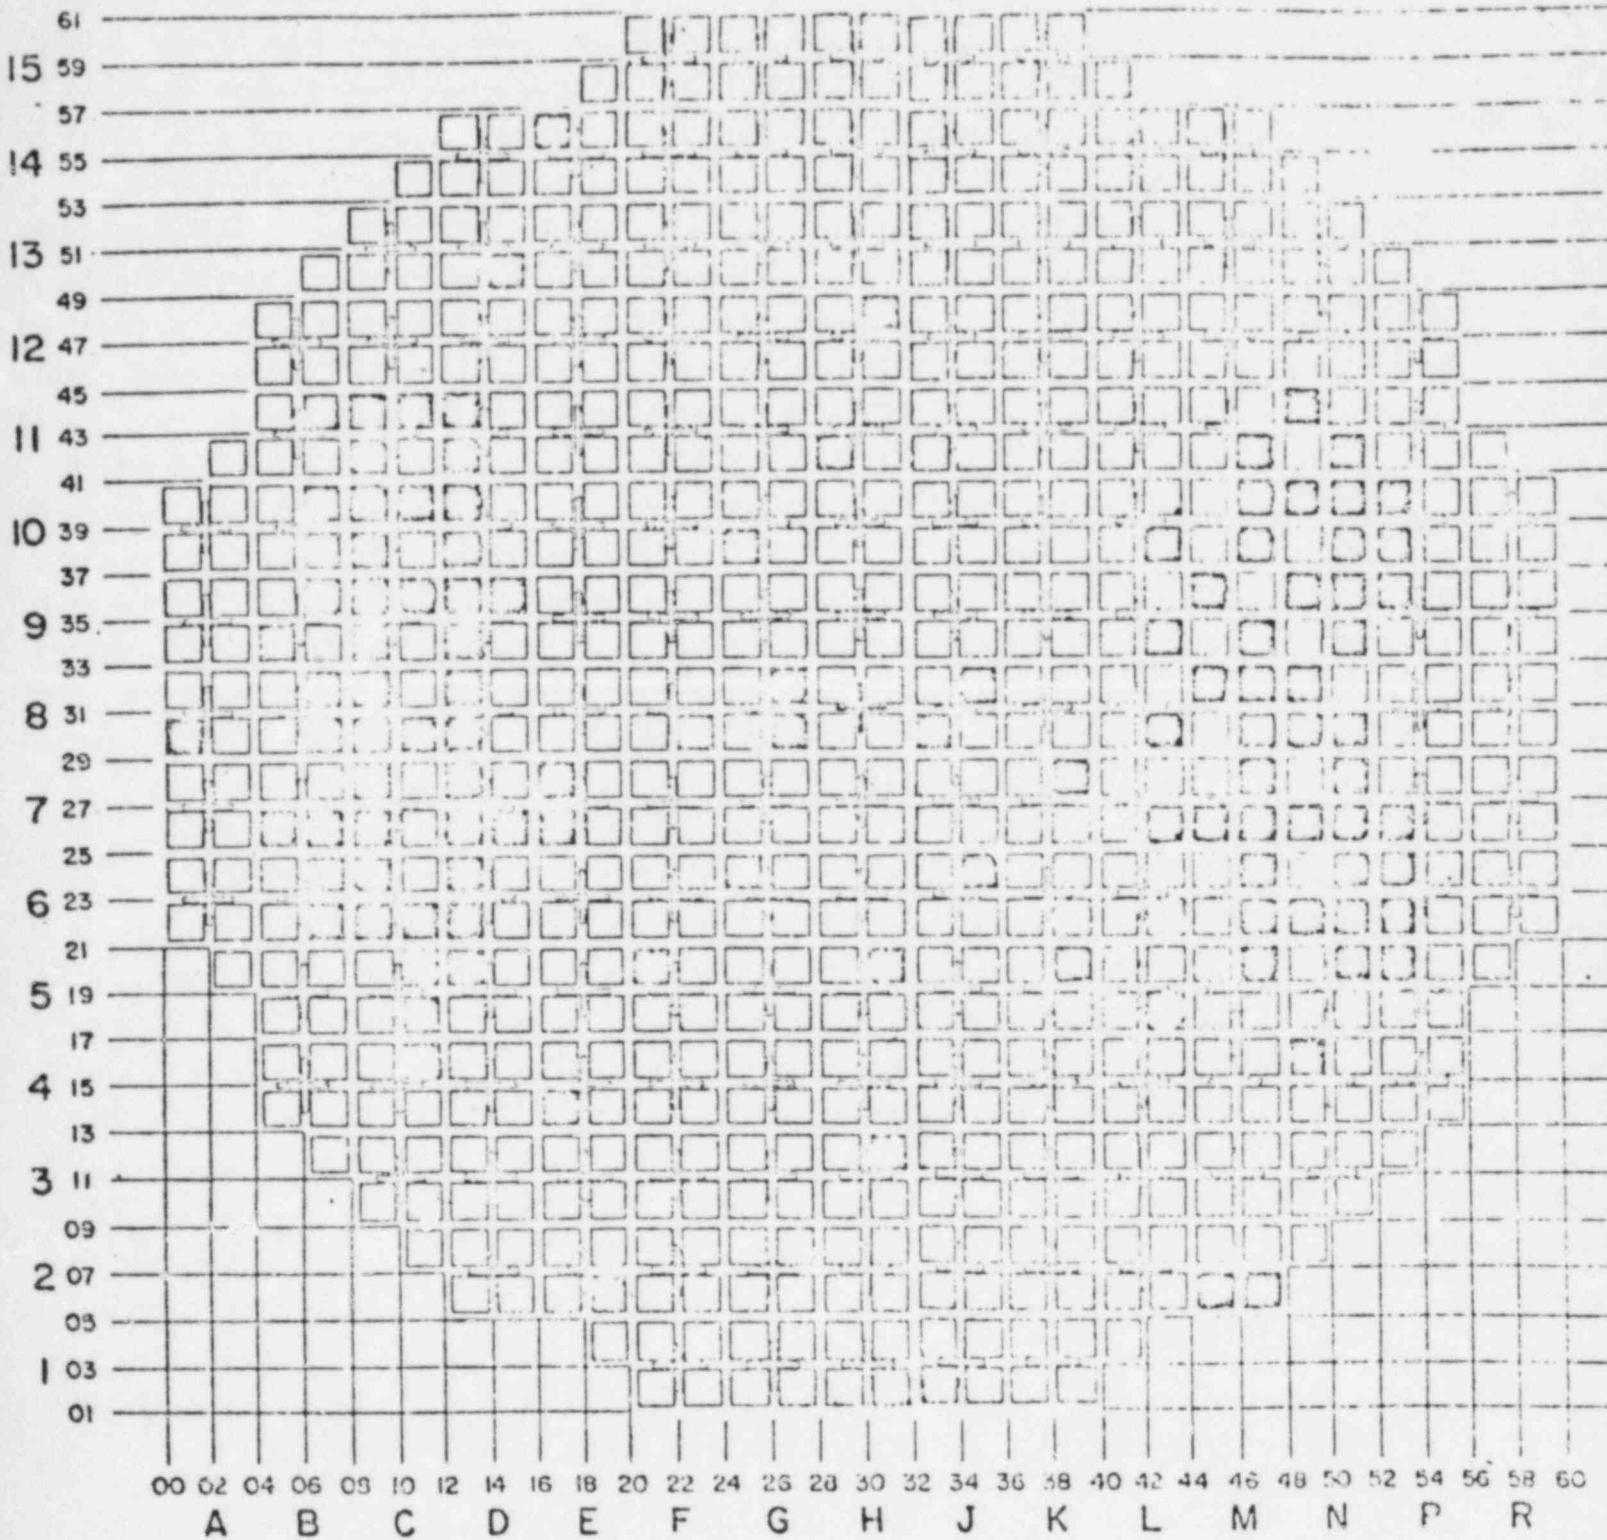
FIGURE 1

Figure 1 is a core map indicating the location of the leakers. Figures 2 to 4 graph three power distributions (equilibrium xenon) typical of the preconditioned shape (2227-Figure 4 (a)) and the shape at 6:57 a.m. on 10-31-74 (1432-Figure 4 (b)). Xenon transients, depending on core location, will increase the bottom peaks by 0 to 25%.

Figure 1 indicates that about 80% of the assemblies on the periphery (one assembly removed) of cells that experienced major rod movements (D7, C6, C8 and symmetric locations) failed. Figure 7 shows the local power distribution at about 15,000 MWD/T for a controlled and an uncontrolled D3 2.13 w/o assembly. A 2.13 w/o Gd assembly is included to compare the local factors of pins A7 and G1, which are about 25% higher for the D3 assemblies.

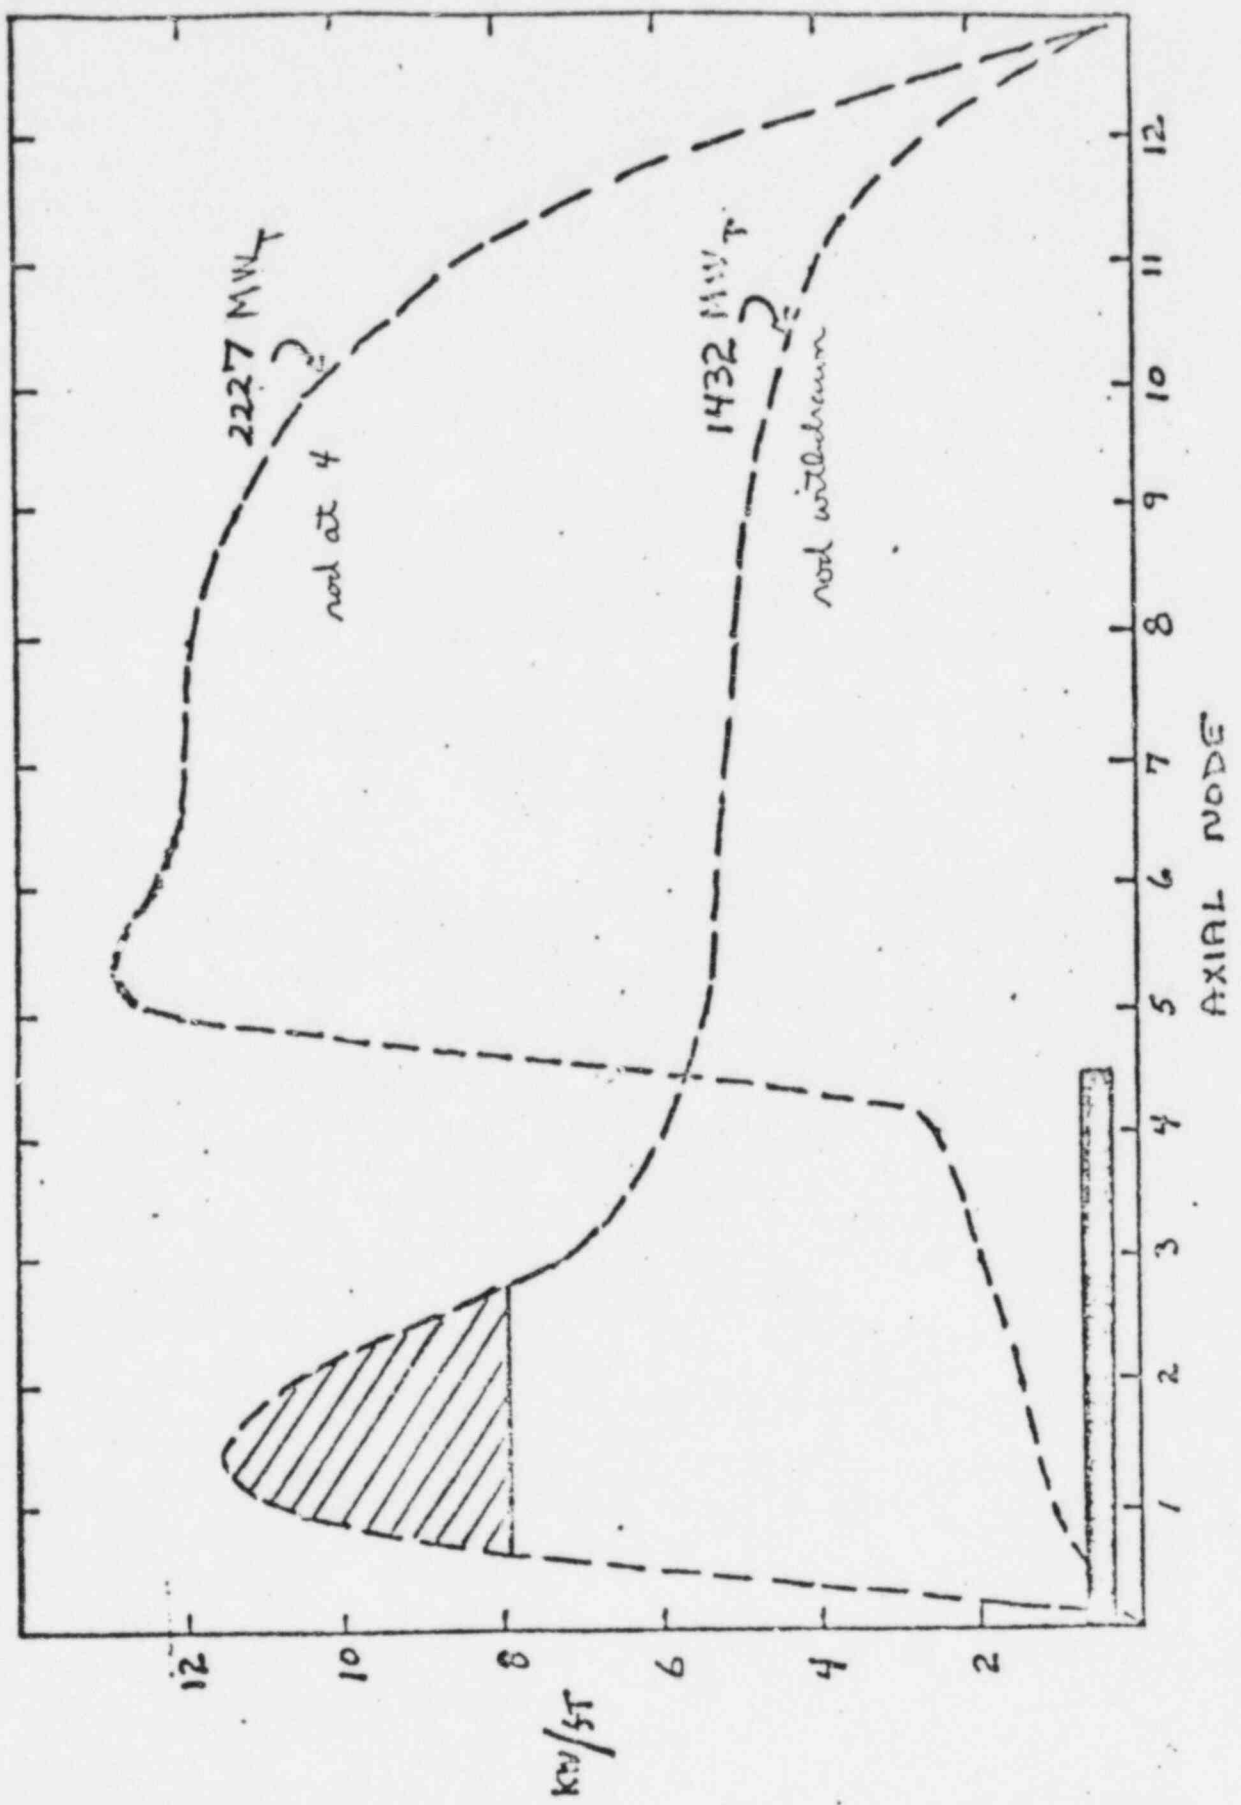
FIGURE 2

C10 WITHDRAWN

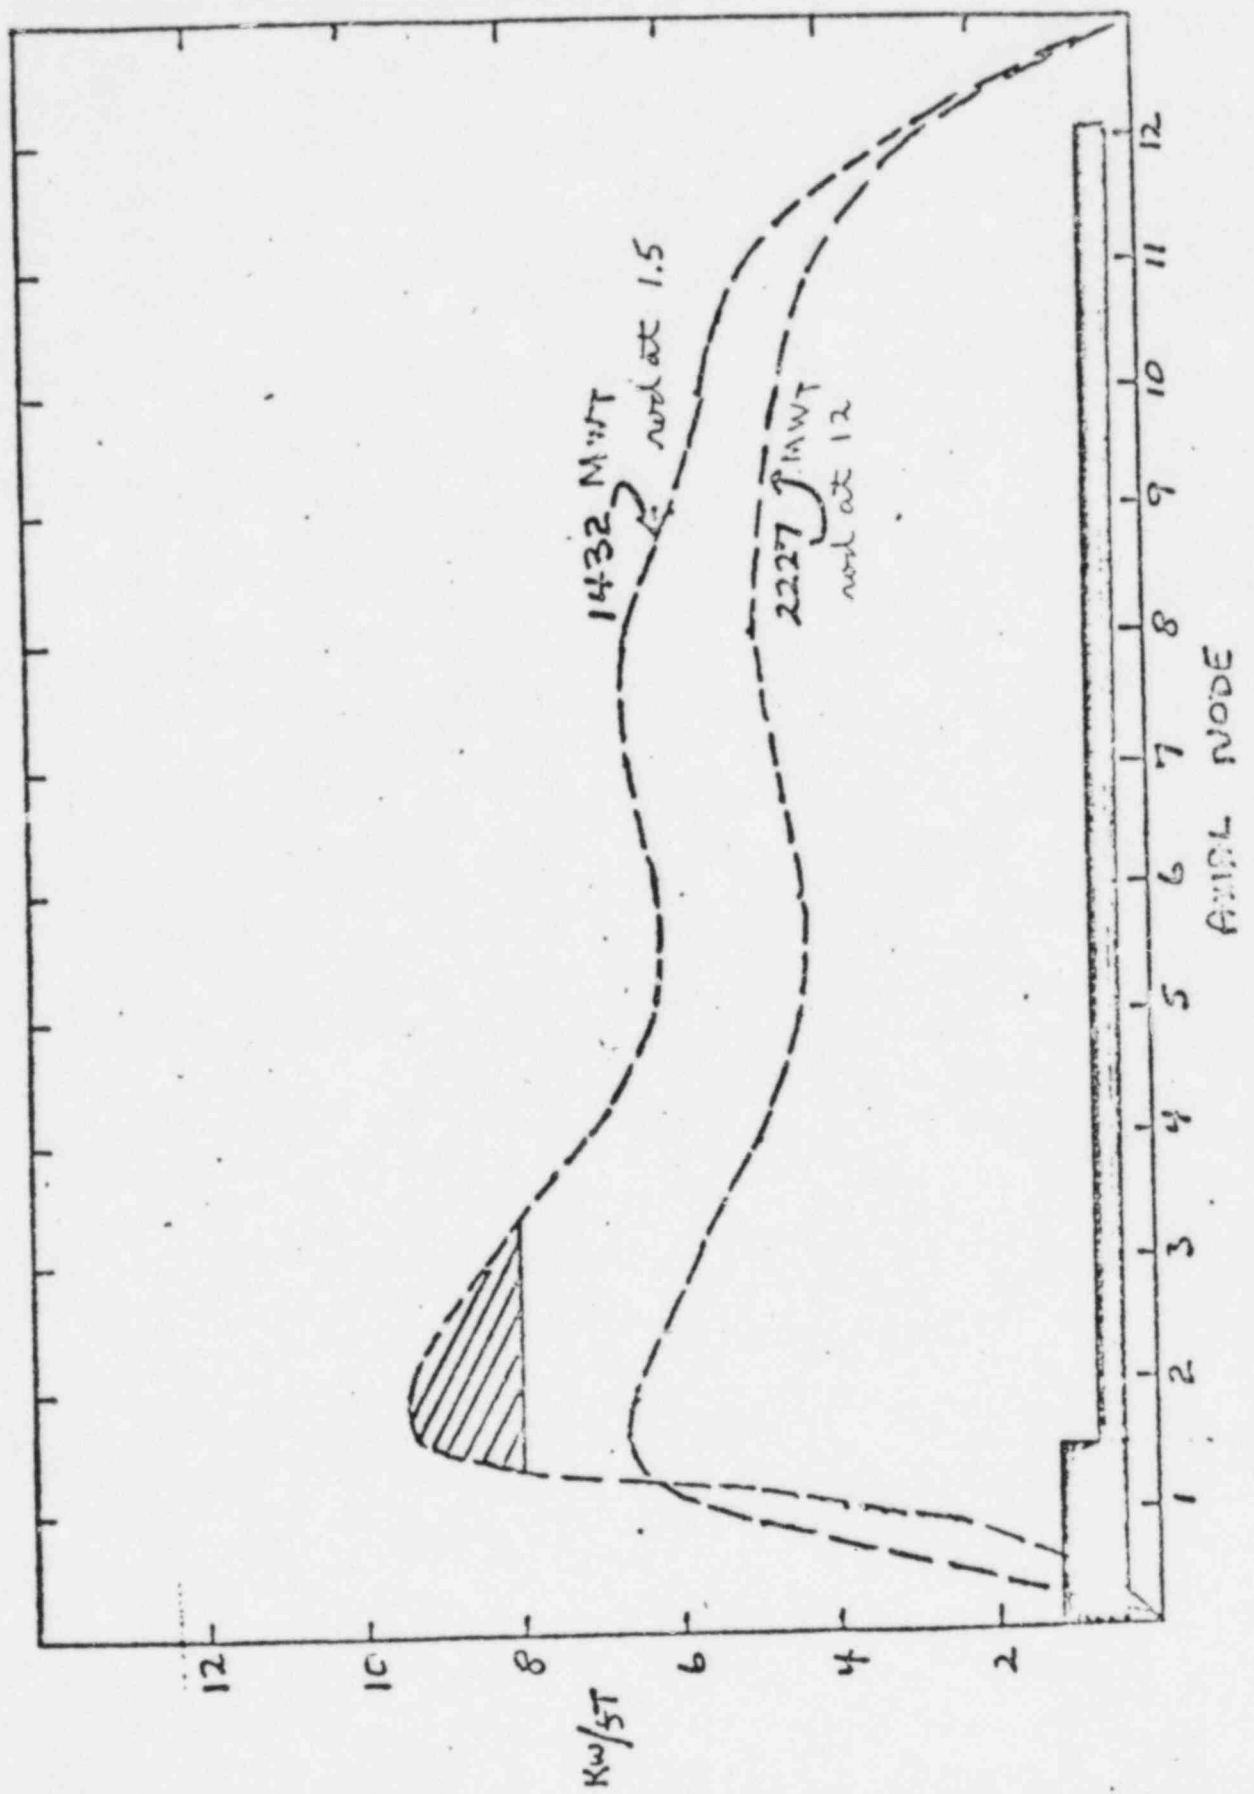
FIGURE 3

CORNER PIN G-8 FROM 12 TO 1.5 INSERTED

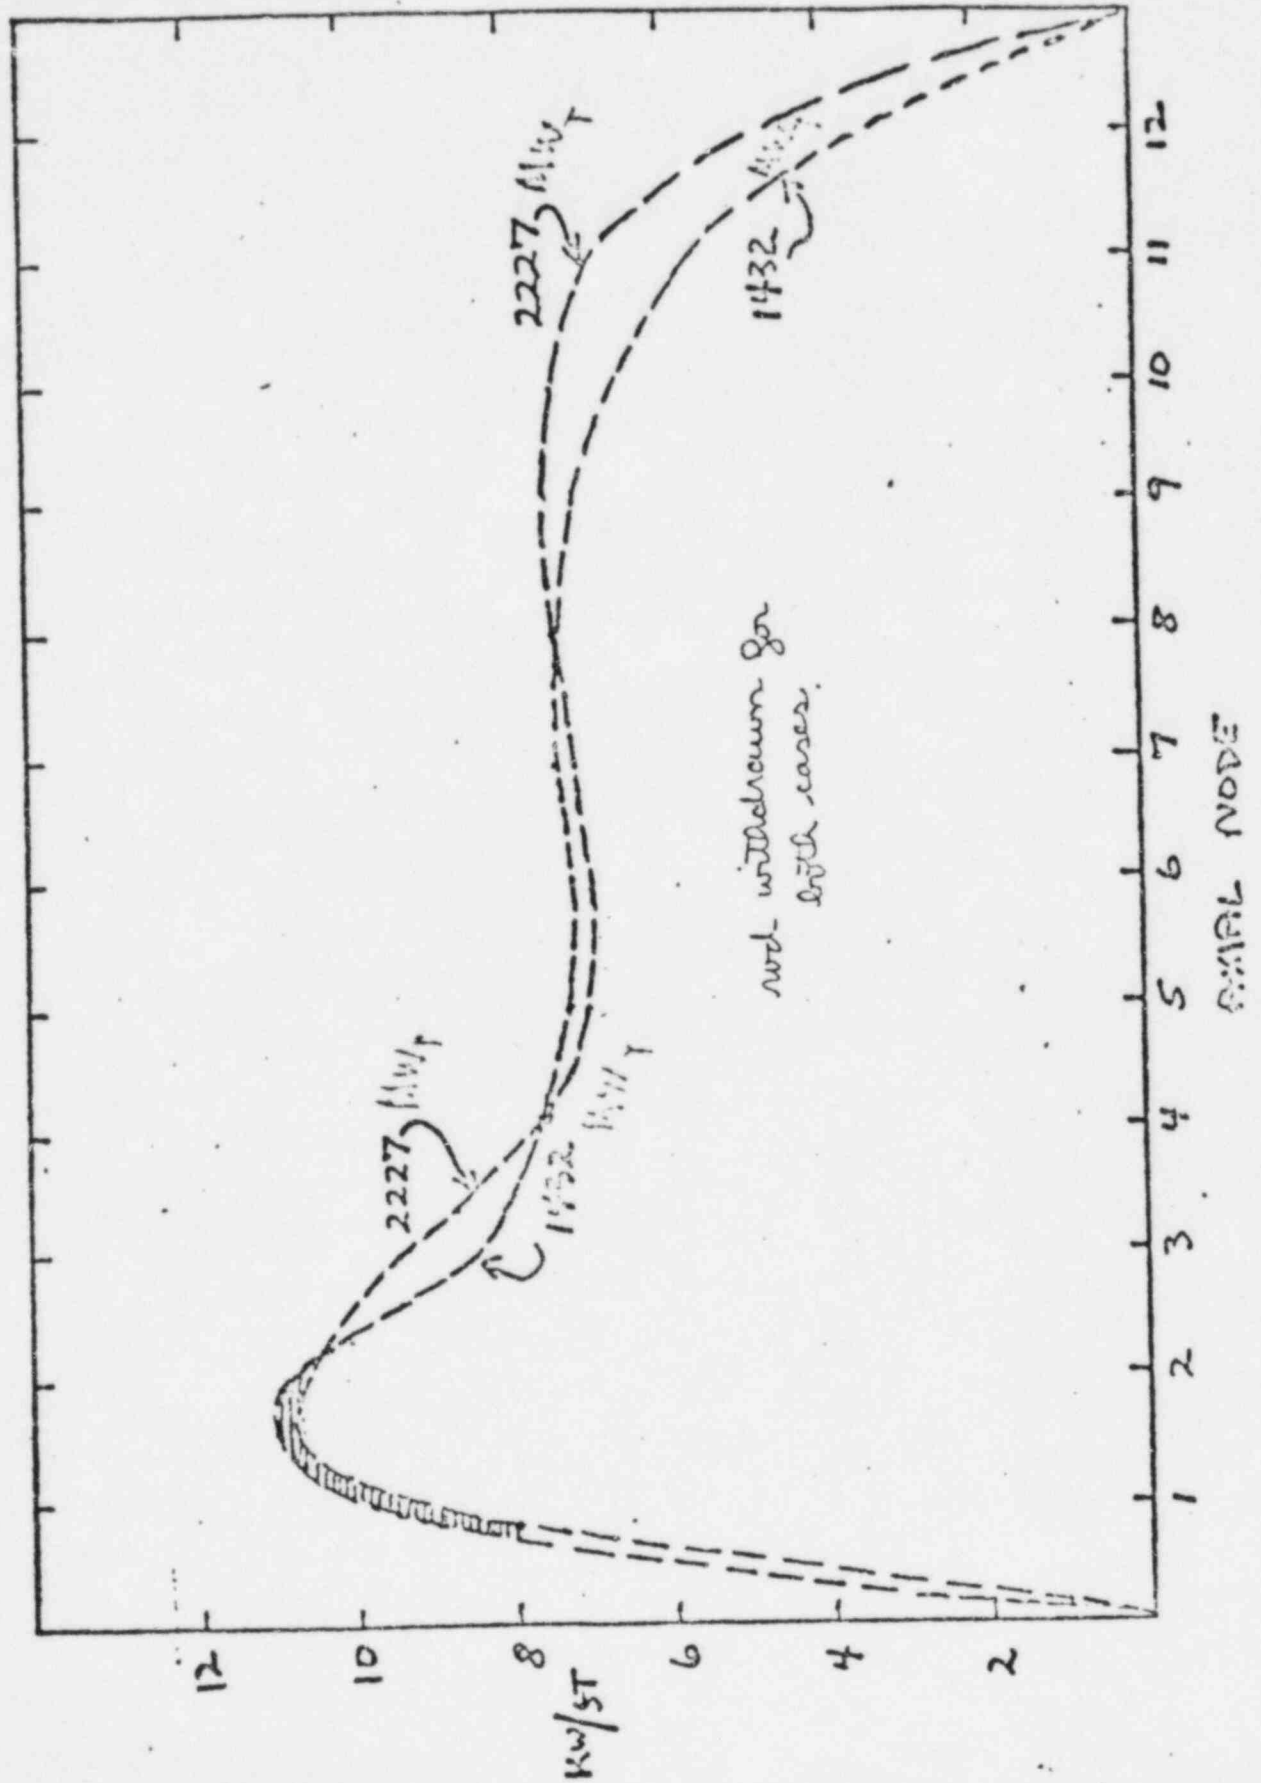
FIGURE 4

H3 UNCONTROLLED

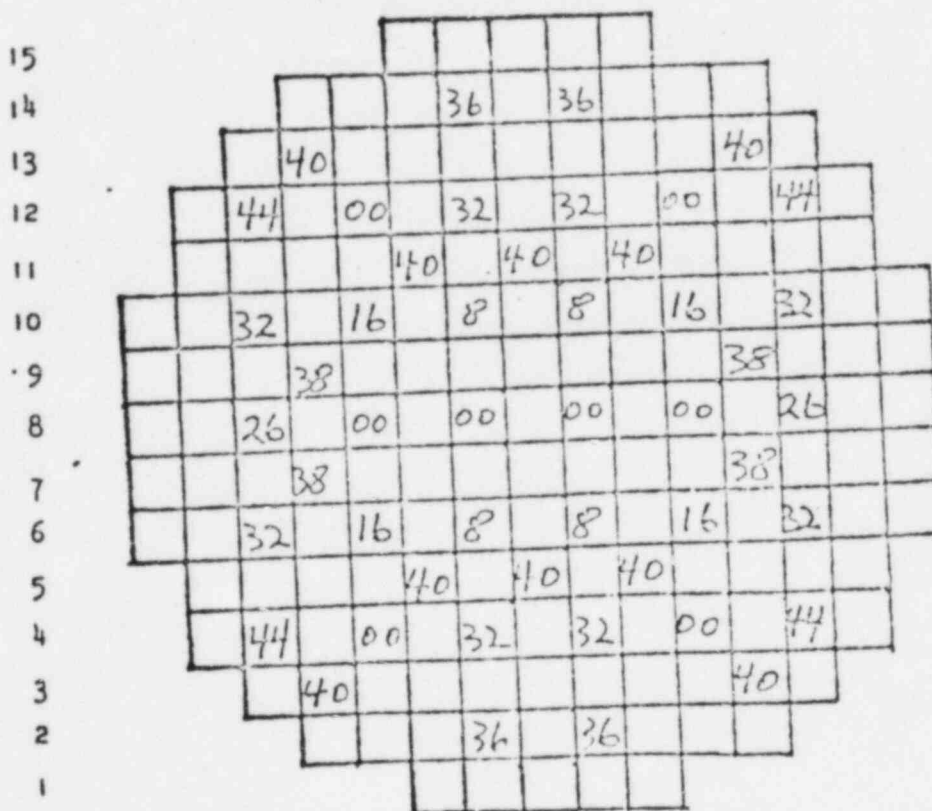
FIGURE 4(a)

Prior to reducing power.

K EFF		<u>1.00073</u>	
<del>26</del> S =		<u>2.062</u>	(A+R)
POWER LEVEL		<u>2227</u>	MW <sub>TH</sub>
CORE INLET SUBCOOLING		<u>21.5</u>	BTU/lb
TOTAL CORE FLOW		<u>86.7</u>	M-lb/hr (in channel)
PRESSURE		<u>1015</u>	PSIA
CRD		<u>B2</u>	0.121
DATE OF LAST SE- QUENCE CHANGE		<u>9-28-74</u>

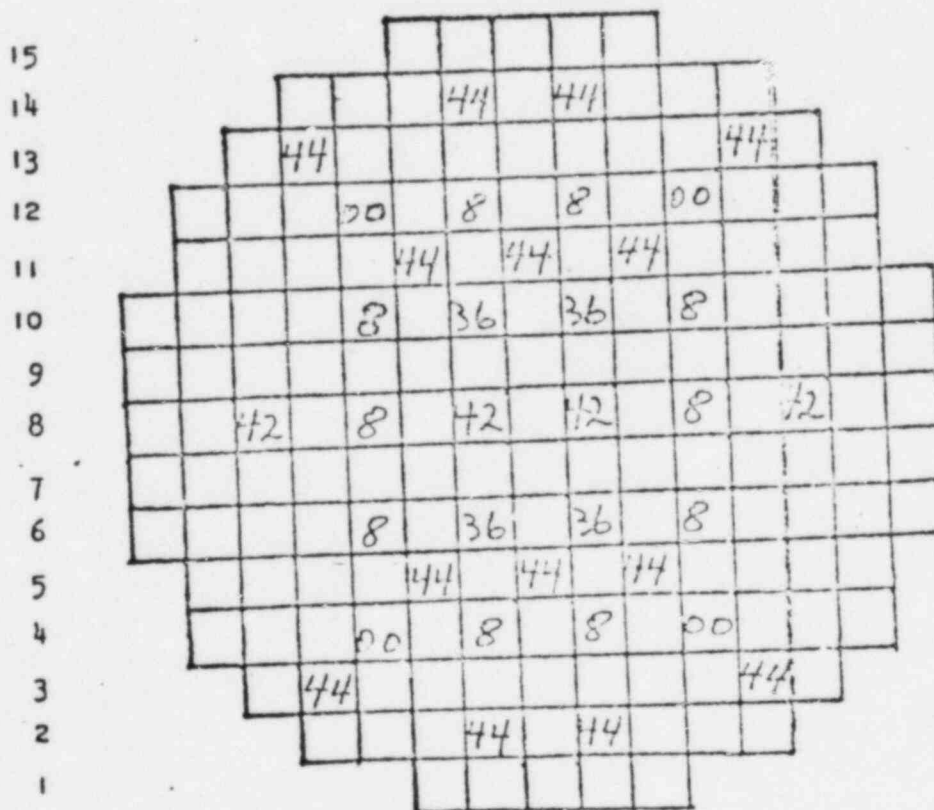
FIGURE 4(b)

6:57 AM conditions

K EFF	<u>1.00967</u>	
<del>SE</del> S =	<u>2.655</u>	(12, 6, 2) (AX ?)
POWER LEVEL	<u>1432</u>	NW <sub>TH</sub>
CORE INLET SUBCOOLING	<u>23.5</u>	BTU/lb
TOTAL CORE FLOW	<u>48.0</u>	M-lb/hr (in channel)
PRESSURE	<u>976</u>	PSIA
CRD	<u>0.034</u>	
DATE OF LAST SE- QUENCE CHANGE	<u>                    </u>

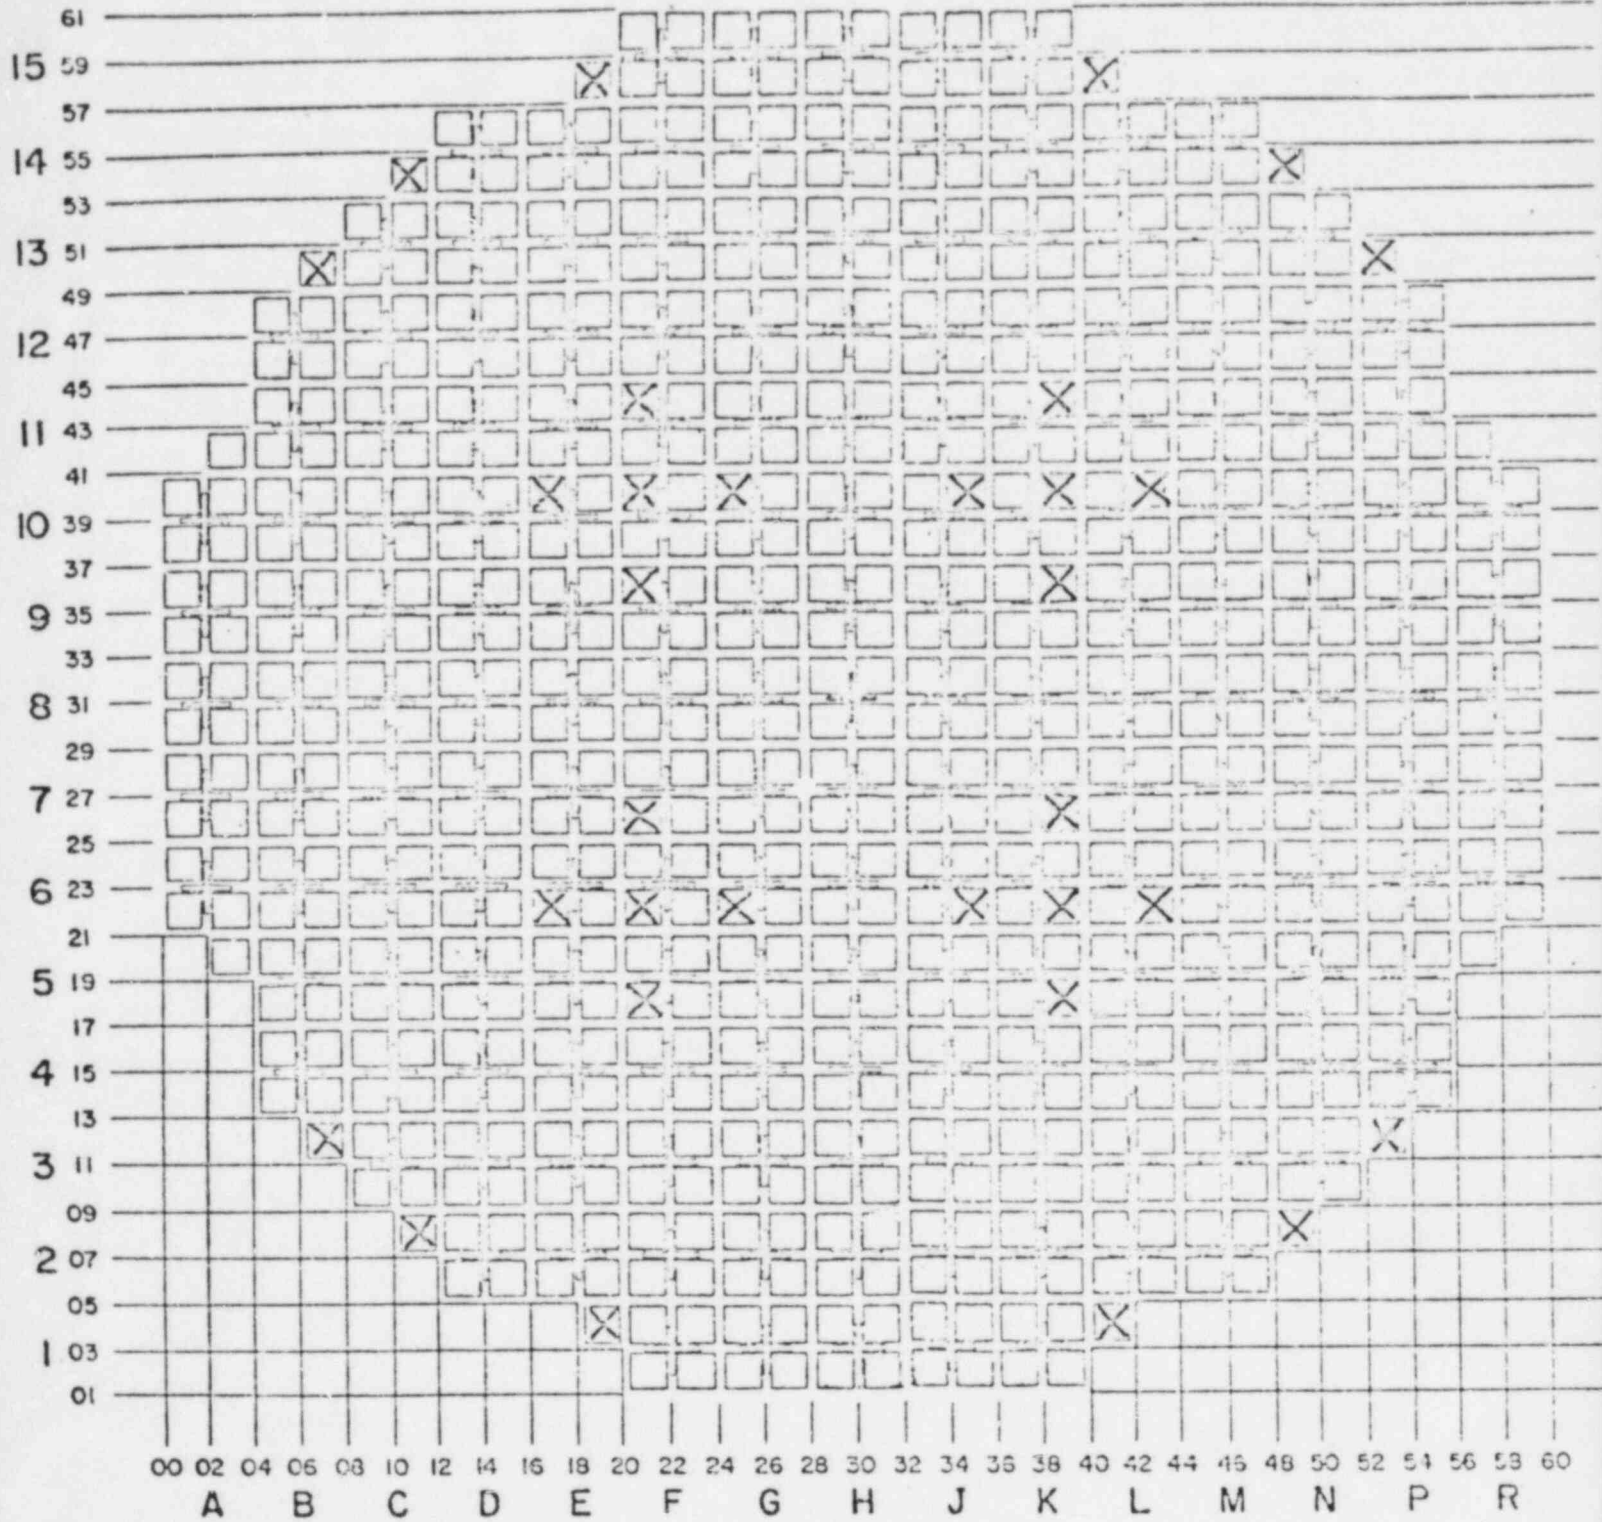
FIGURE 6

- (a) None of the Cycle 2 edge assemblies, including those moved to the center for Cycle 3, failed - Figure 6.
- (b) There were three assemblies from cells that had 3 out of 4 failures at ECC-1 that were moved to uncontrolled locations on the edge for Cycles 2 and 3. None of these three has failed yet.
- (c) Four edge assemblies failed during Cycle 3. One, DDO209, was classified as a suspect leaker at ECC-2.
- (d) Of 50 Cycle 3 assemblies that were reconstituted at ECC-1, six failed. All but one may be attributed to 10-31-74.

Edge assemblies during cycle 2

10-31-74 average exposure  
 $\approx 7400 \text{ mwd/T}$

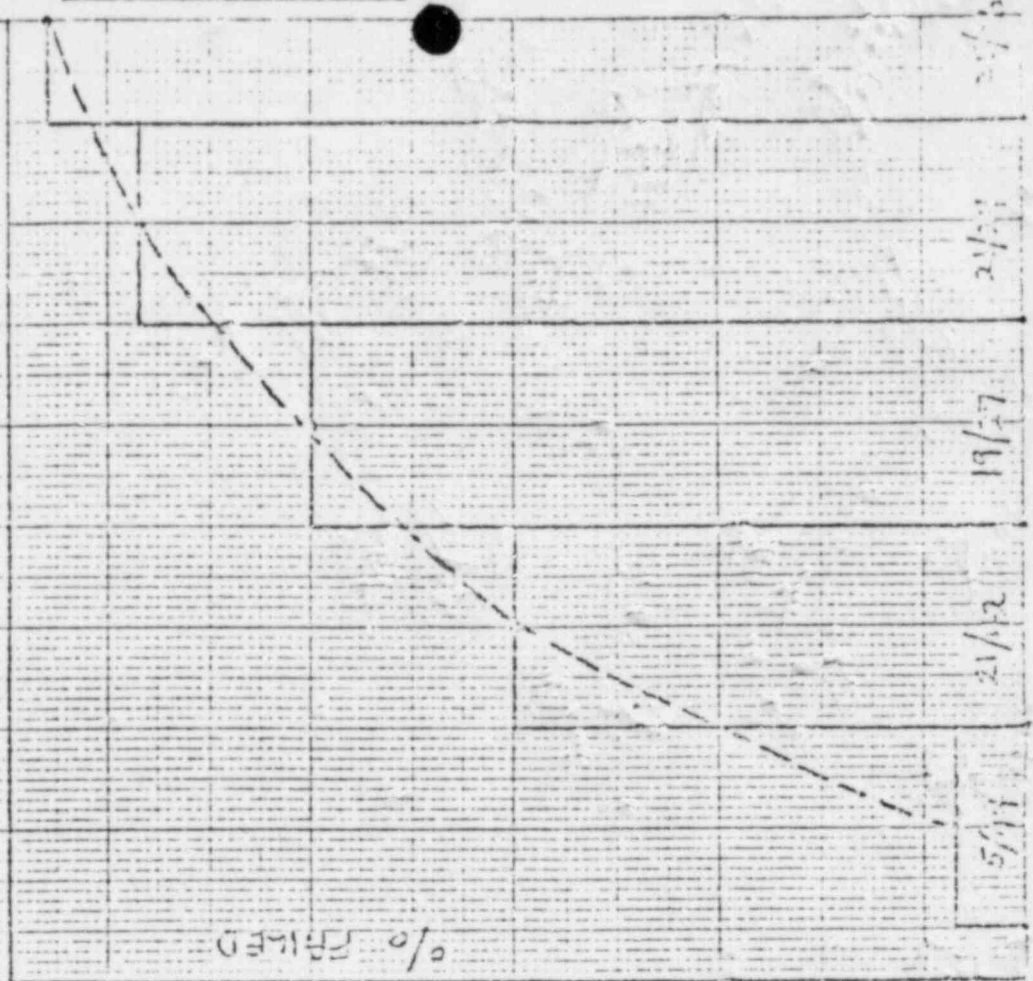
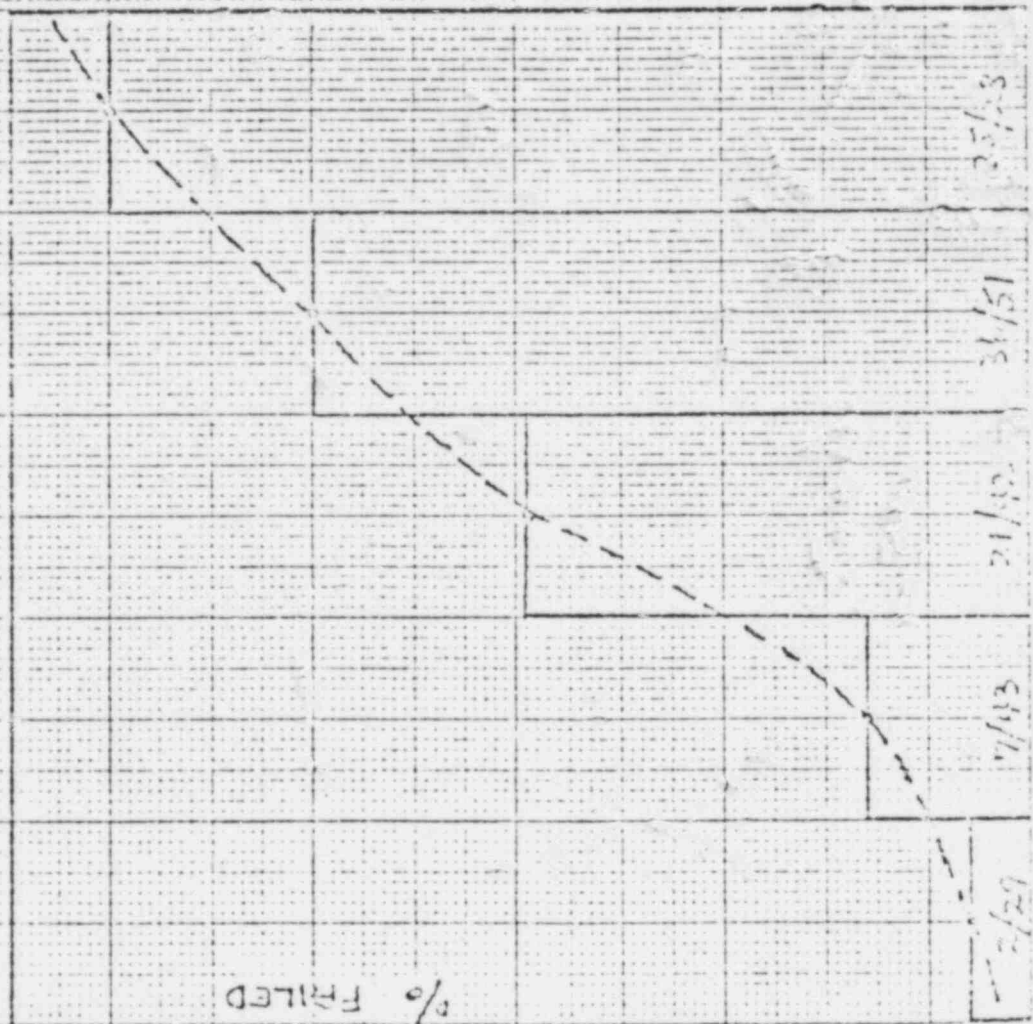
An analysis was done with a FLARE-type code to determine the kW/ft of nodes that exceeded 8 kW/ft on a pin. The study was done at equilibrium xenon for 12-inch nodes (a correction factor was applied to account for transient xenon). The results are summarized in Figure 8. Only original core fuel is included, and power changes were assumed to be instantaneous. Some comments on the results follow:

- (a) The failures do not appear to be related to previous cycle operation.
- (b) 22 Failures of 433 assemblies (5%) were at less than 8 kW/ft on 10/31/74. Thus, none of these was assumed to be related to the October 31, rod movements.
- (c) 5 of 74 assemblies (7%) failed when the envelope (or 8 kW/ft, which ever was greater) was violated by 1 kW/ft or less. The failure rate increased rapidly as the step change above the envelope increased.
- (d) The effect on fuel failures of more gradual increases in power, soak periods, exposure, and length of time fuel remains "preconditioned" requires more data than is currently available.

% FAILED OF THOSE ASSEMBLIES  
WITH CERTAIN  $\Delta$  KW/FT ABOVE  
THE ENVELOPE AT 6:57 A.M.

% FAILED OF THOSE ASSEMBLIES  
WITH CERTAIN PEAK KW/FT AT  
6:57 A.M.
