Examination and Evaluation of
Safe End From Nozzle N6B on
Nine Mile Point Reactor

DC-65

5 March, 1970

Prepared for: Division of Compliance
United States Atomic Energy Commission

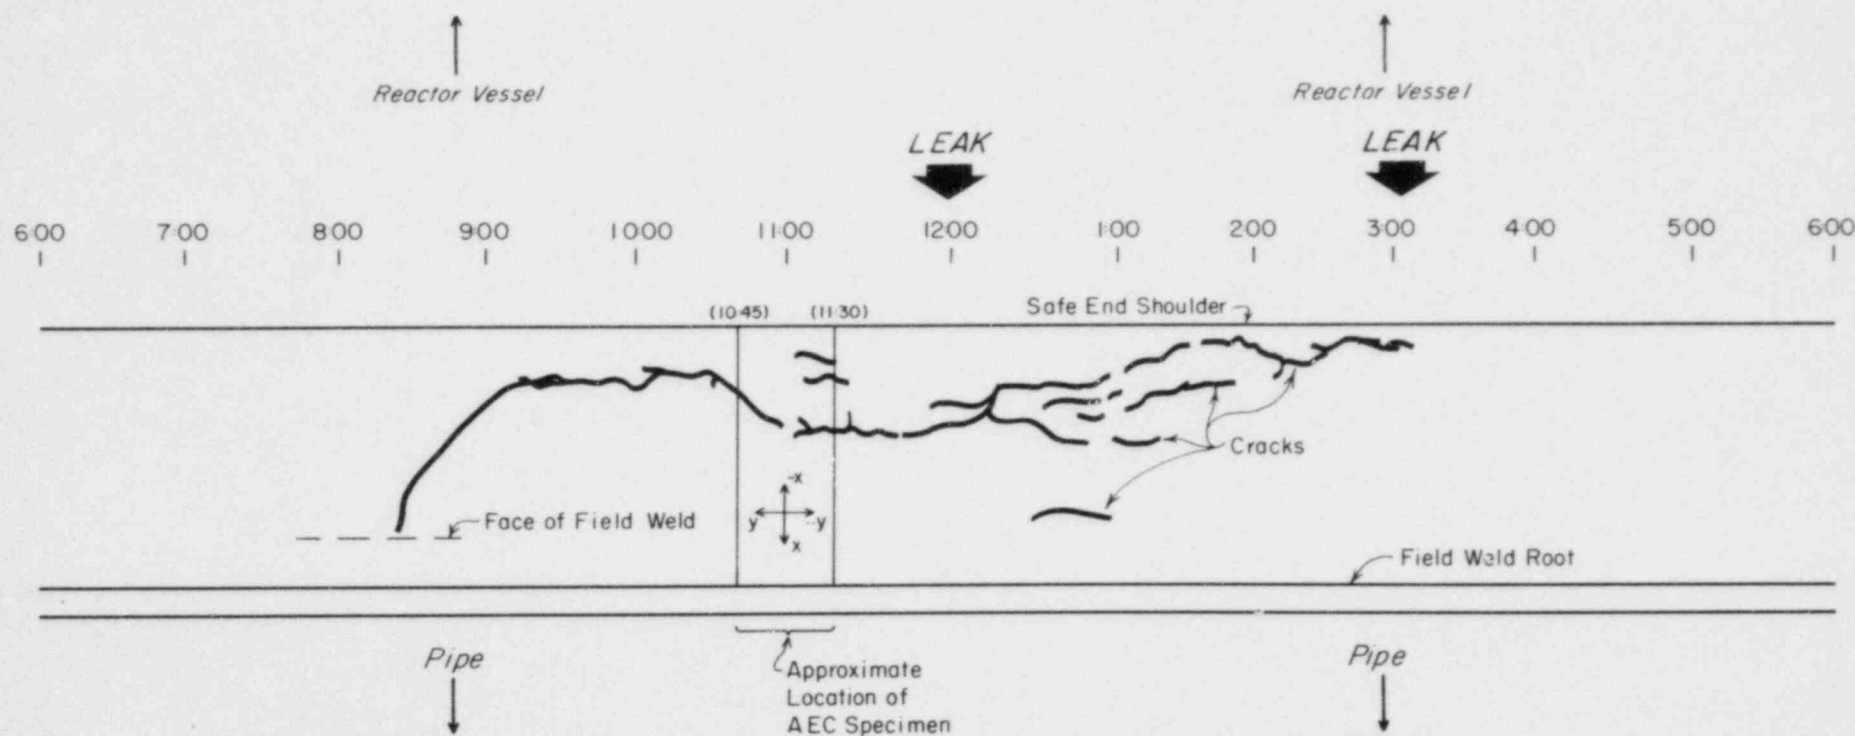
The region from which the specimen was removed is shown in figure 1. The region of cracking was determined from radiography performed before the specimen was removed. The arrangement of cracks as determined in radiography is shown schematically in figure 2. This radiograph was taken by GE personnel and the determination was made through a double thickness of metal (i.e. through both walls).

Figure 2. Schematic description of radiographic indications from safe end showing location of cracks. The 12:00 position was the top of the tube. Radiographs were taken through the double thickness of the tube before specimens were removed. Location of the AEC specimen is noted. Approximate location of leaks noted.

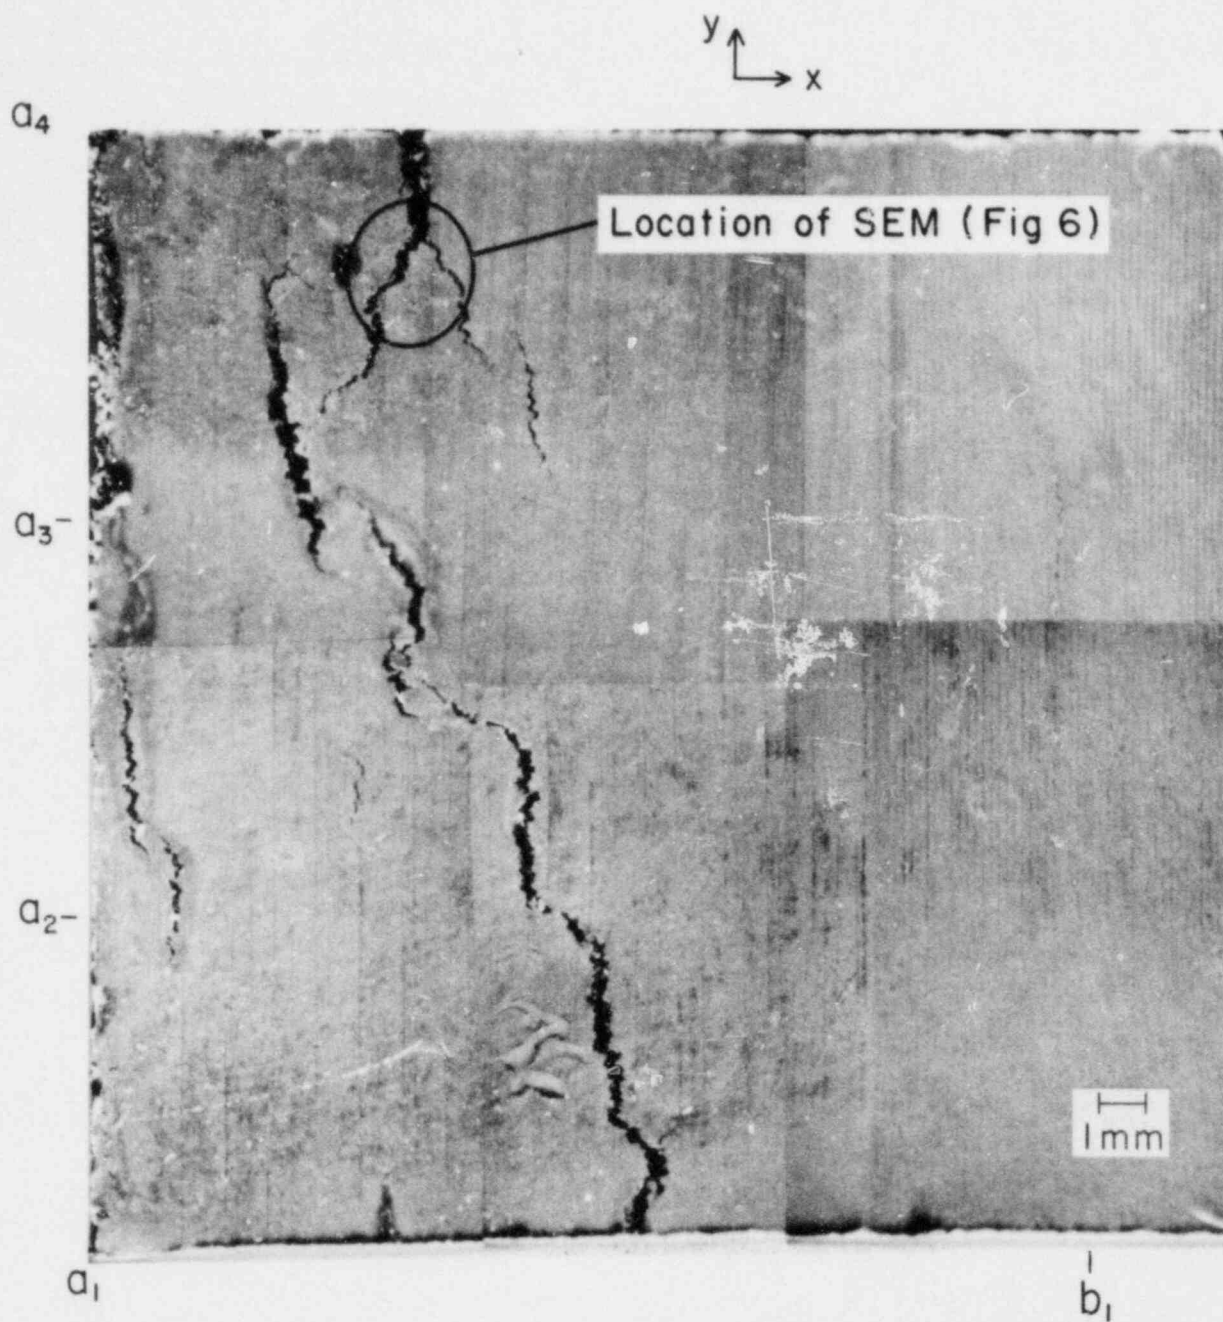
Figure 5 shows an inside view of the AEC specimen surface where the cracking was most extensive. This cracking was most extensive next to cut number 3, i.e. the end of the specimen toward the reactor vessel.

Figure 5. Optical macrograph showing view of inside surface of the AEC specimen. Coordinates relate to figure 4. Circled region shows site where scanning electron micrograph obtained (figure 6).

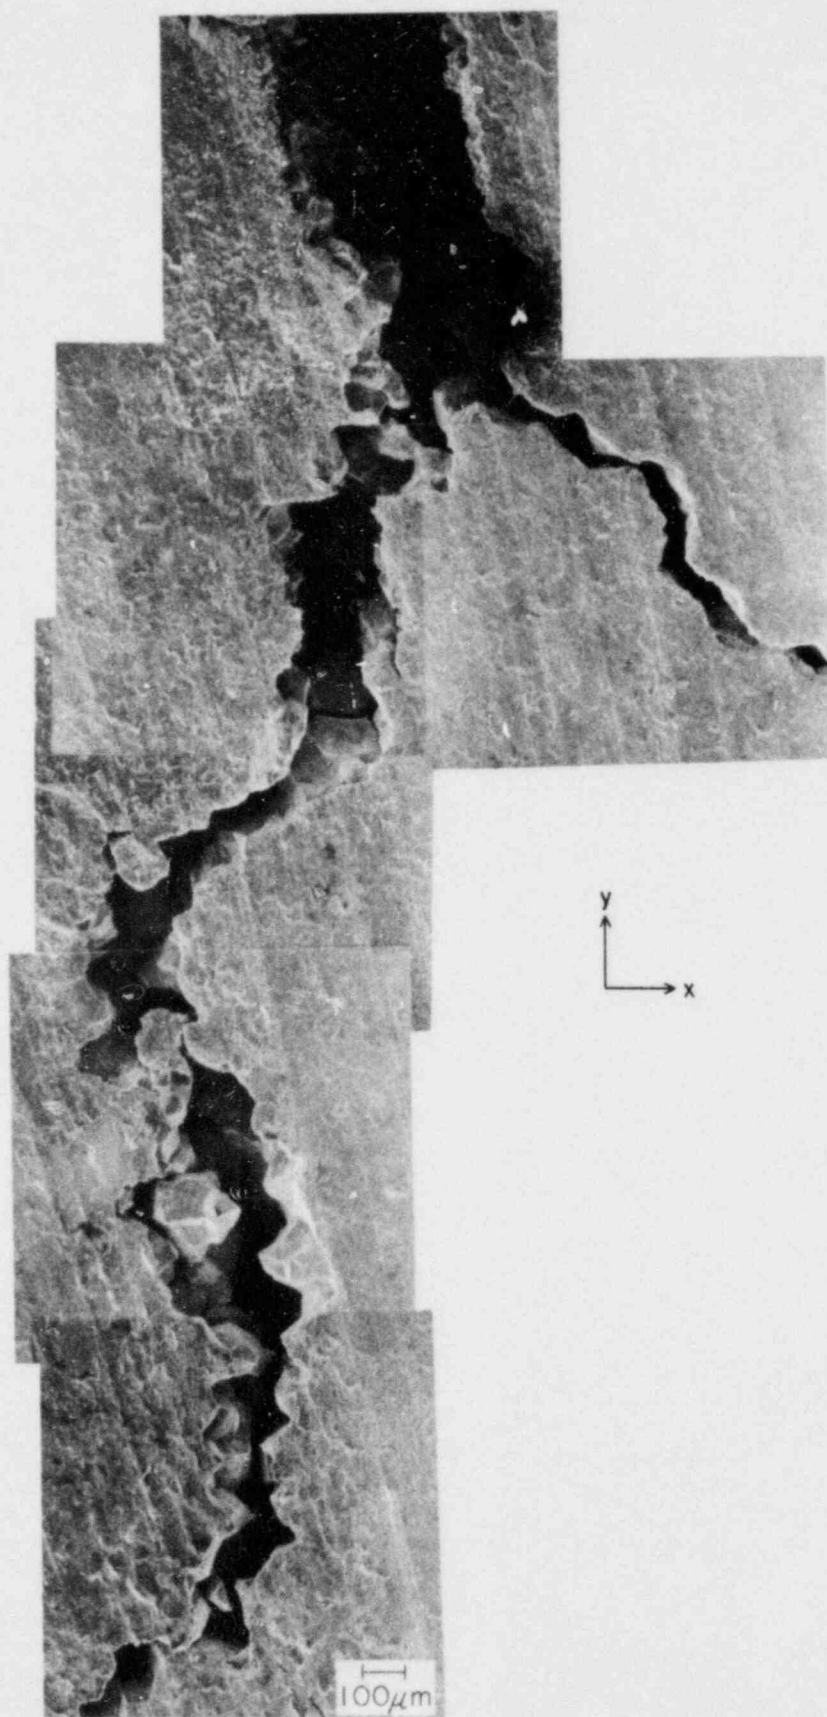
Figure 6 is a scanning electron micrograph from the region circled in figure 5. This shows the inside surface of the pipe and looks into the crack in the +z direction. The cracking is clearly intergranular. There appears to be little evidence of any significant plastic deformation. A further significant observations here is that there is no pattern of intergranular penetration on the surface. This suggests that the cracking process is not a stress assisted intergranular corrosion but is a type of stress corrosion cracking.

There is no evidence that this failure is simply an intergranular corrosion phenomenon which was accelerated by stress. The SEM micrograph of figure 6 shows no evidence of general intergranular corrosion. The only attack apparent is associated with the crack itself.*

Figure 6. Scanning electron micrograph from inside surface of AEC specimen.
Note site of micrograph in figure 5.

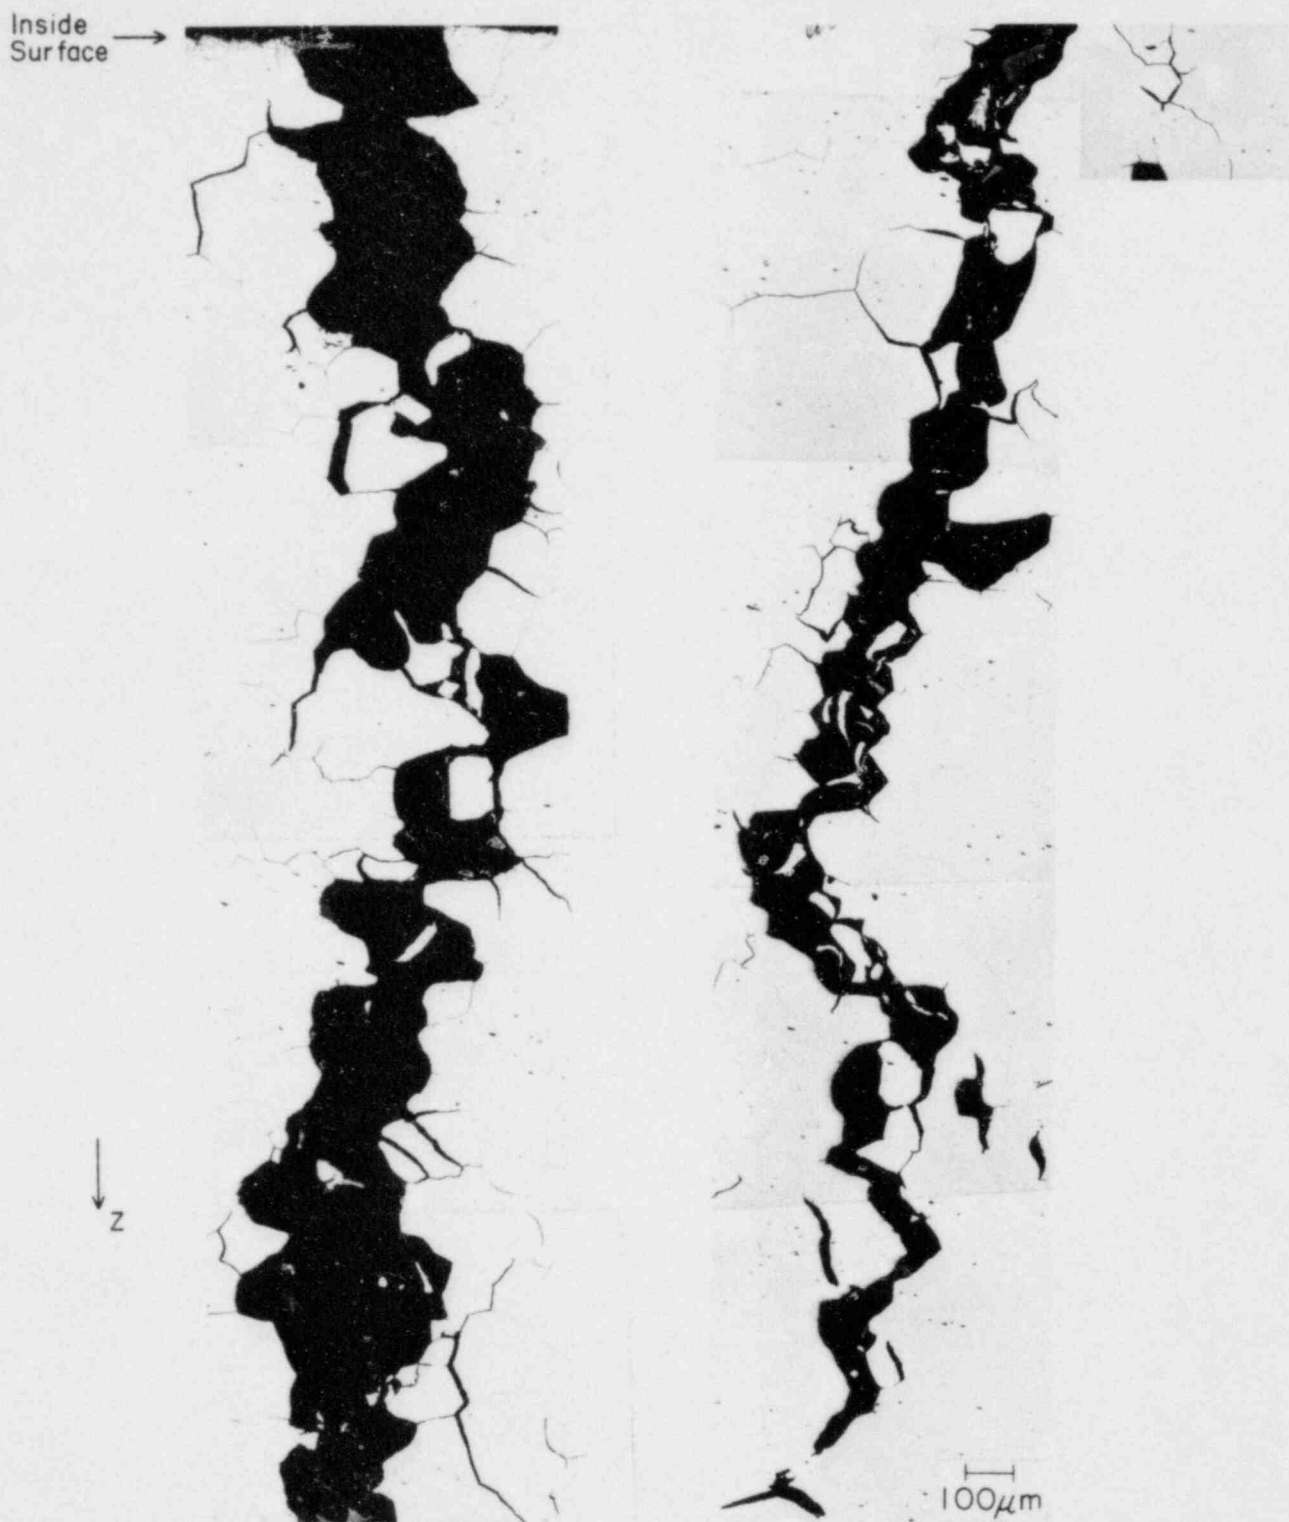
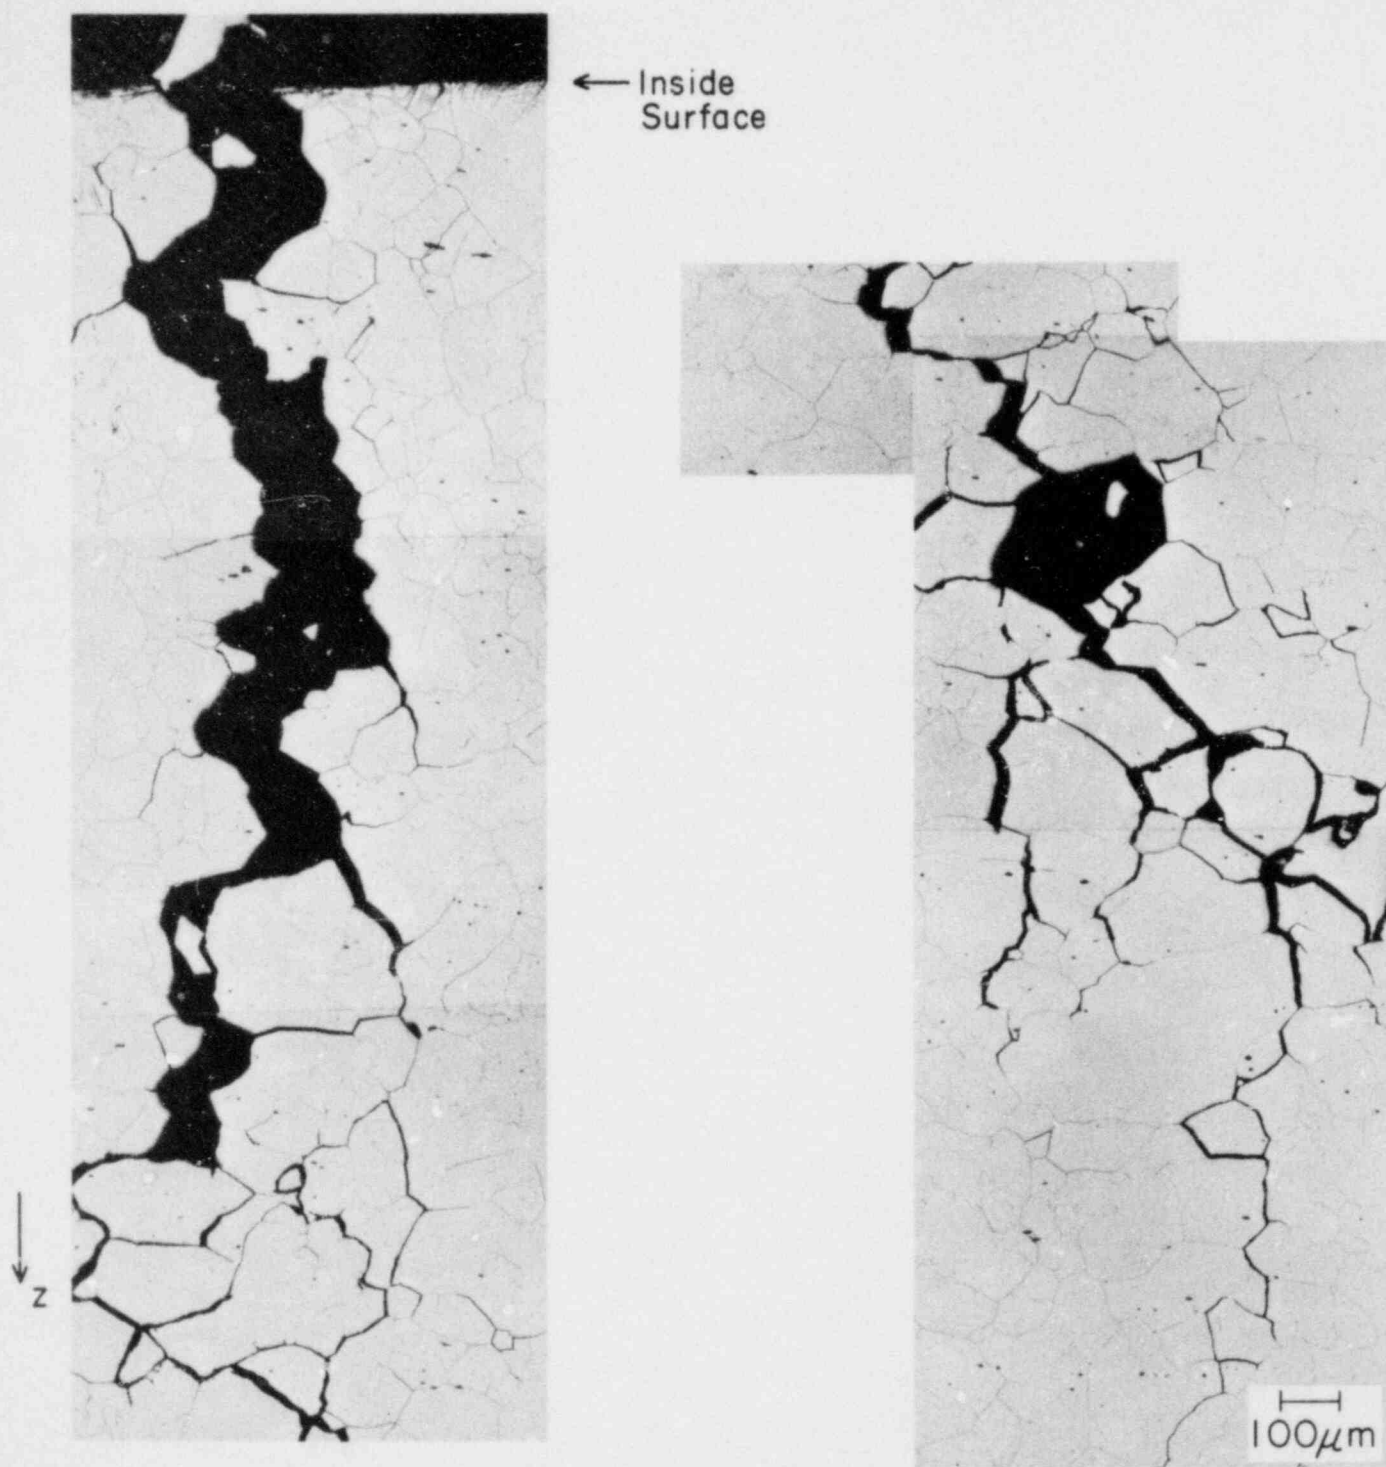
Figures 7 and 8 are optical micrographs from specimen B on the a_2 - b_2 face looking in the +y direction. The cracks start from the inside surface and progress in the +z direction. On these figures it should be particularly noted that there is little evidence of significant plastic behavior of the material. There are no strain markings nor do the grains at the fracture edge have a "taffy-like" appearance indicative of gross local plastic deformation.

This observation is significant in the latter discussion where the differences between stress corrosion cracking and purely mechanical failures are discussed. The former usually exhibits little local deformation associated with the crack.

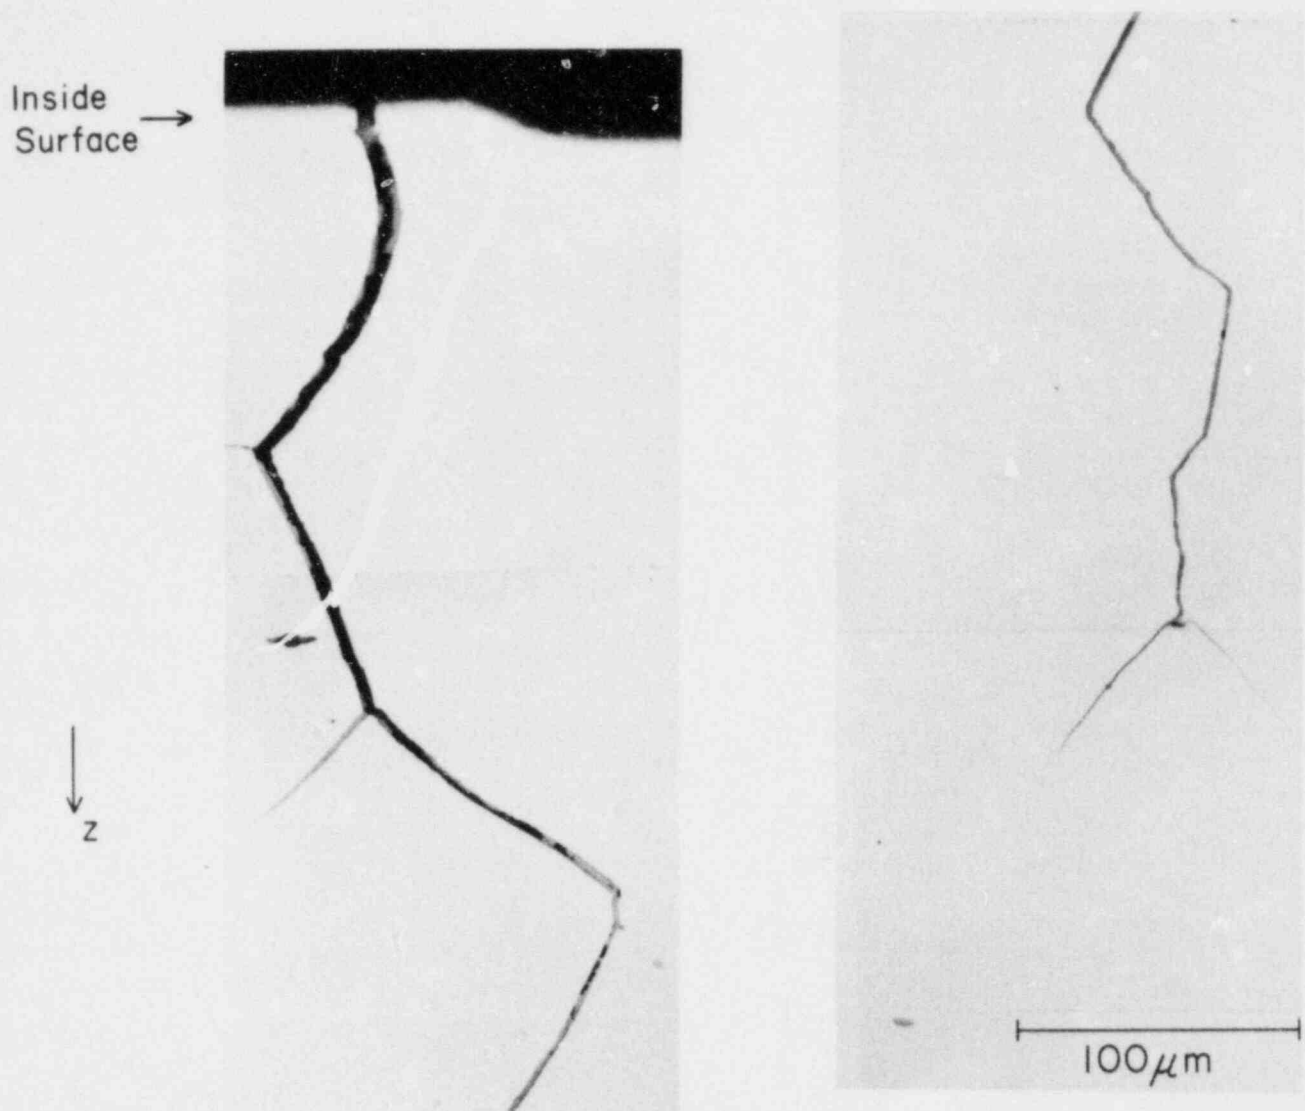
Figure 9 is an optical micrograph showing a crack from specimen E along the b_2 - c_3 face and looking in the +y direction. This cracking mode is again intergranular but the extent drops off with the distance away (+x direction) from a_1 - a_4 interface. This suggests that residual stresses from the weld and also the adjacent thickness discontinuity (See Fig. 1) interacted with the moment in the pipe due to differential expansion of the vessel and vertical pipe. This moment was presumably constant over the safe end. This interaction suggests that the observed cracking is strongly stress dependant. It further suggests that the crack may have initiated and propagated only when the reactor was at power.

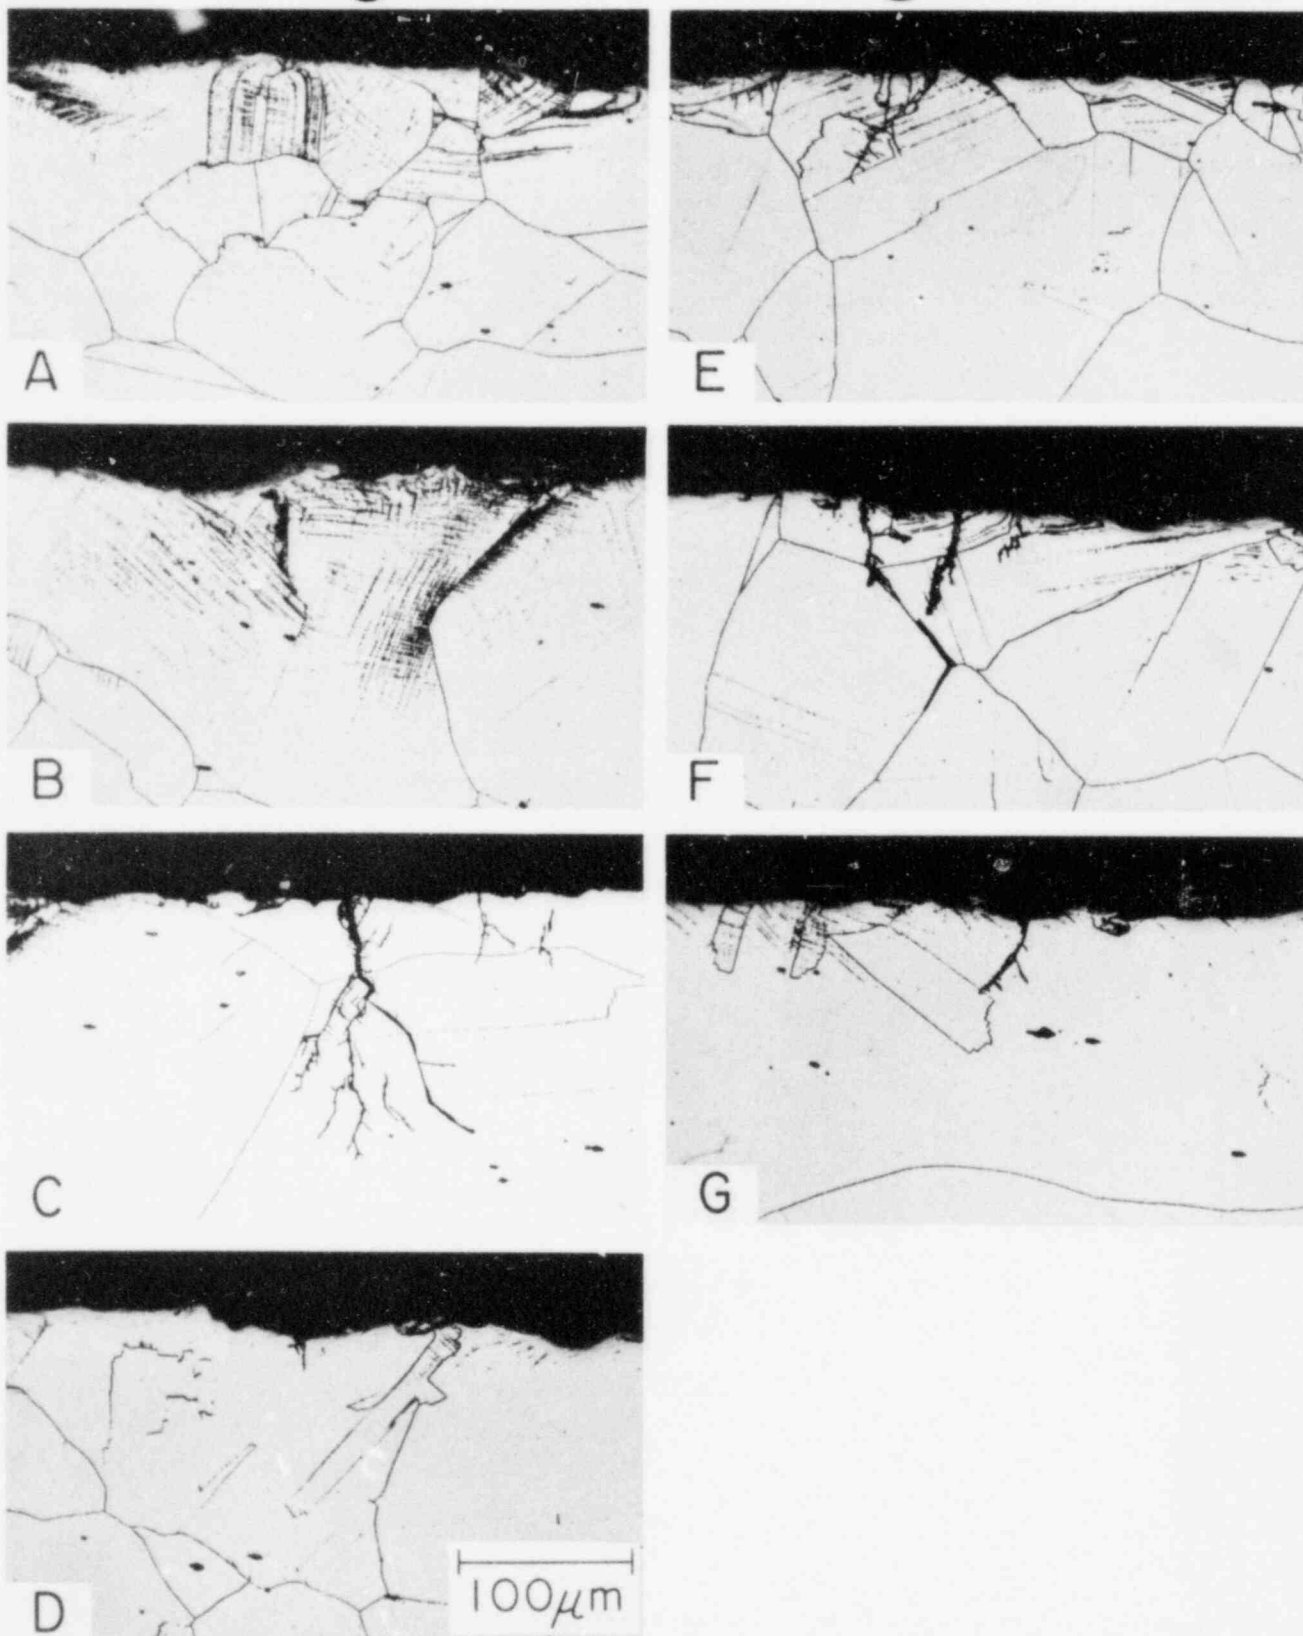
The outside surface of the AEC specimen was also examined metallographically. Figure 10 shows schematically where a specific set of specimens was taken from specimen B. These specimens were taken from the a_2 - b_2 face of specimen B and looking in the +y direction. The capital letters (A,B,C ...) indicate approximate locations where micrographs were taken. These micrographs are shown in figure 11 and have letter designations corresponding to those of figure 10. Figure 11 shows that transgranular cracks had initiated from the outside surface. Some of the specimens show extensive evidence of strain markings near the surface. These should be compared with the edge of the crack in figures 8 and 9 where no such strain markings are evident. This comparison is again significant with respect to establishing whether the intergranular cracking from the inside surface was due to stress corrosion or to a purely mechanical type of failure. The strain markings of figure 11 are no doubt the result of rough handling of the piping during construction. This amount of cold work, in itself, at this location is probably not significant. The point to be made here is simply that the evidence of strain markings on the surface is not associated with the intergranular cracks.

Another factor of significance is the relatively limited extent of these cracks into the metal. Since relatively high stresses are known to be required for the intergranular cracks and since the chloride induced transgranular cracks propagate easily at 20-50% of the yield, it would seem that the transgranular cracks would have progressed further if the chloride were present at the site of cracking over the entire duration of the plant operation. While there are obvious alternatives to this interpretation (i.e. lack of moisture, too low a chloride concentration), this limited extent of cracking will be discussed later with respect to fixing the time of cracking.

Figure 11. Photomicrographs of cracks on outside surface of specimen B. Cracks are propagating in the $-z$ direction. Surface viewed is the $x-z$ plane.

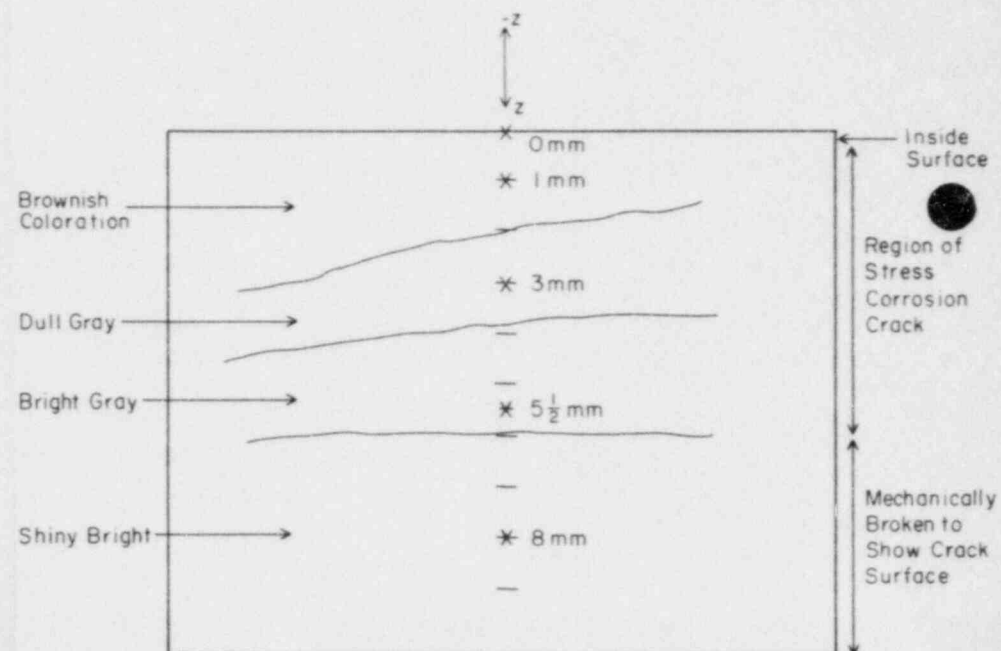
The surfaces of the cracks were examined optically and a color photograph of the cracked surface is shown in figure 12a. The cracked surface appears to have three zones. The first (next to the inside surface) is generally dark brown; the next is a dull gray; and the third (next to crack root) is a bright gray. Beyond this the shiny bright region is the result of breaking the specimen open to expose the surface.

These different regions on the crack face were examined using the scanning electron microscope. A series of pictures at various magnifications was taken at each of these discrete regions. A schematic figure showing these regions is given in figure 12b. The scanning electron micrographs are shown in figures 13-17. These figures are designated as 0 mm, 1 mm, 3 mm, 5-1/2 mm, and 8 mm - these being the respective distances away from the inner surface in the +z direction. The plane of the crack surface is approximately parallel to the y-z plane.

Figure 12. View of face of crack. Crack face is in the y - z plane. Specimen broken apart for viewing. (a) Ektachrome color print and (b) Schematic diagram showing various regions of crack. Distances from inside surfaces noted locate sites where scanning micrographs taken. Specimen broken open to show surface of stress corrosion crack. Shiny bright region results from this breaking process.

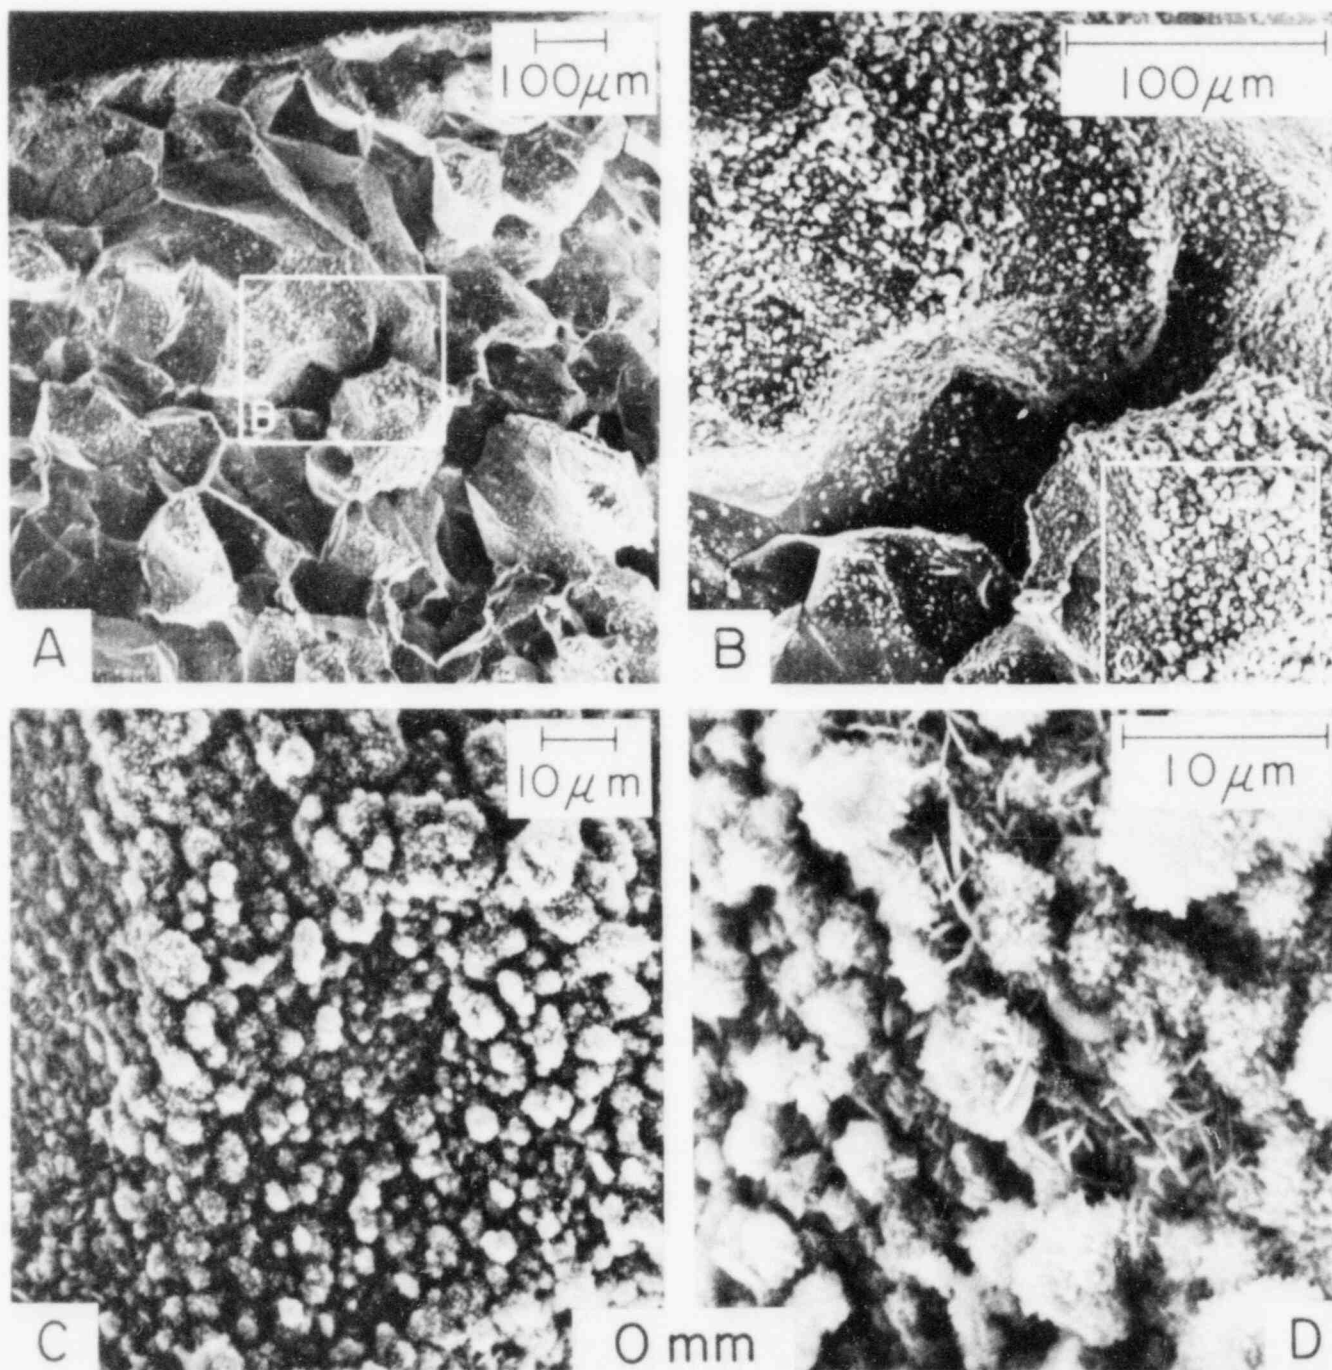
The micrographs of figures 13-17 show clearly that the crack is intergranular and that very little gross plastic deformation occurred.

Of particular interest, especially at the higher magnifications is the morphology of the corrosion product. The corrosion product on the 5-1/2 mm point (figure 16) has a shape often found on surface exposed to high temperature water at high pH¹. These shapes are typical of those formed by precipitation from the solution. The precipitates at the 3 mm site (figure 15) appear to have some structure but to be less well formed. At 1 mm (figure 14) the precipitates seem to have little structure at all. At the 0 mm (figure 13) site, just inside the inside surface of the specimen, the precipitates

form an altogether different shape. The essential features of this shape is a spherical "pebble" with "needles" emanating from the surface. The micrograph of the intentionally broken region at 8 mm (figure 15) shows the expected ductile behavior.

Figure 13. Scanning electron micrographs of stress corrosion crack surface corresponding to 0 mm position noted in figure 12.

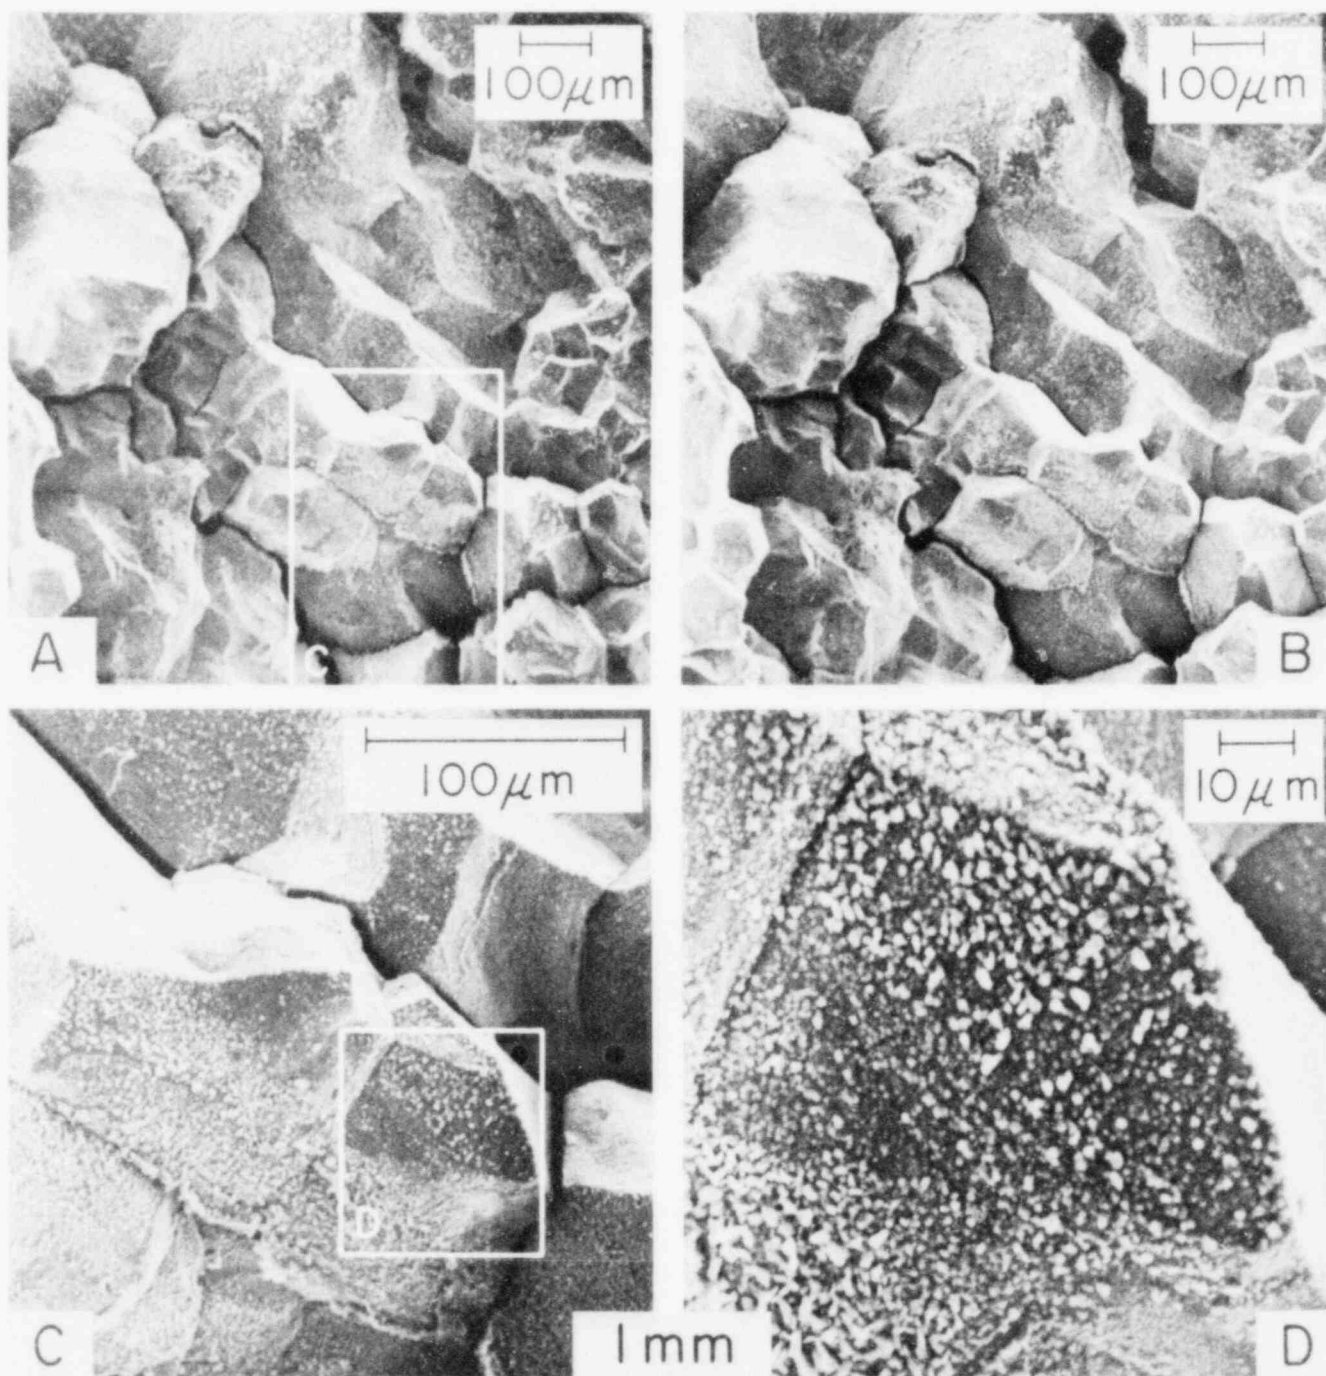
Figure 14. Scanning electron micrographs of stress corrosion crack surface corresponding to 1 mm position noted in figure 12.

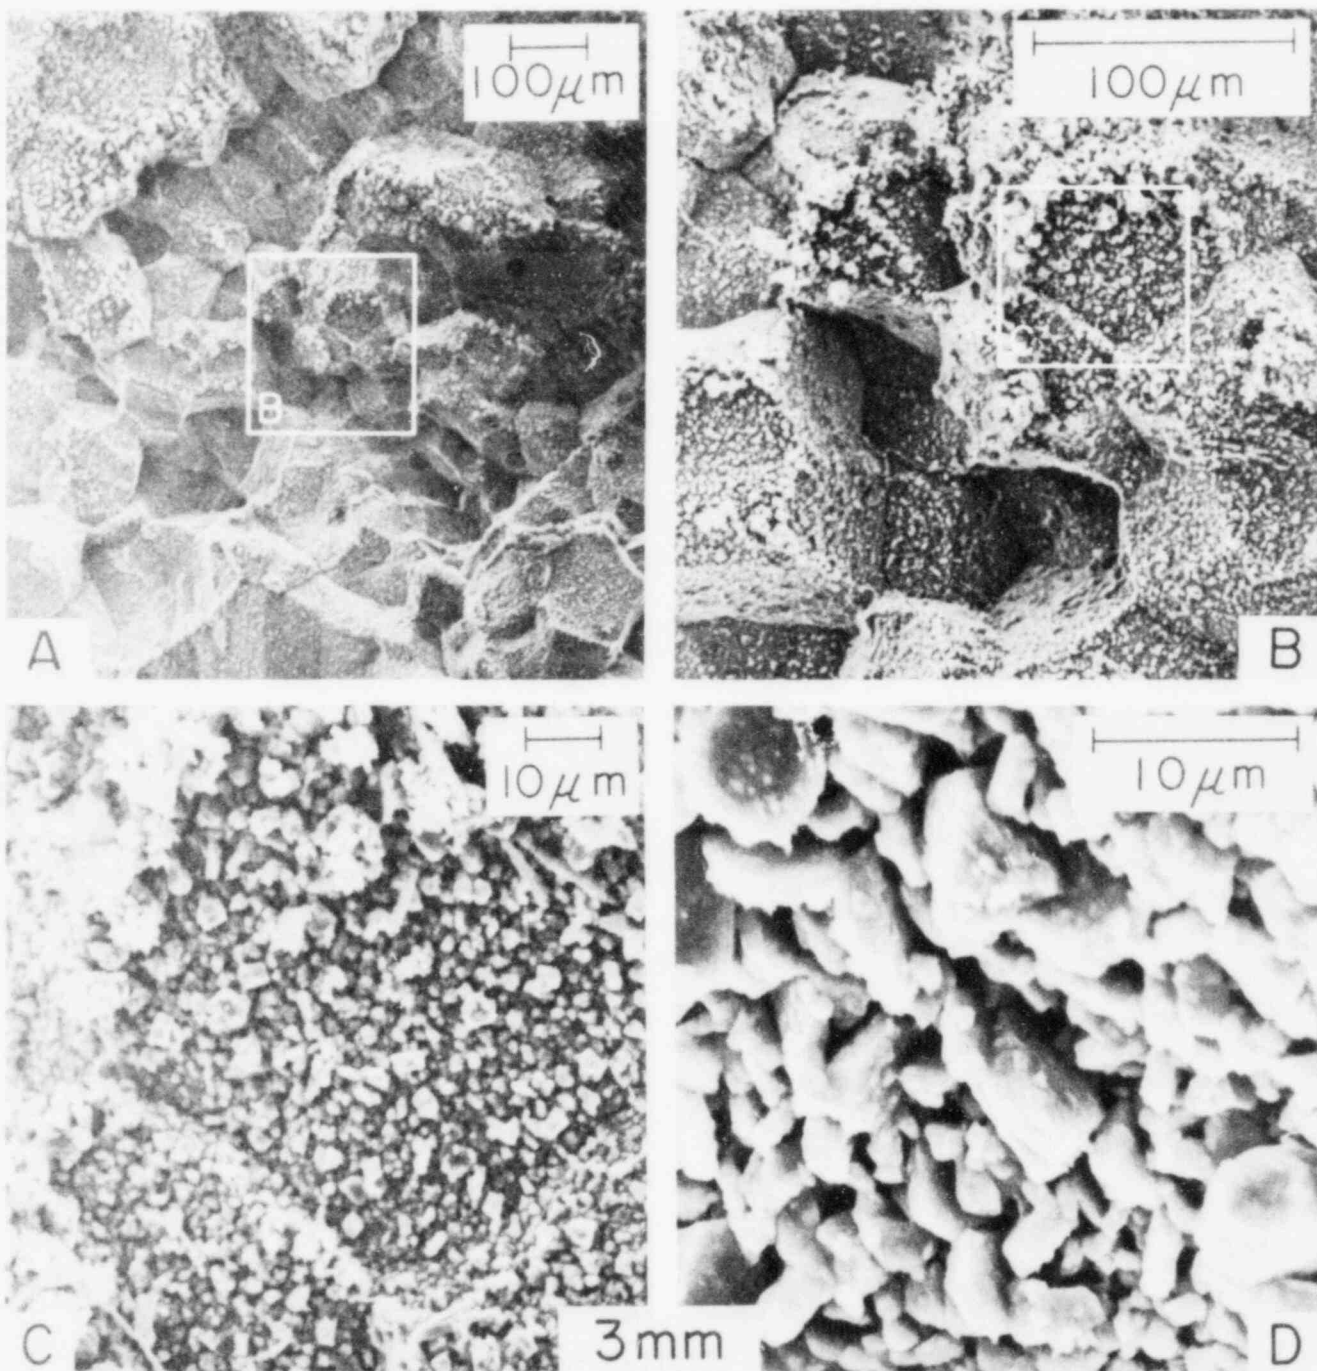
Figure 15. Scanning electron micrographs of stress corrosion crack surface corresponding to 3 mm position noted in figure 12.

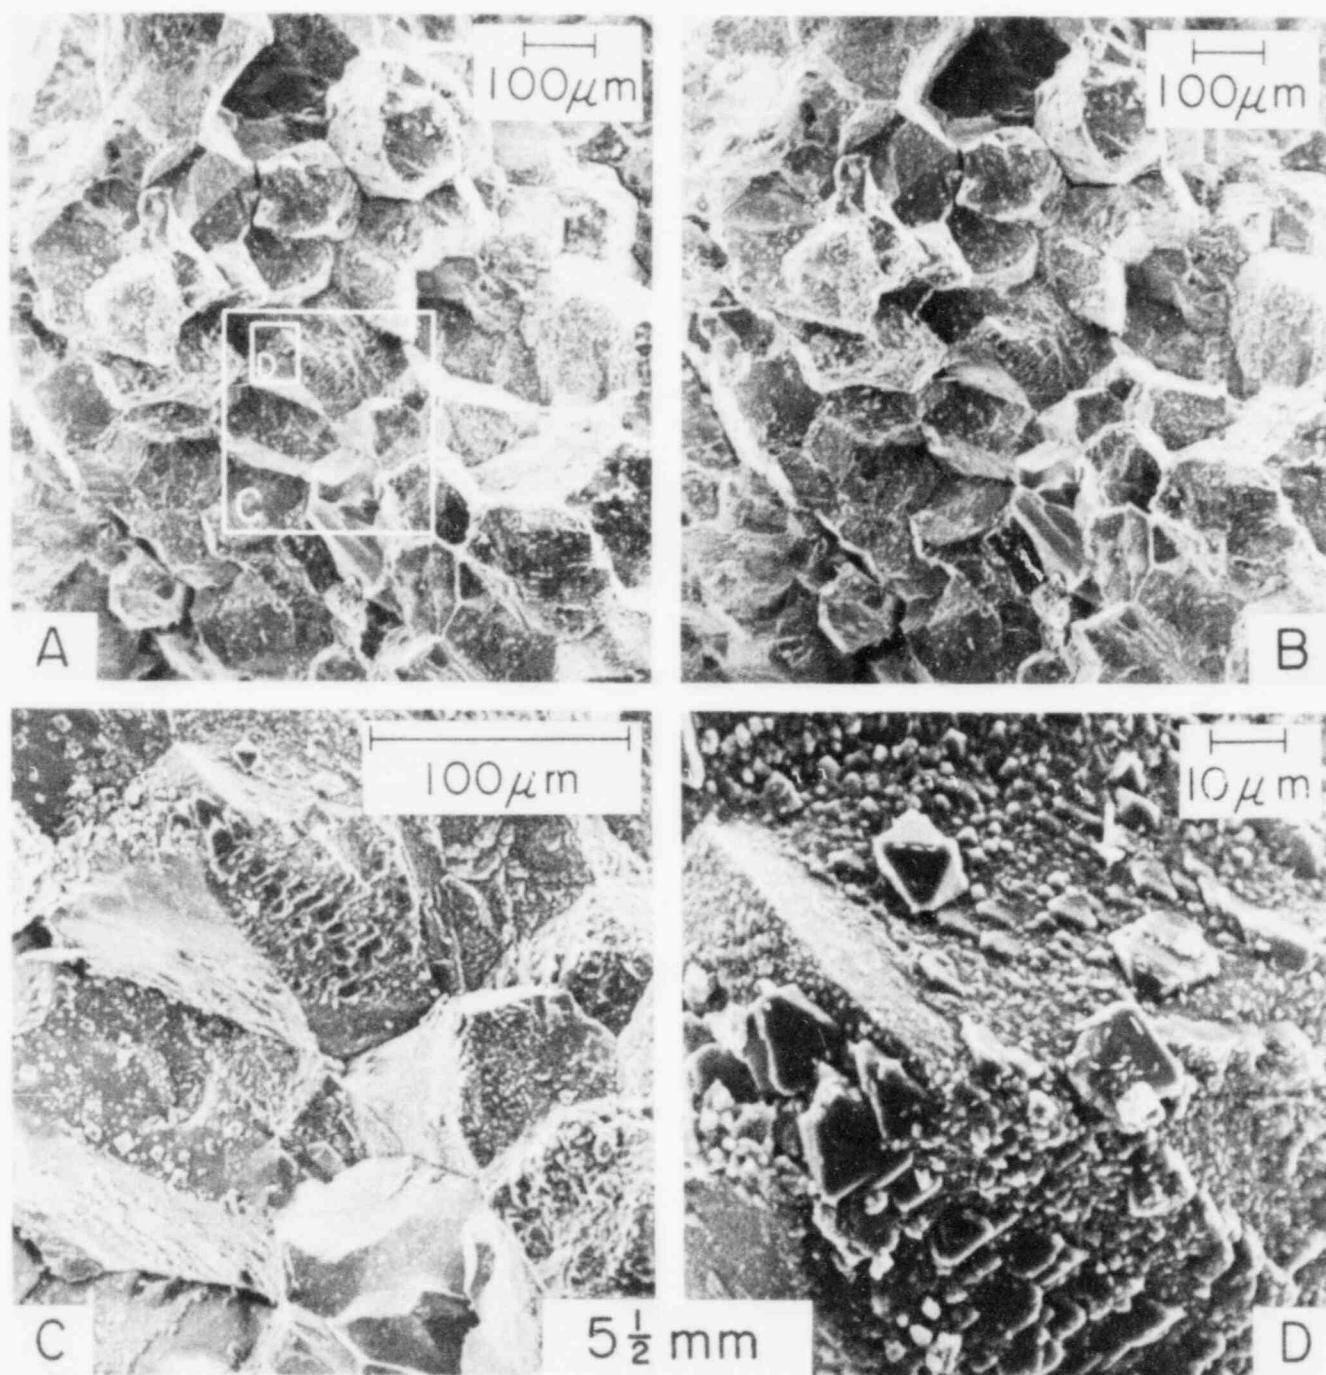
The octahedral morphology of the crystals at the 5-1/2 mm position of figure 25 has been observed before by Kabele and Daniel¹ who examined the corrosion products on stainless steel surfaces in static autoclaves. This octahedral morphology is that usually preferred by magnetite.

Figure 16. Scanning electron micrographs of stress corrosion crack surface corresponding to 5-1/2 mm position noted in figure 12.
