Examination and Evaluation of
Safe End From Nozzle N6B on
Nine Mile Point Reactor

DC-65

5 March, 1970

Prepared for: Division of Compliance
United States Atomic Energy Commission

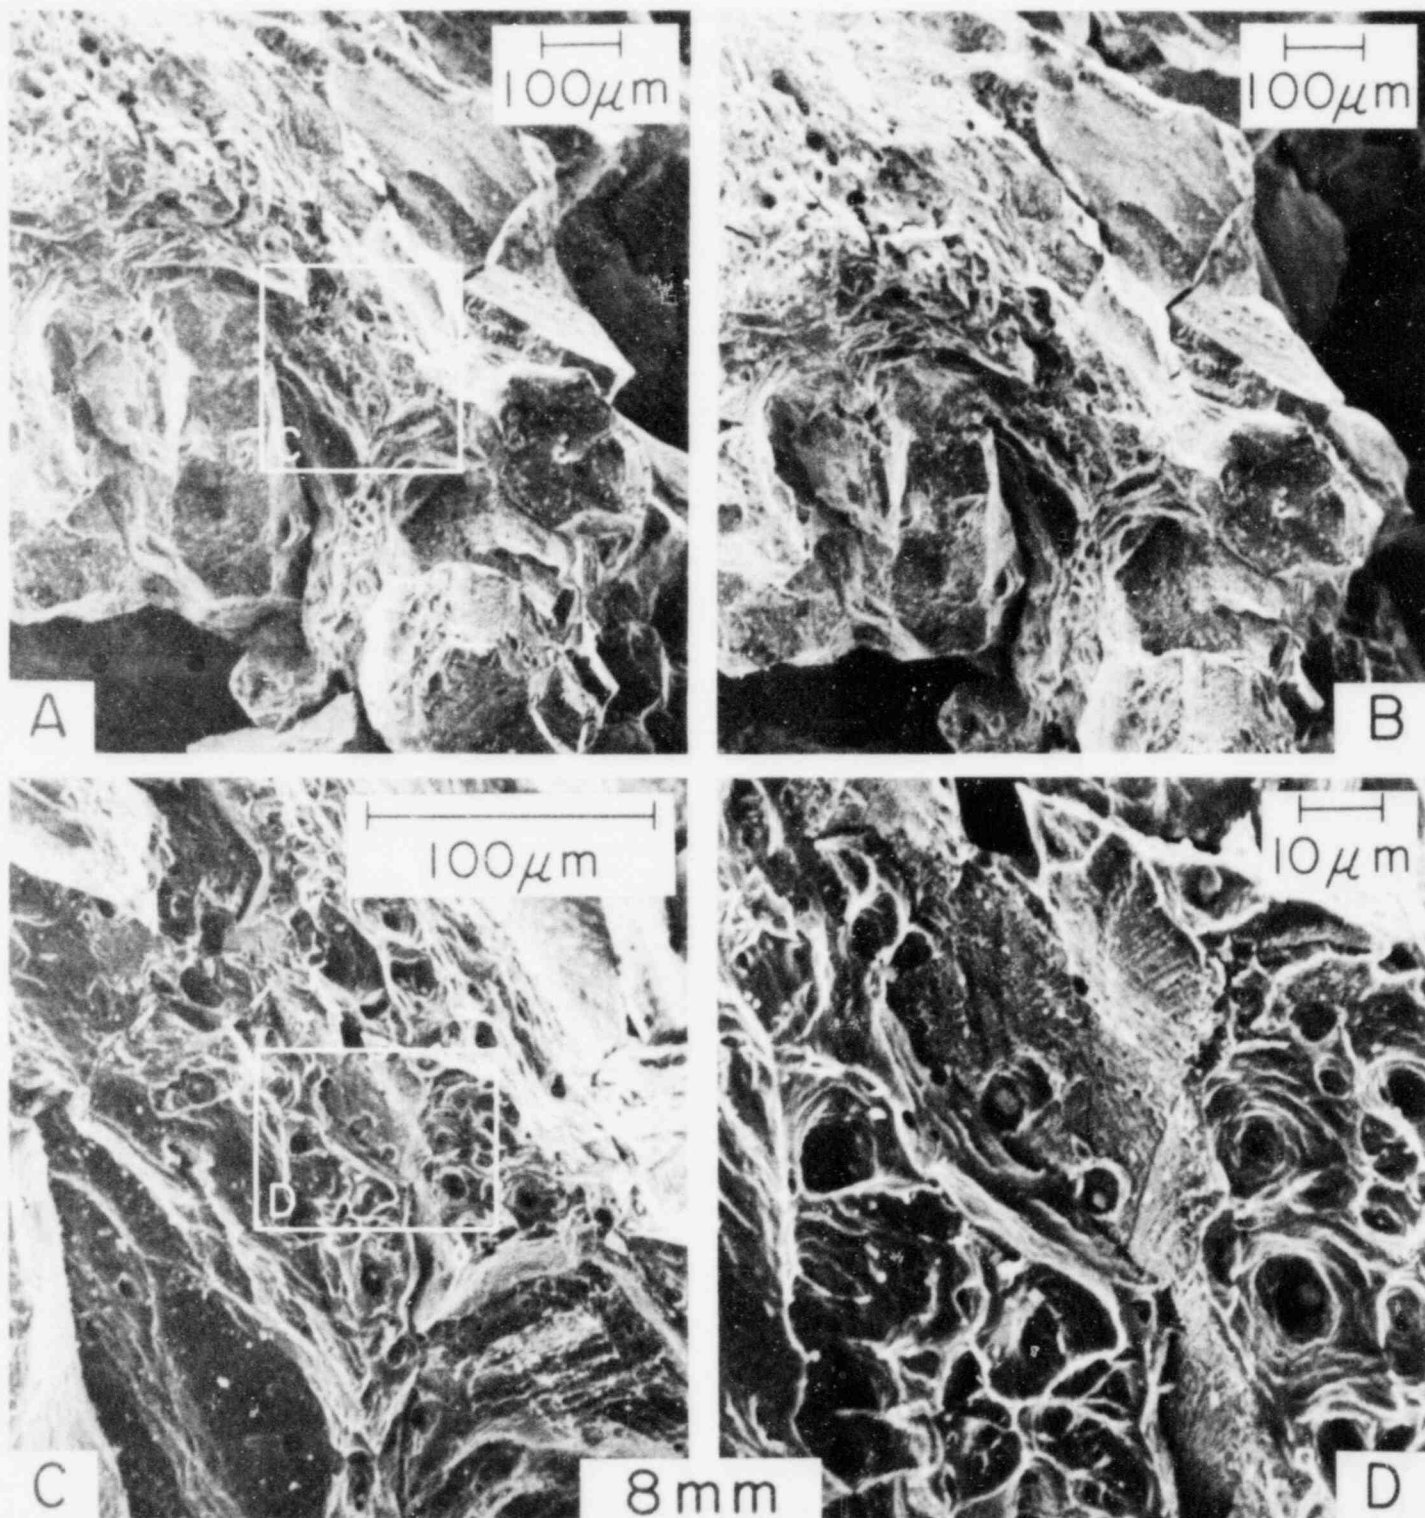
The micrographs of figures 13-17 show clearly that the crack is intergranular and that very little gross plastic deformation occurred.

Figure 17. Scanning electron micrographs of stress corrosion crack surface corresponding to 8 mm position noted in figure 12.

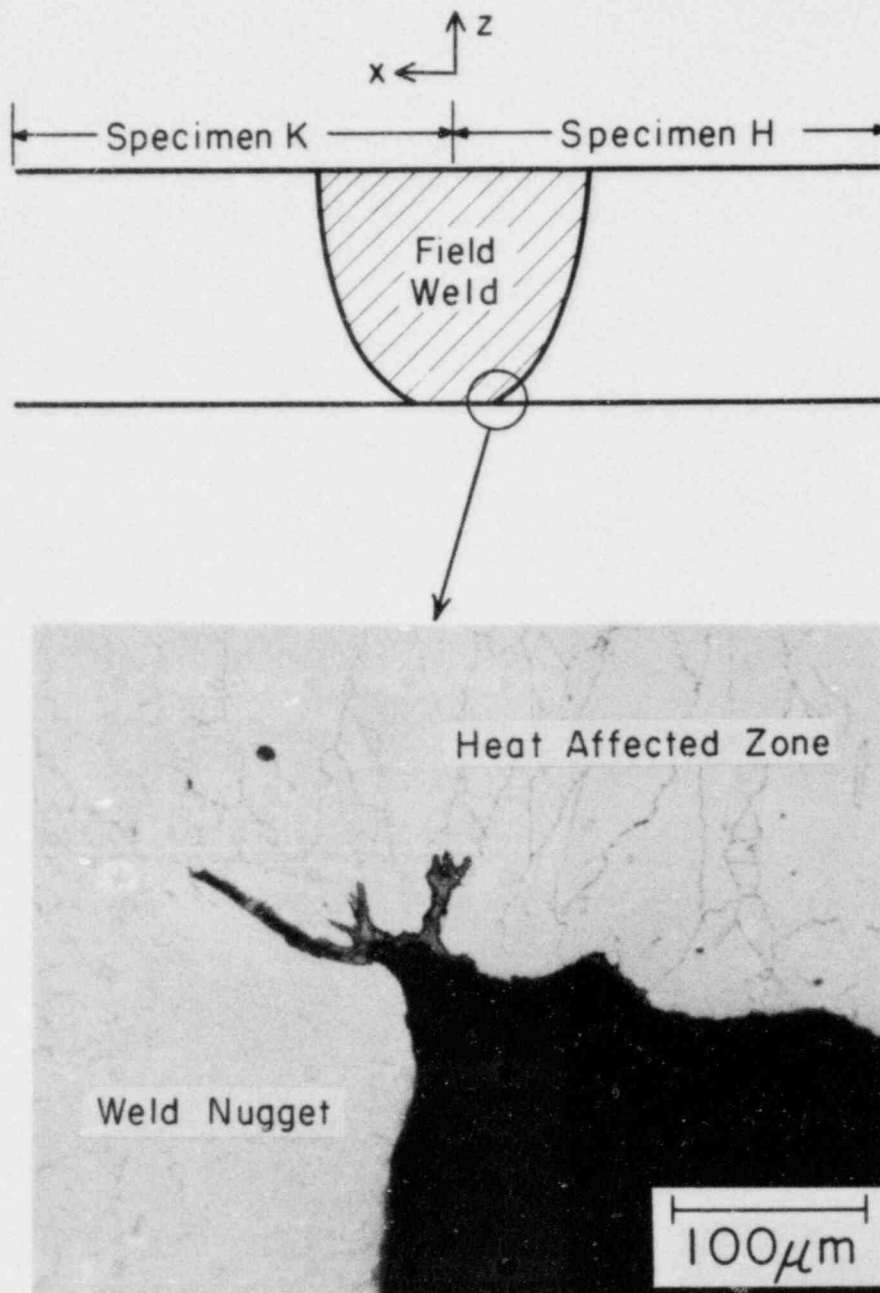
Figure 18 shows a weld defect on the ID surface from specimen H looking in the y direction on the c_2-d_2 face. The apparent defect runs along the d_2-d_3 line. There is no clear evidence for this defect being caused by SCC but it may have been. The general appearance suggests that it may be due to a weld defect.

Figure 18. Optical micrograph from specimen H along inside surface along d_2 - d_3 . Plane viewed is x-z.

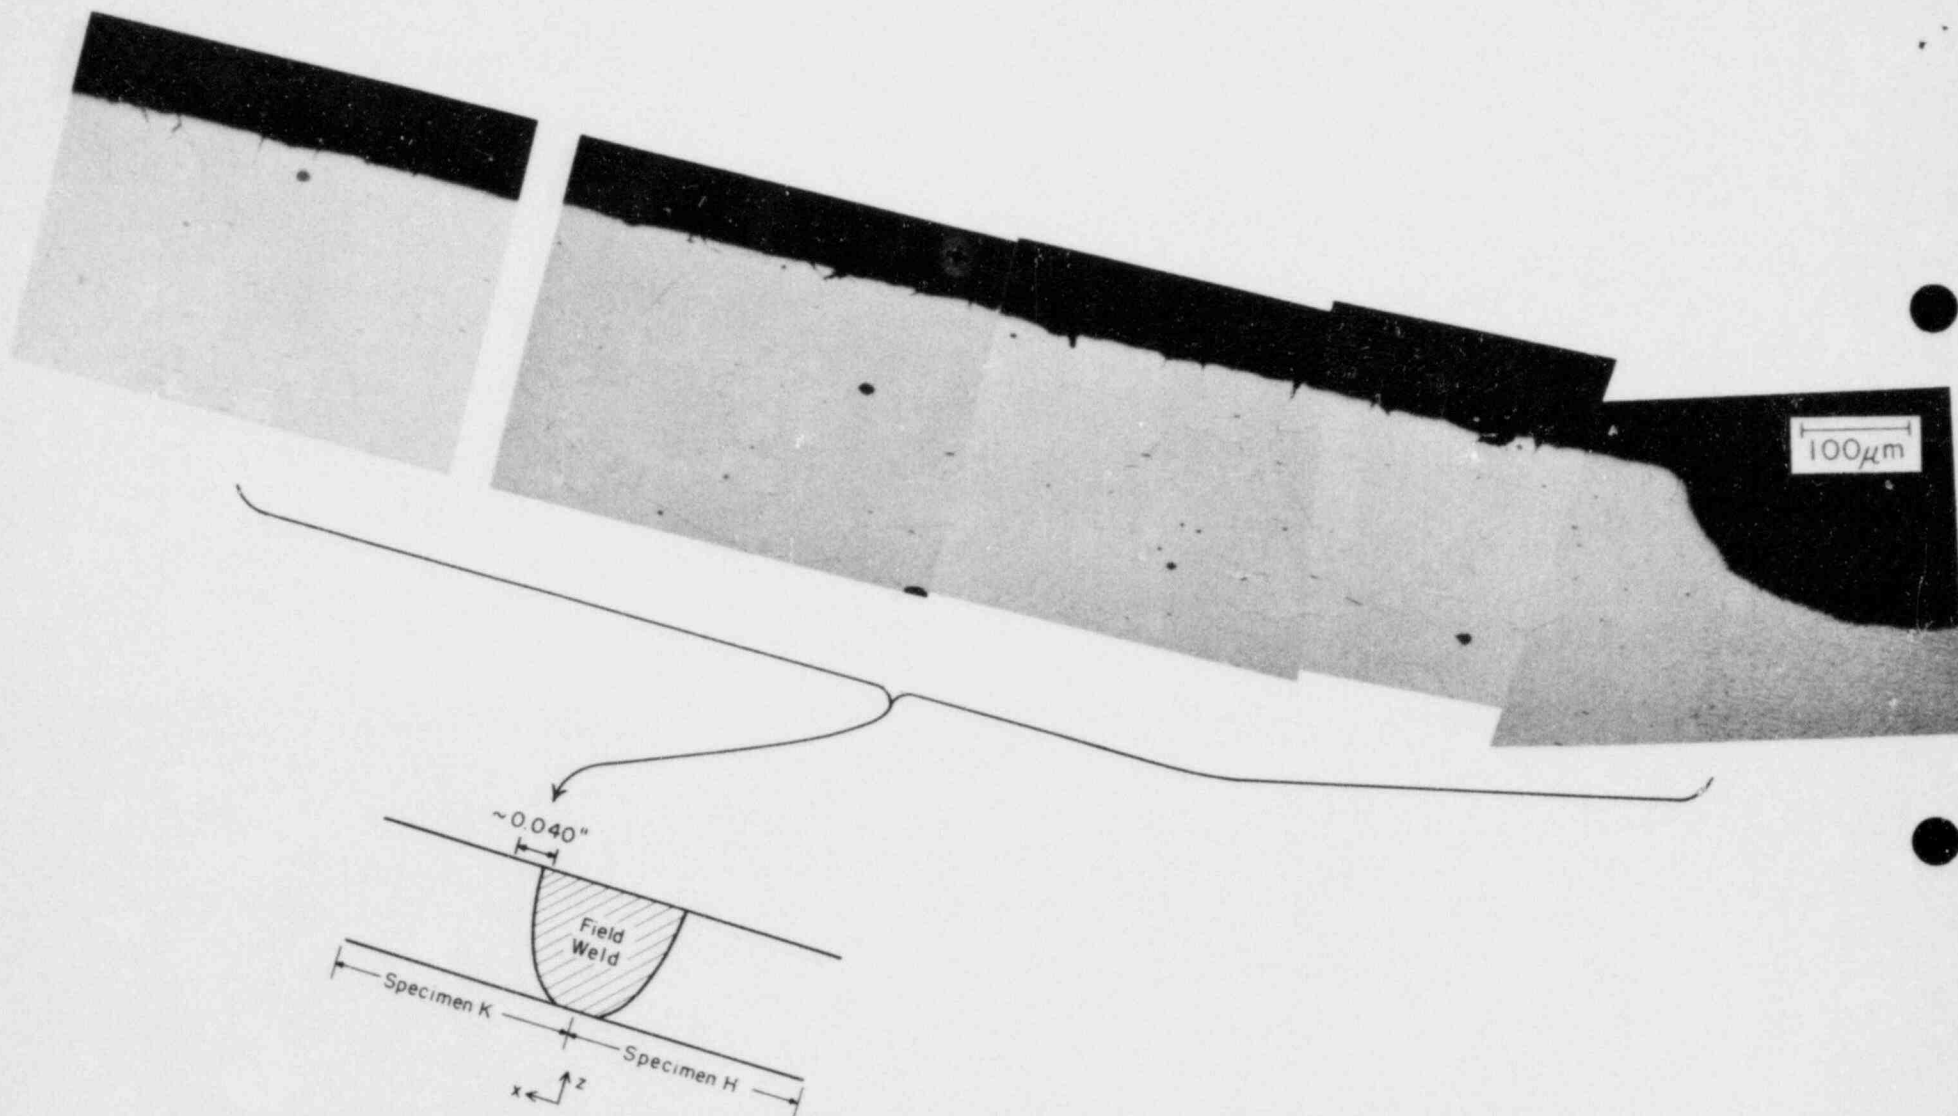
Figure 21 shows a set of micrographs from the outside surface of specimen K along the interface e_2-f_2 . A small amount of intergranular penetration is noted in all cases. These pictures were taken to ascertain the behavior of the weld sensitized region; however, it is not possible to determine whether these intergranular penetrations are related to pickling of the tubing prior to installation or are related to a stress corrosion process which occurred during the operation of the reactor.

Figure 21. Optical micrographs from specimen K showing outside surface. Penetrations are extending in the $-z$ direction from the surface. The plane viewed here is along the e_2 - f_2 line.

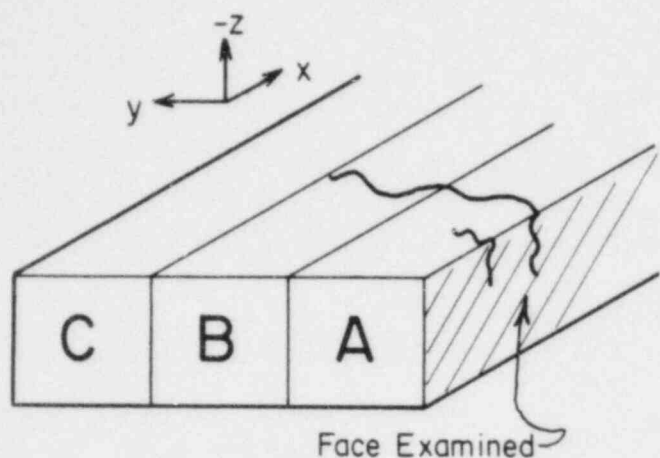
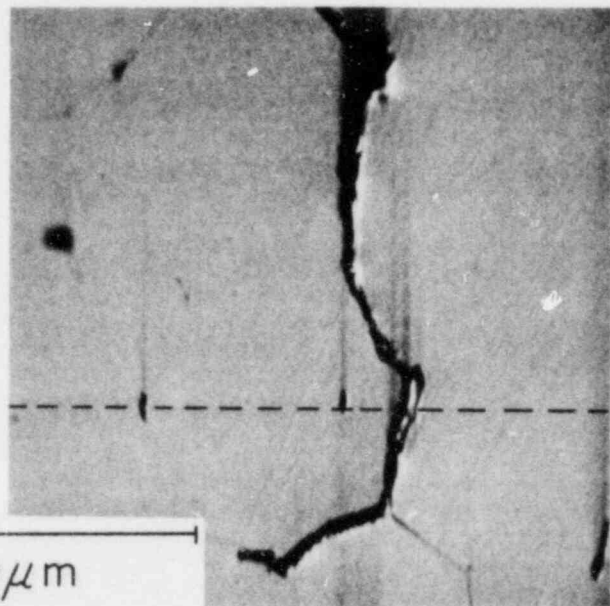
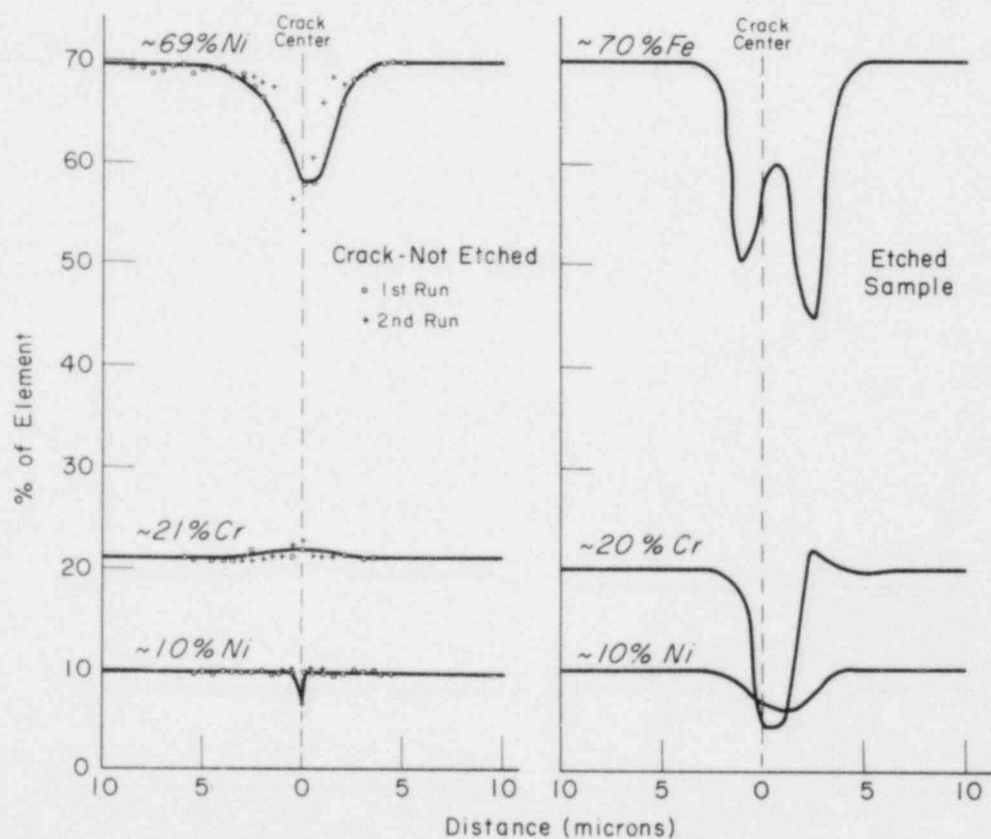
Figure 22a is a schematic diagram showing the region examined by a microprobe scan; figure 22b shows scanning micrographs of the regions examined; figure 22c and d are results from scans across the crack. These scans were conducted step-wise across the cracks. The concentrations of these elements were calculated using an analyzed Type 316^{*} stainless steel standard. Steps were taken at 0.5 micron intervals. These scans were conducted on the a_1 - b_1 surface of specimen A. The zero point of the coordinates was taken as the center of the crack. The trace was taken to be approximately perpendicular to the plane of the crack face. No particularly unusual distribution of iron, chromium, or nickel was noted. The composition of all the elements naturally decreased in the vicinity of the crack. The slight humps and irregularities are associated with grayish precipitates.

Figure 22. (a) Schematic location showing where microprobe trace across crack was performed. (b) Photographs showing where traces performed. (c) - (d) Results from separate determination at different sites along crack.

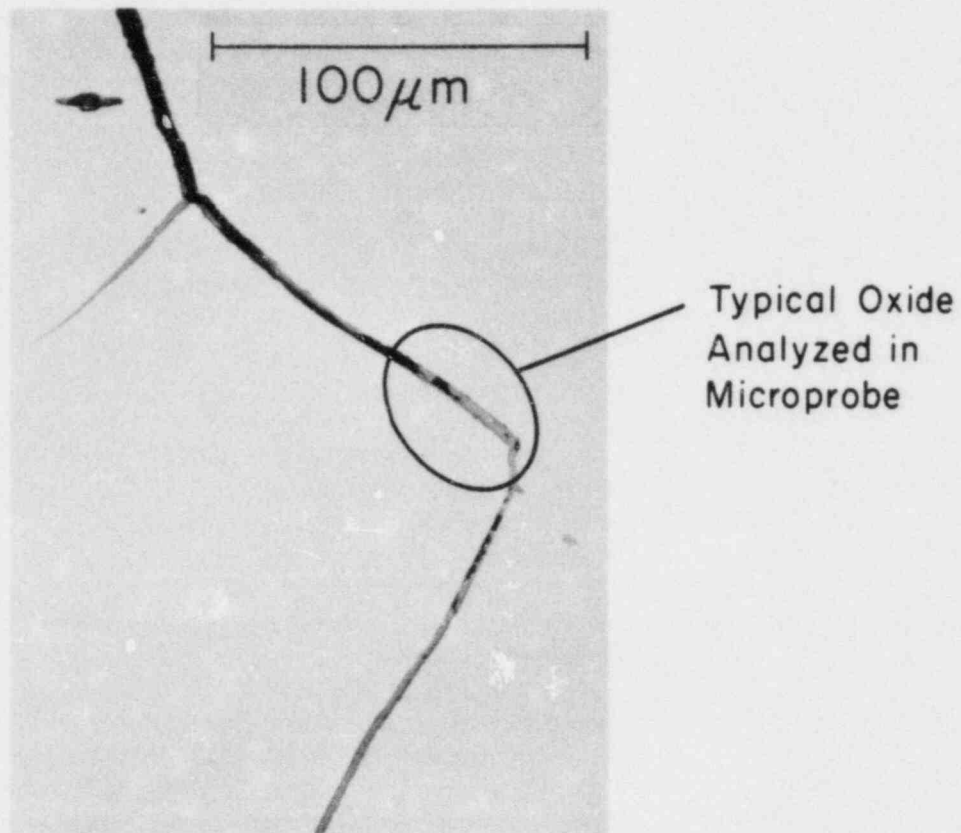
The oxide material in a crack similar to the one shown in figure 23 was analyzed for the entire spectrum of elements starting with the element magnesium. Only elements Fe, Cr, Ni, Mn and a trace of Si and Mn were detected. Special attention was directed toward finding elements Cu, F, Cl, Br, Pb, S, As, but none was found in significant quantities above the minimum sensitivity of 0.03 to 0.1 weight percent. There appears to be a slight indication of copper enrichment. The enrichment of copper on iron base surfaces is common because high purity water is often exposed to heat exchangers constructed

Figure 23. Typical oxide in crack showing where the x-ray spectrum was analyzed. This is not the region examined but the oxide is typical.

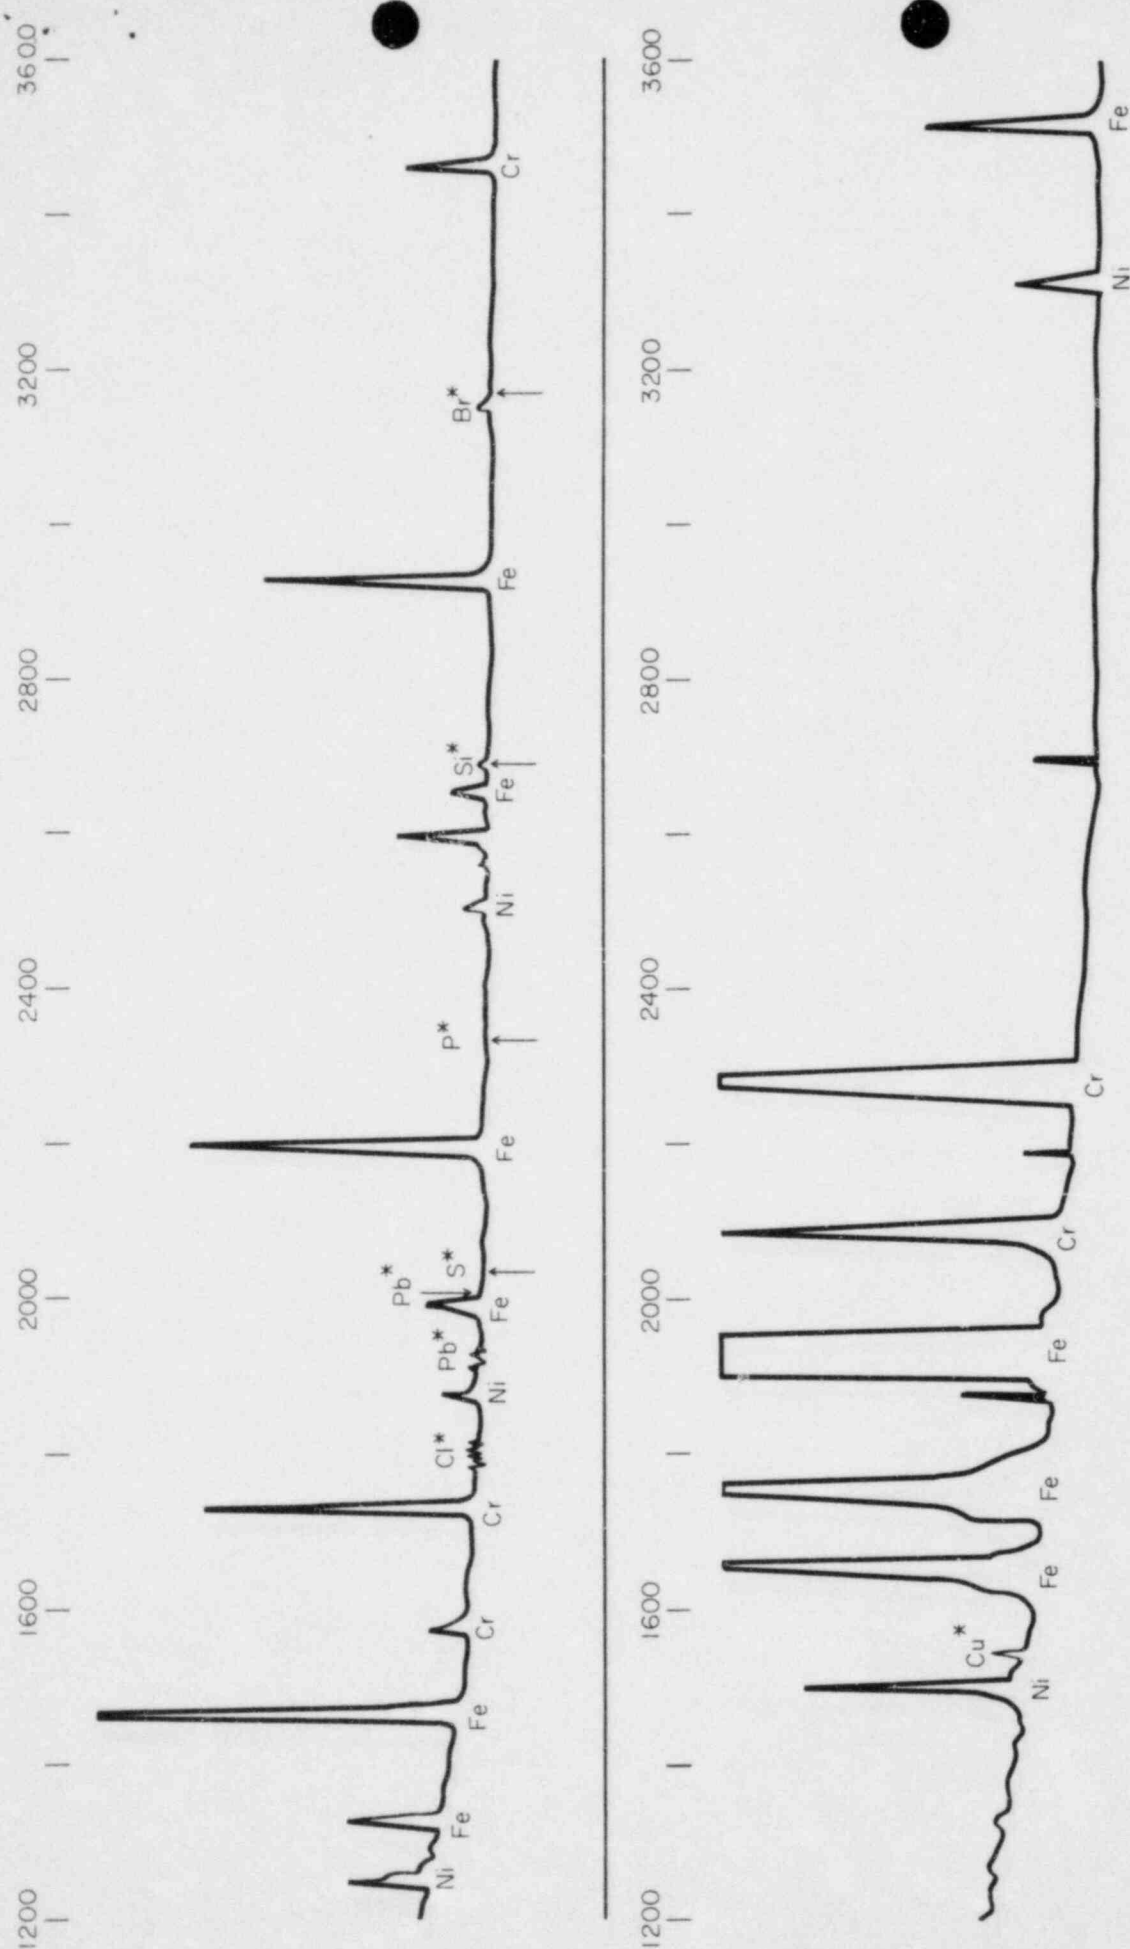
of copper base alloys. Figure 24 shows the result of the scan of the spectrum. On figure 24 the various spectral peaks are designated for the respective alloy elements which were found. Also the locations of primary peaks for other elements, sought but not found, are noted.

Figure 24. Intensity of x-ray emissions from spectral scan of one piece of oxide in crack by microprobe. Special regions where primary peaks should have occurred for particularly sought elements as noted with asterisk.

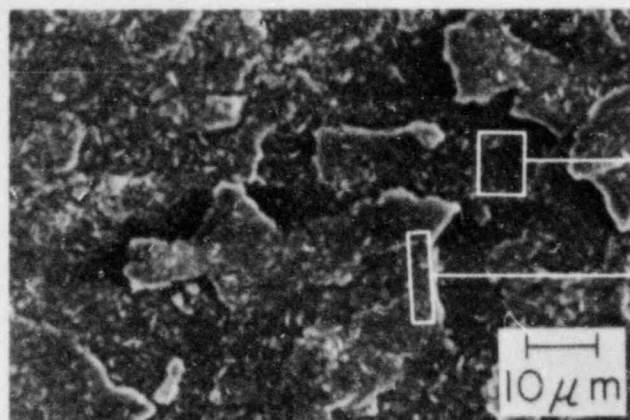
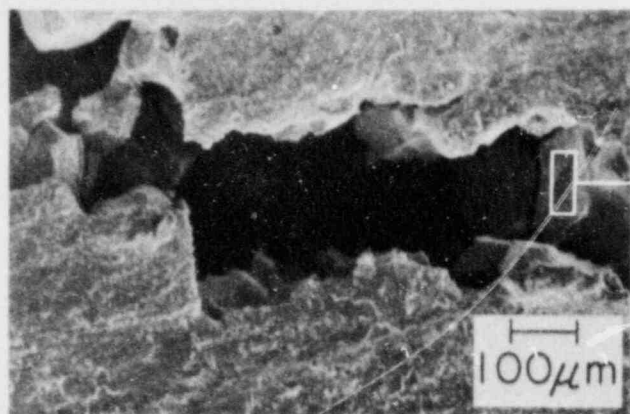
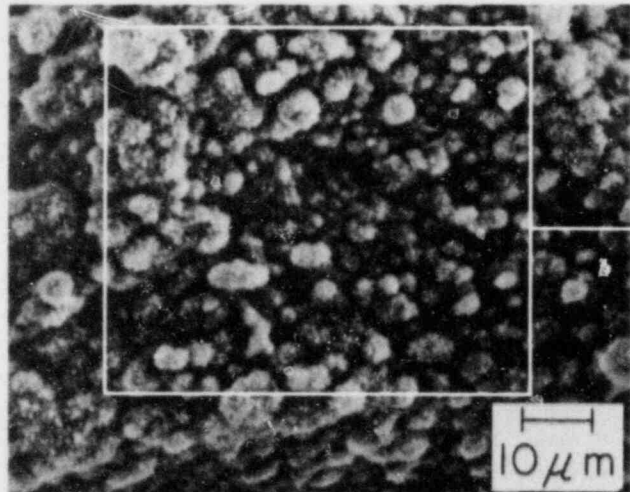
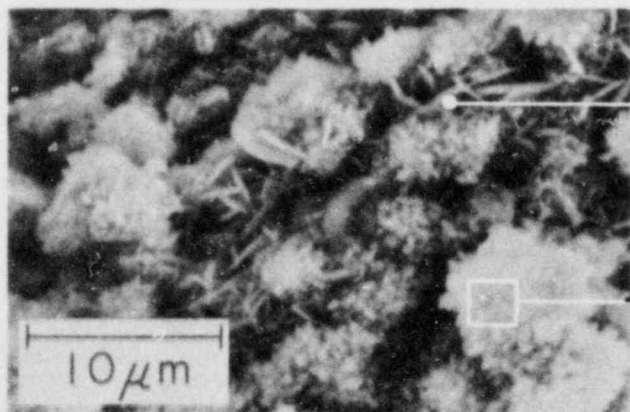
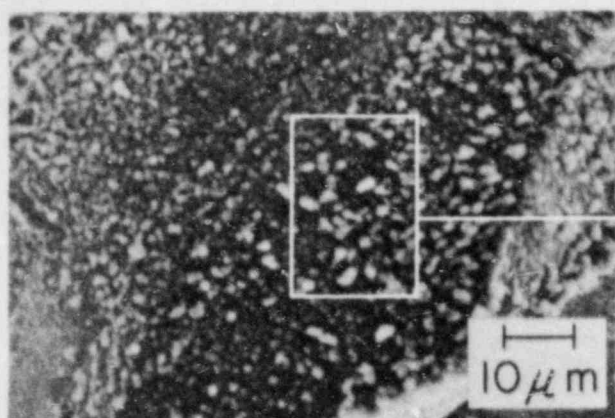
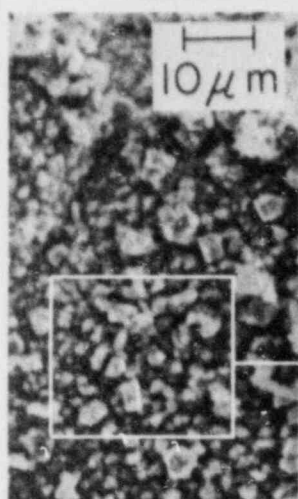
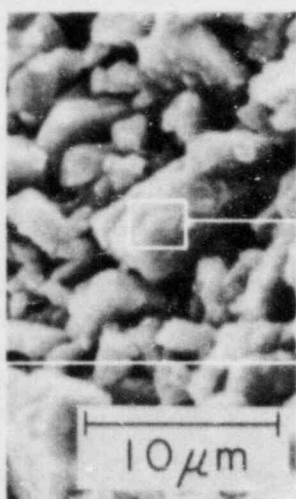
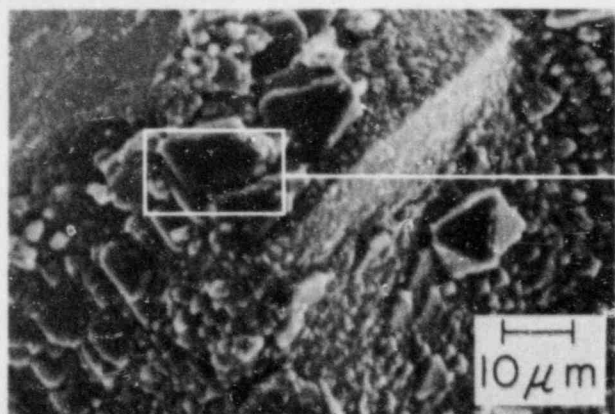
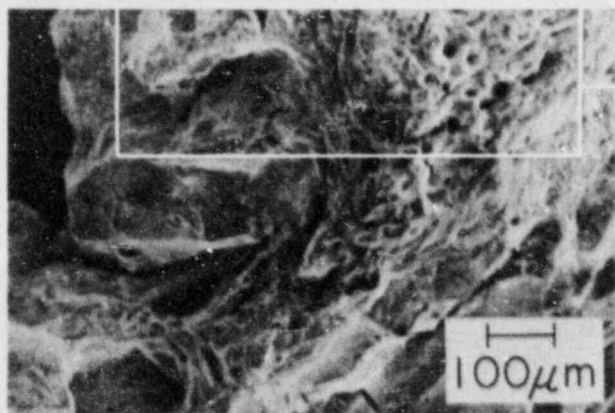
Figures 13-17 showed distributions and morphologies of precipitates on the crack surface. The chemical composition of these precipitates was determined approximately using the microprobe. Figure 25 shows the complete set of results including the site from which the analyses were taken and the Cr to Fe ratio as determined directly from the x-ray peaks for the two elements. In addition, for comparison, the morphology and chemistry of surface scale is shown in figure 25. There are three very important observations here:

1. The Cr/Fe ratios are generally higher than that in the alloy.
The theoretical ratio in the alloy is $\text{Cr:Fe} = 18:74 = 0.24$. However, the uncorrected ratio from x-ray emission from examining a clean surface is 0.4. Thus, the ratios in figure 25 should be compared with the latter number.
2. The Cr/Fe ratio at the crack mouth is very high.
3. There are wide local ranges as noted at the 3 mm position.

The basis for these enrichments in chromium appear to be related to the relative solubility products of the iron hydroxides and chromium hydroxide. The latter are less soluble and therefore would tend to precipitate earlier. The enrichment at the crack mouth is probably related to a change in pH

thereat. Work on chemistries in restricted geometries has shown that inside cracks of iron base alloys the pH at room temperature lies in a range of about $\text{pH} = 3.0$. Presumably the basis for the very great enrichment of Cr at the 0 mm position is related to the great driving force for precipitation when the pH changes from that inside the crack (low pH) to that in the bulk environment (neutral pH).

The wide range of Cr/Fe ratios at the 3 mm position suggests that the crystals formed at different times when the solution contained widely varying ratios of Fe and Cr soluble ions. For example, the Cr/Fe = 0.8 value was from a generally broad area which certainly includes some of the substrate. Most of the dissolution contributing to the enriched chromium may have come from the dissolution of the carbides which are rich in chromium. The iron rich crystals may have come at a time when the chromium free zone was dissolving at the tip of the propagating crack.

The difference in Cr/Fe ratio of the "pebbles" and "needles" at the 0 mm position suggest again that the composition of the solution inside the crack changes with time. Thus, it is reasonable that the first precipitate to form, i.e. the inside or pebble part, is higher in chromium because of its lower solubility product; the needles are still high in chromium but have a relatively lower Cr/Fe ratio.

The relatively high Cr/Fe ratio found in the surface scale of figure 25 suggests that the dissolving alloy precipitates so that the chromium is enriched according to the previous comment concerning the effect of pH on solubility products.

Figure 25. Montage showing scanning micrograph from face of stress corrosion crack. Special notations locate regions where microprobe determination were made. The location of each micrograph is the same as that in figure 12. Most of the scanning micrographs are from the series shown in figures 13-17. For reference the Cr/Fe ratio of scale-free type 304 stainless steel is 0.4. These ratios are from direct scale readings and are not corrected.
