QUAD CITIES 1
NUCLEAR GENERATING PLANT

CONTROL ROD BLADE
INSPECTION AND EVALUATION

April 1974

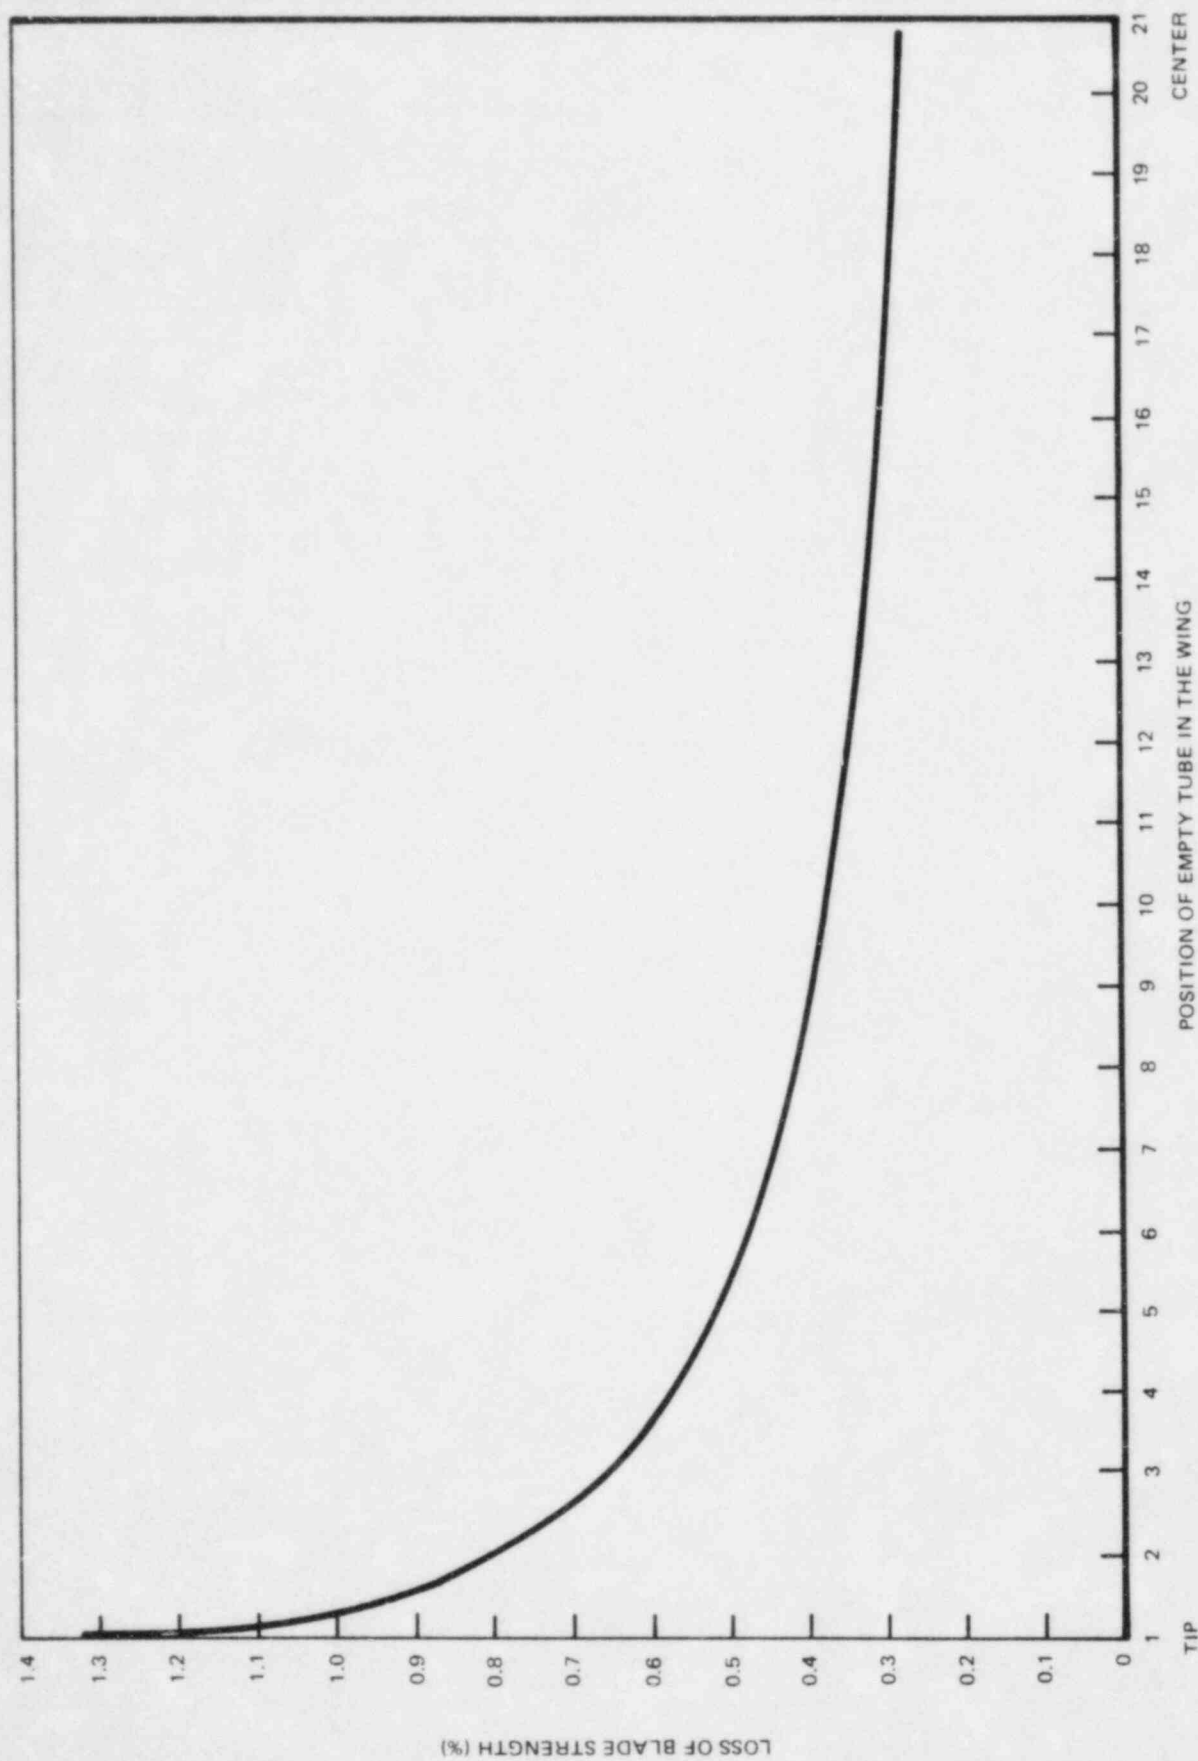
Figure 1. Change in Control Blade Strength Per Empty Poison Tube

1. No wing should contain more than four inverted tubes.
2. Each inverted tube location is assigned a value for a change in control rod blade strength in accordance with Figure 1. The sum of the values for each inverted tube in a control rod blade (all four wings) must not exceed 4%.

*Numbers represent location of B₄C tubes in the wing per Figure 1.

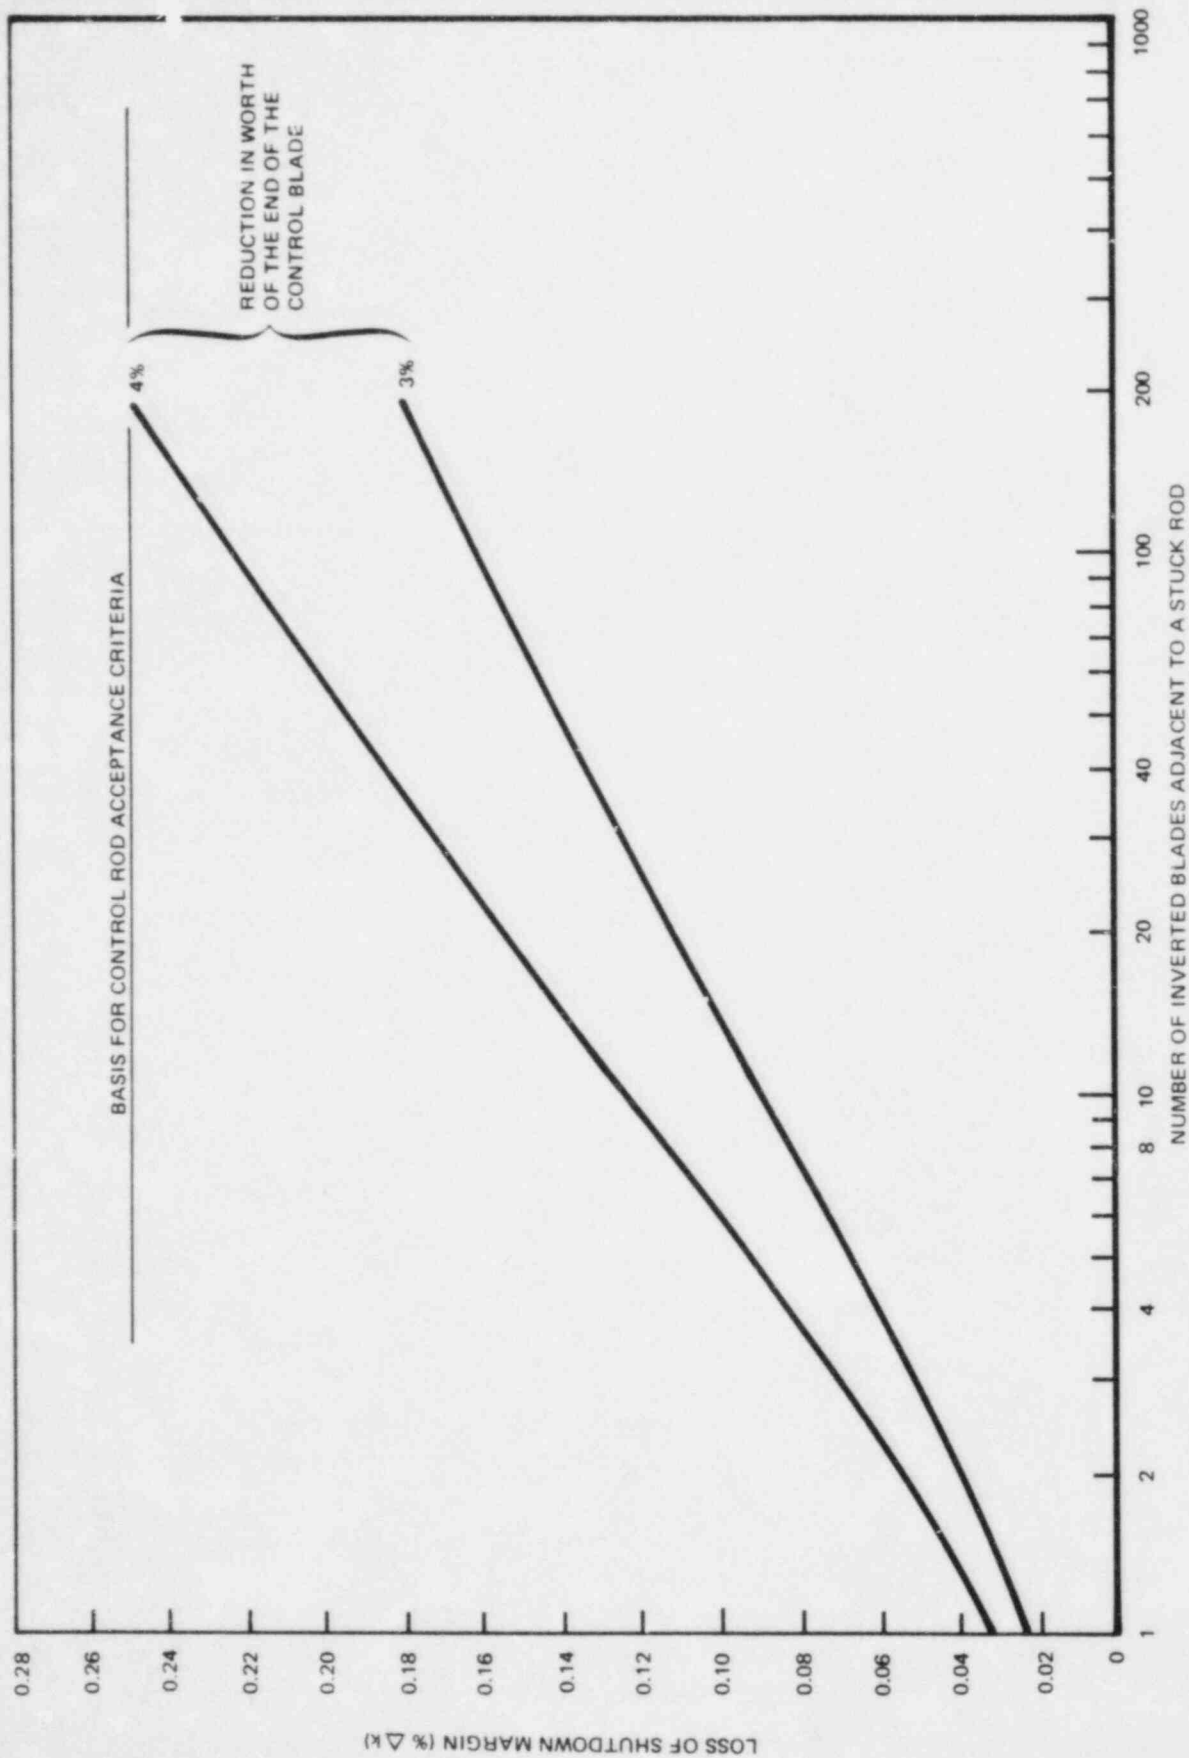
Figure 2. Loss of Shutdown Margin Versus Number of Inverted Blades with 12 in. - 15 in. B_4C Slump Placed Adjacent to a Stuck Control Rod - Equilibrium Core With Axially Distributed G_d

Based on the inverted tubes found in Quad Cities Unit 1, the shutdown margin could be reduced 0.04% ΔK for certain fully withdrawn control rods due to B_4C in inverted tubes slumping to the maximum during the next operating cycle. The rod position most affected by surrounding blades with inverted tubes is position 10-15. This is adjacent to a number of rods which contain inverted tubes. Other inverted tubes will be sufficiently separated from the rod of concern (10-15) so as to have no effect on shutdown margin with the rod fully withdrawn.
